# 1963 - 1967 Corvette: Service Bulletin: Fuel Gauge System Diagnosis

**Subject:** Fuel Gauge System Diagnosis

**Source:** Chevrolet Technical Service Bulletin

**Bulletin Number:** DR #752, Section VIII

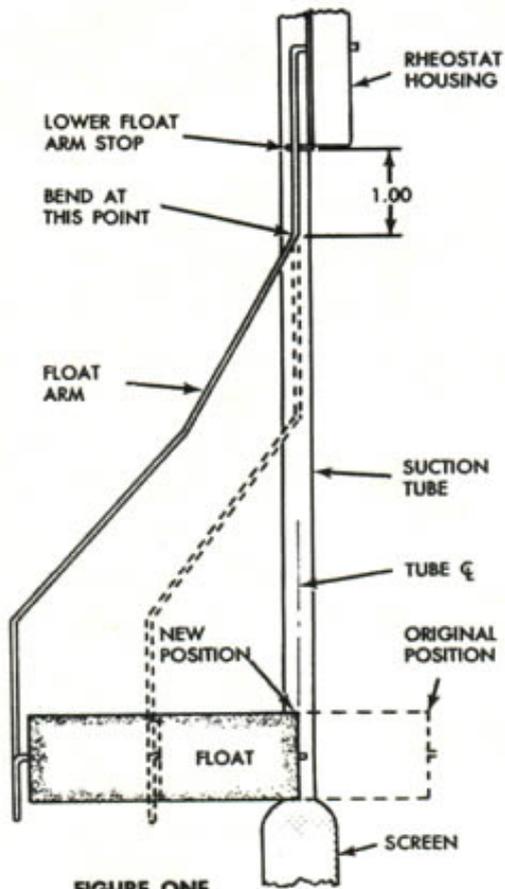
On the 1965 Chevrolet Station Wagon tank units, complaints of "never reads less than 1/4" or "tank rattle" may be caused by an interference between the tank unit float and the tank ribs due to an improper mounting flange angle. This problem has been corrected in production and identified by an orange paint mark at the sender mounting area.

**CAUTION:** In the above procedure, there is a possibility of breaking the solder joint where the suction tube passes through the mounting plate. If this occurs, or if a new tank sending unit is installed on tanks without the orange paint identification, the replacement sending unit should be reworked per Figure 1 (Page 6) prior to installation.

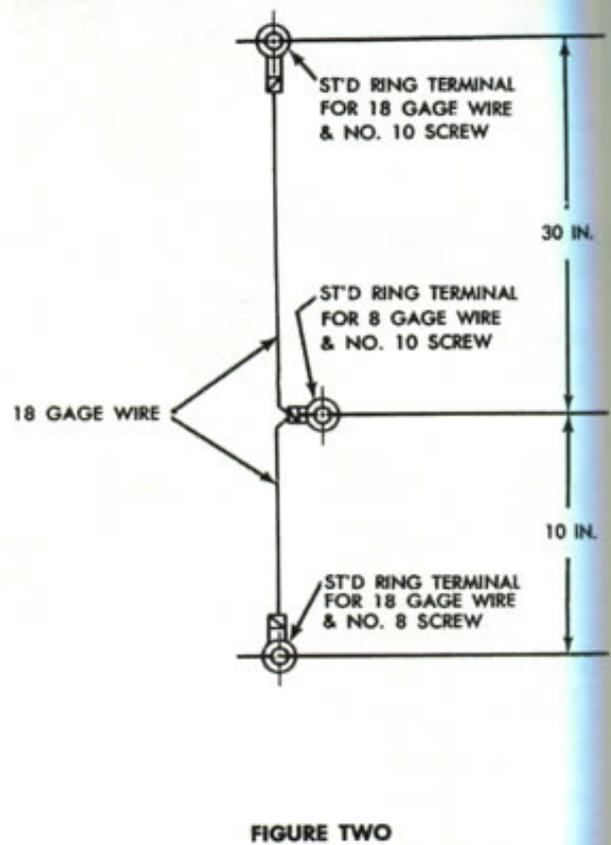
a) Dash unit ground - the 1965 Chevrolet uses two stud mounted clips to both ground and retain the instrument cluster. This circuit is sensitive to dimensional variation and may be tested with a jumper wire from each stud to the chassis.

If ground circuit correction is needed, make a ground wire assembly as shown in Figure 2, Page 6. Install as shown in Figure 3, Page 6.
