1965 Corvette: Service Bulletin: Turn Signal Switch - Failure to Cancel

Subject: Turn Signal Switch - Failure to Cancel

Source: Chevrolet Technical Service Bulletin

Bulletin Number: DR #706, Section XII

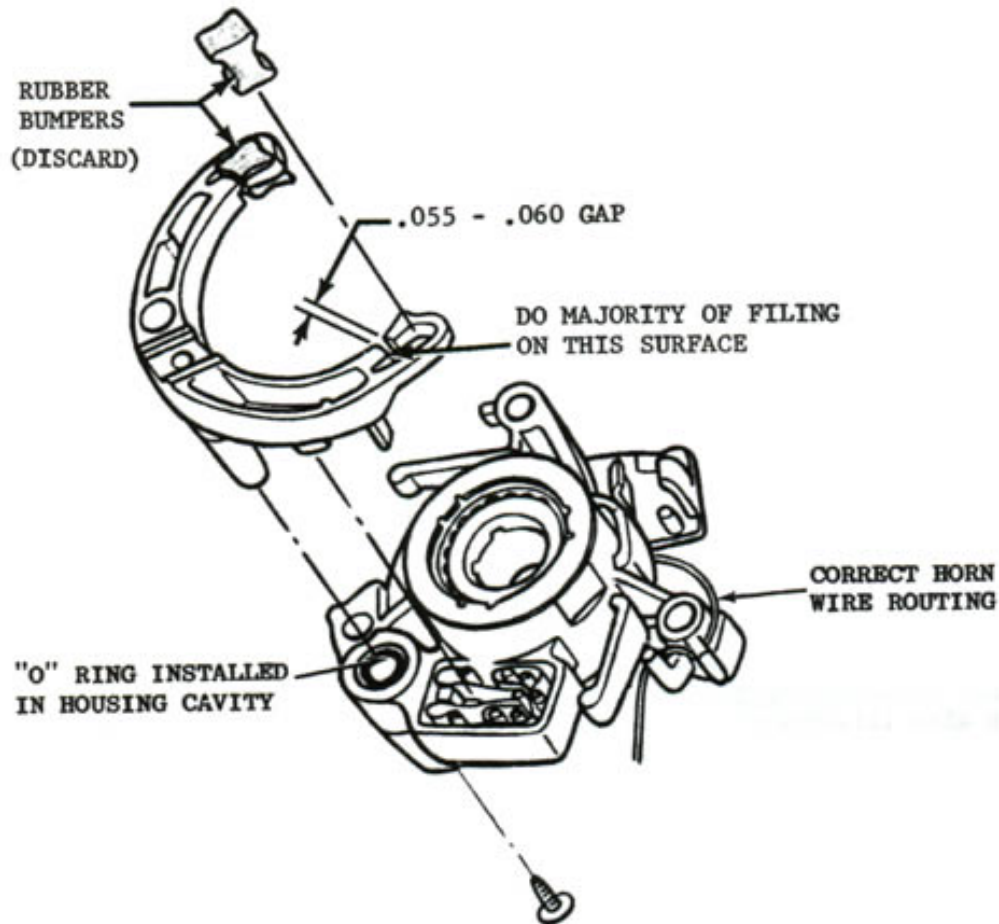
Early production 1965 vehicles, except Chevelle, may exhibit a "failure to cancel" or a "partial cancel" condition of the turn signal switch assembly. This condition is prevalent from the right turn position and caused by a number of variables within the switch assembly. The cancelling cams are not the cause of the malfunction.

A complete failure to cancel is obvious but when partial cancel occurs, the turn signal lights will go out but one brake light will be inoperative. This could easily be incorrectly diagnosed as a bulb, socket, or wiring failure.

It should also be noted that if for any reason the actuator lever is removed from the switch body, the "O" ring must be placed in the body cavity (as shown on the attached sketch) when reinstalling the lever. The correct horn wire routing is also illustrated in the sketch.

1. Remove steering wheel (refer to Section 9 of Shop Manual).

2. Remove and discard both rubber bumpers from the actuating plate (see sketch).
3. Using a small file, such as an ignition point file, open the gap in the cancelling pawls to .055/.060 (rework both sides). NOTE: After cleaning any flash from the moveable arm face, perform the stock removal from the stationary arm.
4. Blow out loose filings with air hose.
5. Replace the steering wheel, temporarily, and test the switch for cancelling.
6. If the switch now works correctly, reinstall the steering wheel. If the switch still fails to cancel, it will be necessary to replace the switch assembly (Part No. 910821).
