1984 Corvette: Service Bulletin: Engine Stops Running When Starting with Air Conditioning "On"

Model and Year: 1984 Corvette with Automatic Transmissions

Source: Chevrolet Dealer Service Bulletin

Bulletin No: 84-240

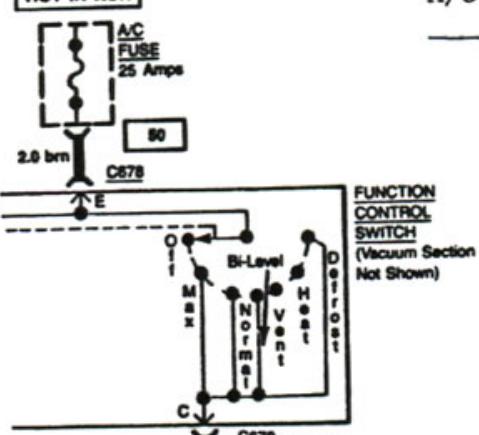
A/C CLUTCH ON REVISED ECM SIGNAL INPUT BLOCK DIAGRAM

Some 1984 Corvettes may exhibit a condition of the engine to stop running; when starting with the air conditioning "on". The following wiring revision will correct this condition and could assist idle quality as well.

This revision requires installing a 16 Ga. wire into the A/C discrete circuit at connector C-467, Pin F of the I/P to ECM harness, routing the wire through the bulk head connector and splicing into the A/C circuit of the engine, between the pressure cycling switch and the compressor clutch (see block diagram).

WIRING ADDITION
(BLACK 16 GA. GXL)
