# 1984 Corvette: Service Bulletin: Engine Stops Running When Starting with Air Conditioning "On"

**Subject:** Engine Stops Running When Starting with Air Conditioning "On"  
**Model and Year:** 1984 Corvette with Automatic Transmissions  
**Source:** Chevrolet Dealer Service Bulletin  
**Bulletin No:** 84-240  
**Section:** 8B (XII)  
**Date:** Feb. 1985

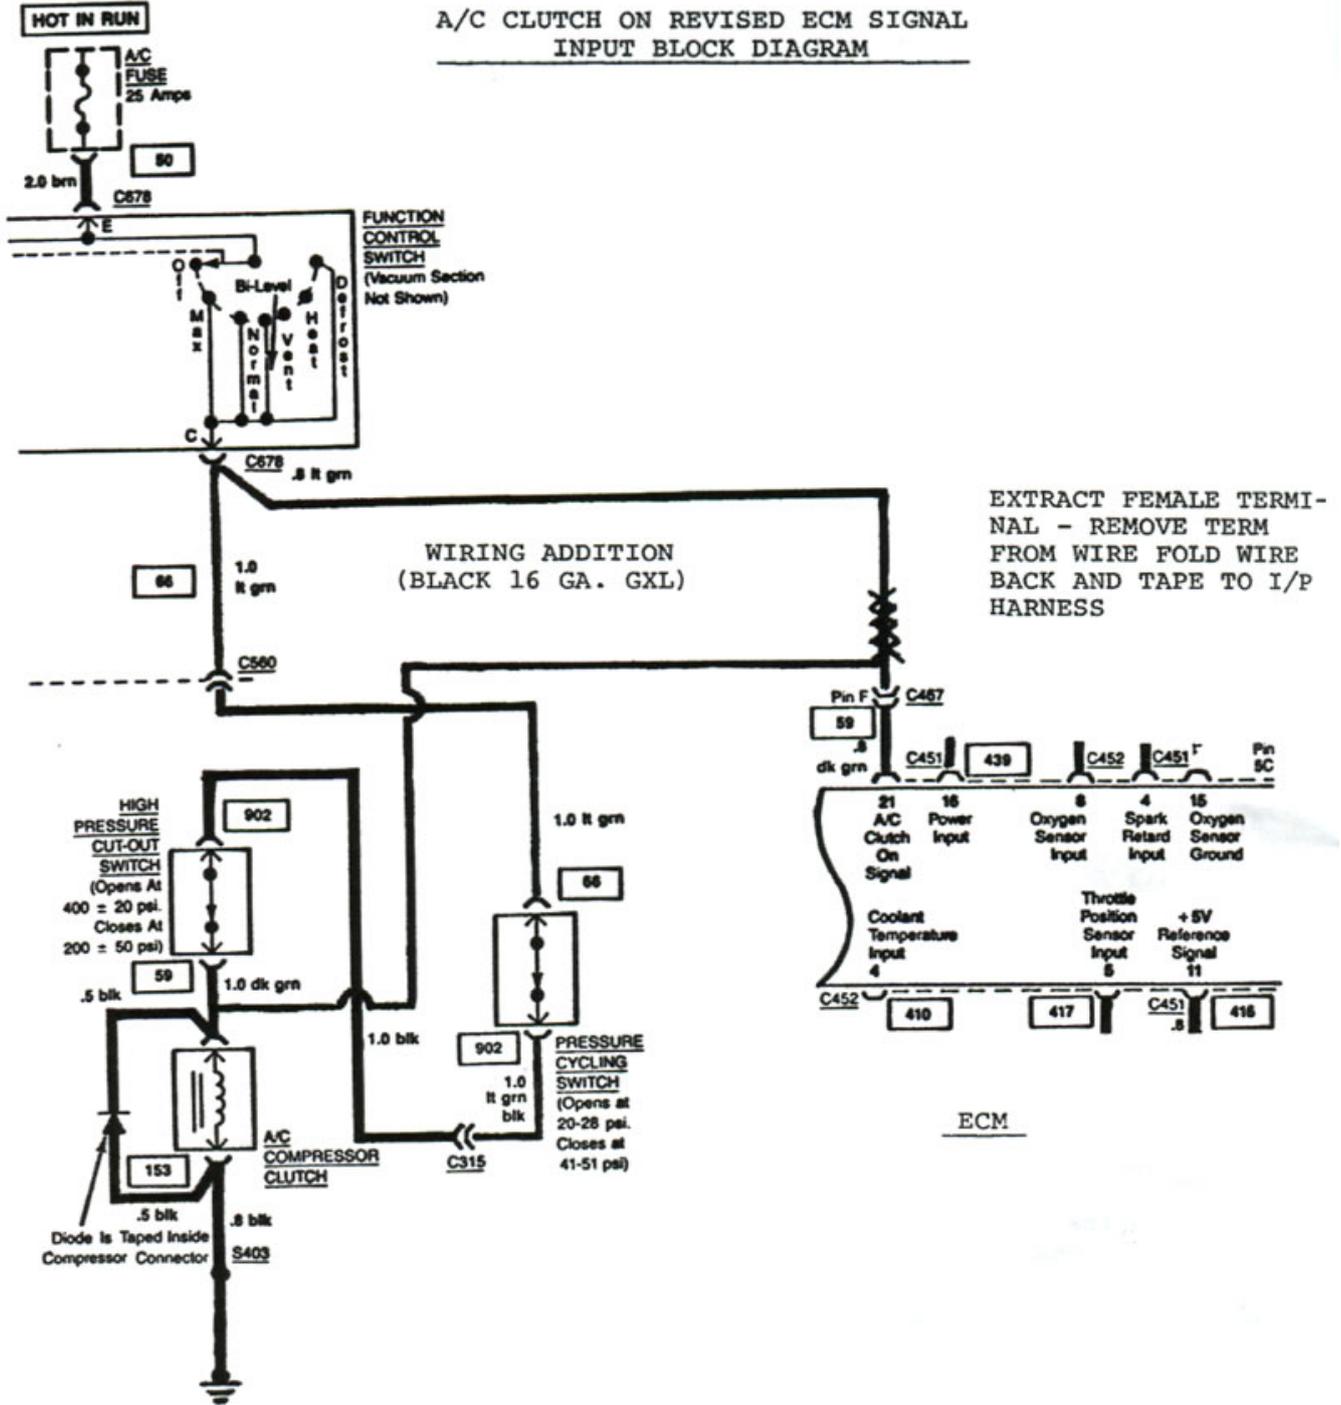
**A/C CLUTCH ON REVISED ECM SIGNAL  
INPUT BLOCK DIAGRAM**

Some 1984 Corvettes may exhibit a condition of the engine to stop running; when starting with the air conditioning "on". The following wiring revision will correct this condition and could assist idle quality as well.

This revision requires installing a 16 Ga. wire into the A/C discrete circuit at connector C-467, Pin F of the I/P to ECM harness, routing the wire through the bulk head connector and splicing into the A/C circuit of the engine, between the pressure cycling switch and the compressor clutch (see block diagram).
