# 1955 Corvette: Service Bulletin: Hard Shifting

<b>CHEVROLET—CENTRAL OFFICE</b> DIVISION OF GENERAL MOTORS CORPORATION DETROIT 2, MICHIGAN	
<b>TECHNICAL SERVICE BULLETIN</b> Service and Mechanical Department	
<b>SUBJECT:</b> HARD SHIFTING - 1955 MODEL PASSENGER CAR 3-SPEED TRANSMISSION	<b>BULLETIN No.</b> DR #236
<b>TO:</b> ALL CHEVROLET DEALERS	<b>SECTION</b> VII January 9, 1956
<p>In cases where hard shifting on 1955 Passenger Models with 3-Speed Transmission is experienced in high frequency shifting operations due to malfunction and/or wear of gearshift controls and butting of transmission gears, the condition may be reduced by installation of a Transmission Control Conversion Kit and three new type transmission gears.</p> <p>The new transmission gears which have more tooth chamfer entered production about July 5, 1955.</p> <p>The revised transmission controls entered production beginning with 1956 Model and the Control Conversion Kit has modified parts for use on 1955 Models.</p>

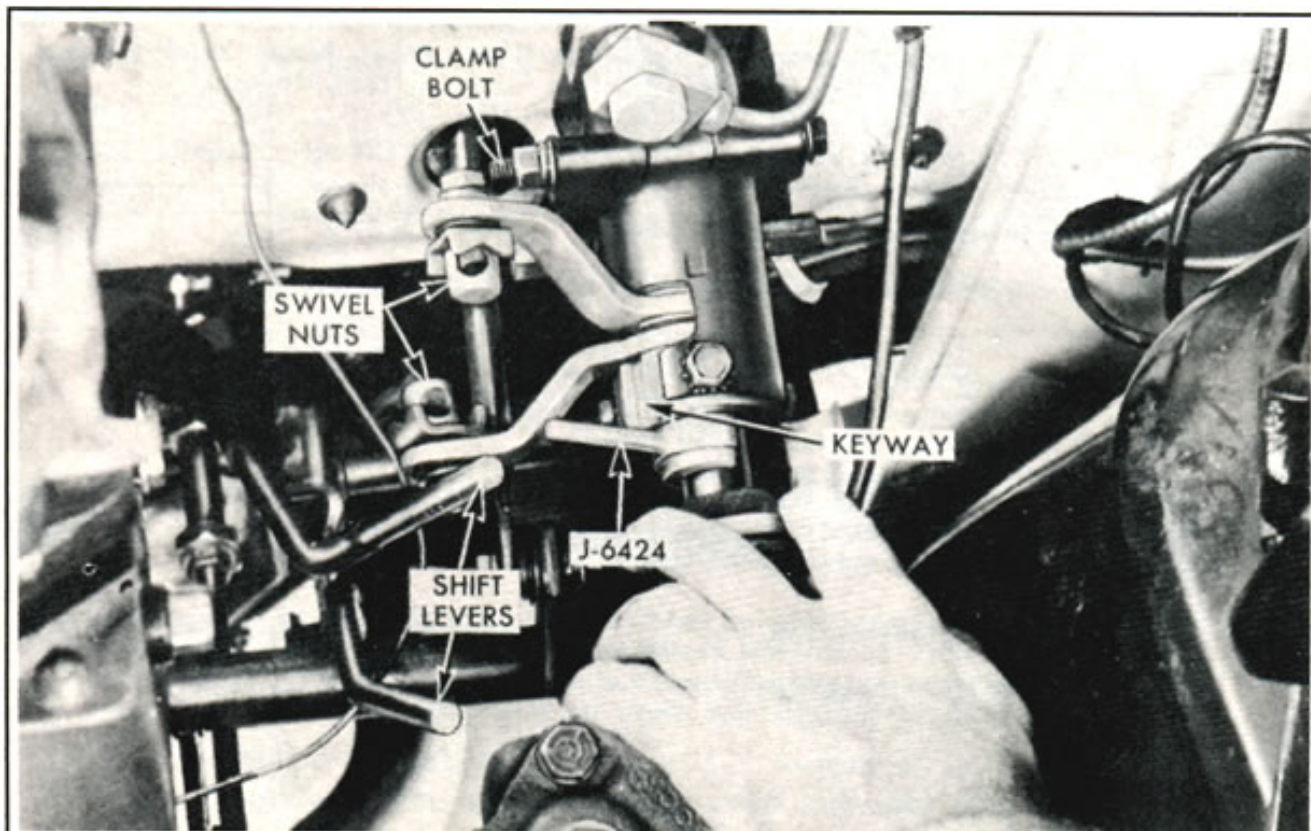
FIGURE I

GEARSHIFT LOWER CONTROL LEVER ALIGNING GAUGE

13. Insert gearshift rod ends in swivels - transmission must be in neutral detent in both ranges. Do not tighten.
14. Install alignment gauge J-6424 inserting side stamped "STD" between steering mainshaft and shifter tube in key area. This sets the required 1/16 eccentricity in proper relation to the key on shifter tube. See figure 1.

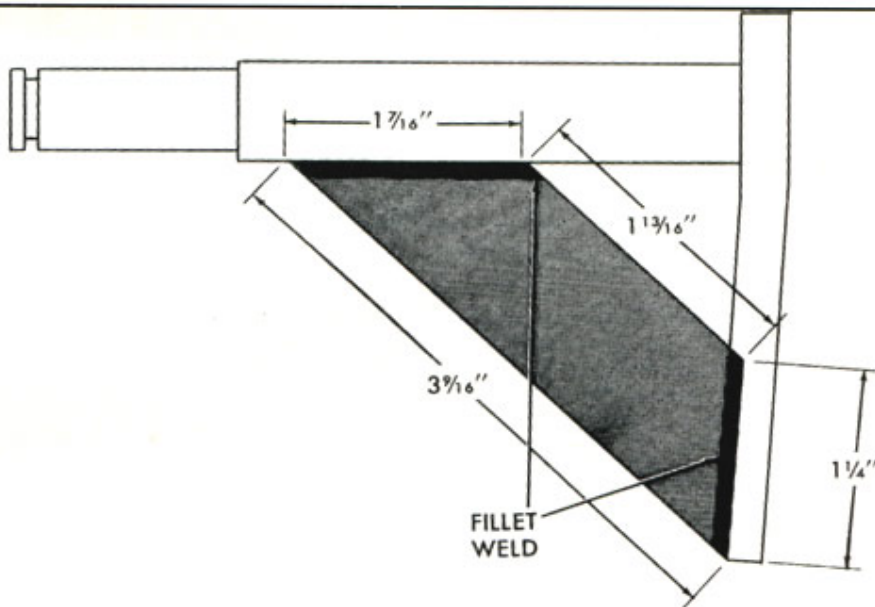
FIGURE 3

TRANSMISSION CONTROL ROD IDLER LEVER SUPPORT

Further improvement of shifting can be made by reinforcement of transmission control rod idler lever support located on left frame rail under toe pan to reduce its deflection. See figure 3.
