1955 Corvette: Service Bulletin: Hard Shifting

CHEVROLET—CENTRAL OFFICE DIVISION OF GENERAL MOTORS CORPORATION DETROIT 2, MICHIGAN	
TECHNICAL SERVICE BULLETIN Service and Mechanical Department	
SUBJECT: HARD SHIFTING - 1955 MODEL PASSENGER CAR 3-SPEED TRANSMISSION	BULLETIN No. DR #236 SECTION VII
TO: ALL CHEVROLET DEALERS	January 9, 1956
<p>In cases where hard shifting on 1955 Passenger Models with 3-Speed Transmission is experienced in high frequency shifting operations due to malfunction and/or wear of gearshift controls and butting of transmission gears, the condition may be reduced by installation of a Transmission Control Conversion Kit and three new type transmission gears.</p> <p>The new transmission gears which have more tooth chamfer entered production about July 5, 1955.</p> <p>The revised transmission controls entered production beginning with 1956 Model and the Control Conversion Kit has modified parts for use on 1955 Models.</p>

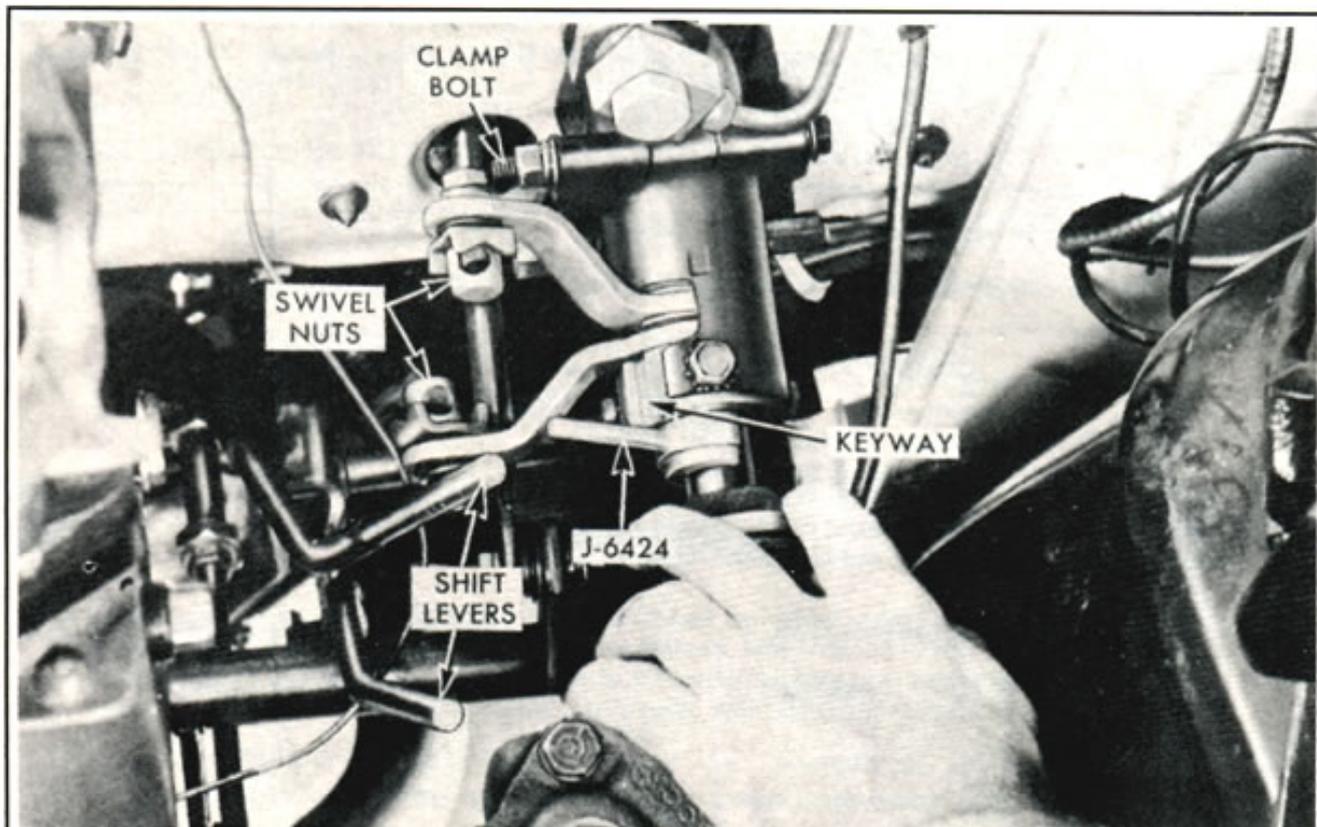
FIGURE I

GEARSHIFT LOWER CONTROL LEVER ALIGNING GAUGE

13. Insert gearshift rod ends in swivels - transmission must be in neutral detent in both ranges. Do not tighten.
14. Install alignment gauge J-6424 inserting side stamped "STD" between steering mainshaft and shifter tube in key area. This sets the required 1/16 eccentricity in proper relation to the key on shifter tube. See figure 1.

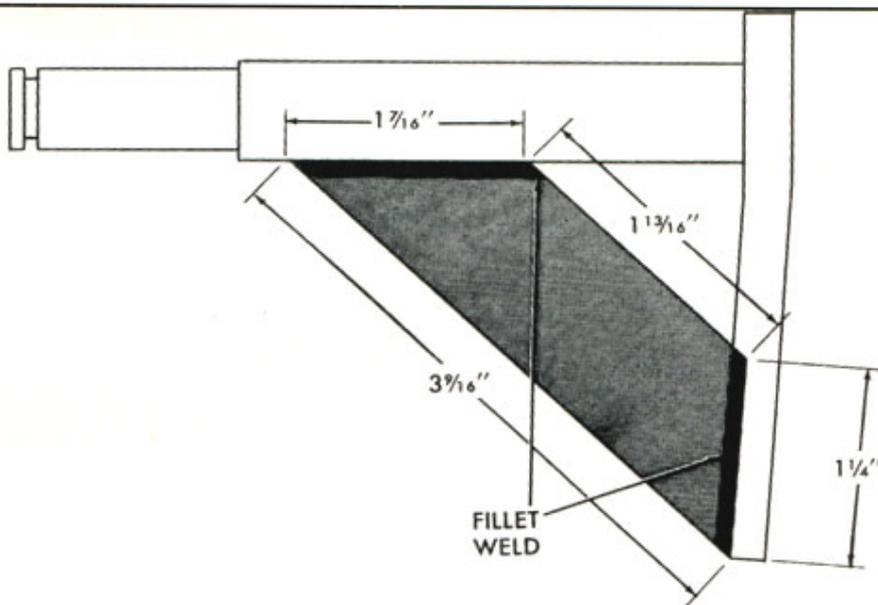
FIGURE 3

TRANSMISSION CONTROL ROD IDLER LEVER SUPPORT

Further improvement of shifting can be made by reinforcement of transmission control rod idler lever support located on left frame rail under toe pan to reduce its deflection. See figure 3.
