# 1955 Corvette: Service Bulletin: Hard Shifting

<b>TECHNICAL SERVICE BULLETIN</b>

Service and Mechanical Department	
<b>SUBJECT:</b> HARD SHIFTING - 1955 MODEL PASSENGER CAR 3-SPEED TRANSMISSION	<b>BULLETIN No.</b> DR #236  <b>SECTION</b> VII
<b>TO:</b> ALL CHEVROLET DEALERS	January 9, 1956
<p>In cases where hard shifting on 1955 Passenger Models with 3-Speed Transmission is experienced in high frequency shifting operations due to malfunction and/or wear of gearshift controls and butting of transmission gears, the condition may be reduced by installation of a Transmission Control Conversion Kit and three new type transmission gears.</p> <p>The new transmission gears which have more tooth chamfer entered production about July 5, 1955.</p> <p>The revised transmission controls entered production beginning with 1956 Model and the Control Conversion Kit has modified parts for use on 1955 Models.</p>

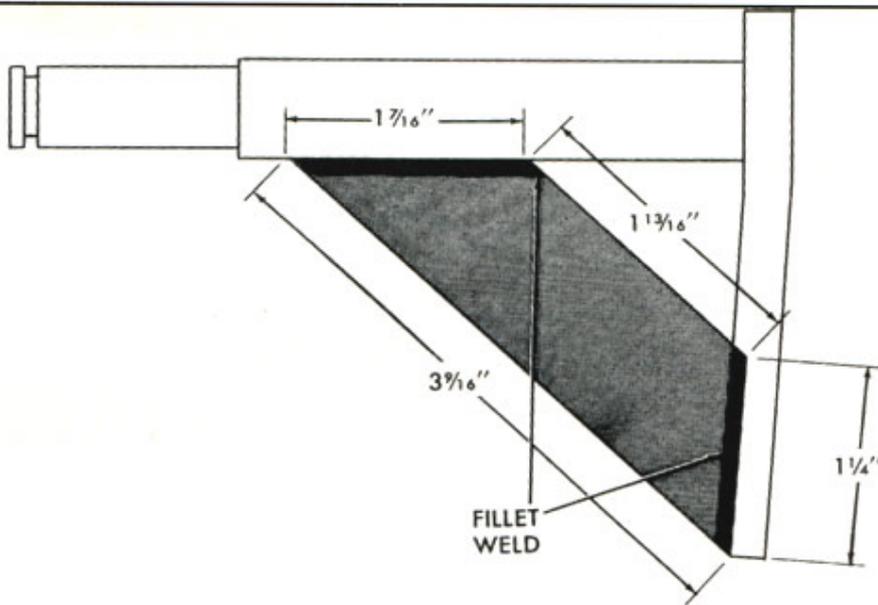
FIGURE 3

TRANSMISSION CONTROL ROD IDLER LEVER SUPPORT

Further improvement of shifting can be made by reinforcement of transmission control rod idler lever support located on left frame rail under toe pan to reduce its deflection. See figure 3.
