1970 - 1973 Corvette: Service Bulletin: Engine Overheat

Model and Year: 1970 - 1973 Corvettes with 454 Cu. In. Engines and Air Conditioning

Bulletin Number: 73-T-28, Section VI

Date: May 14, 1973

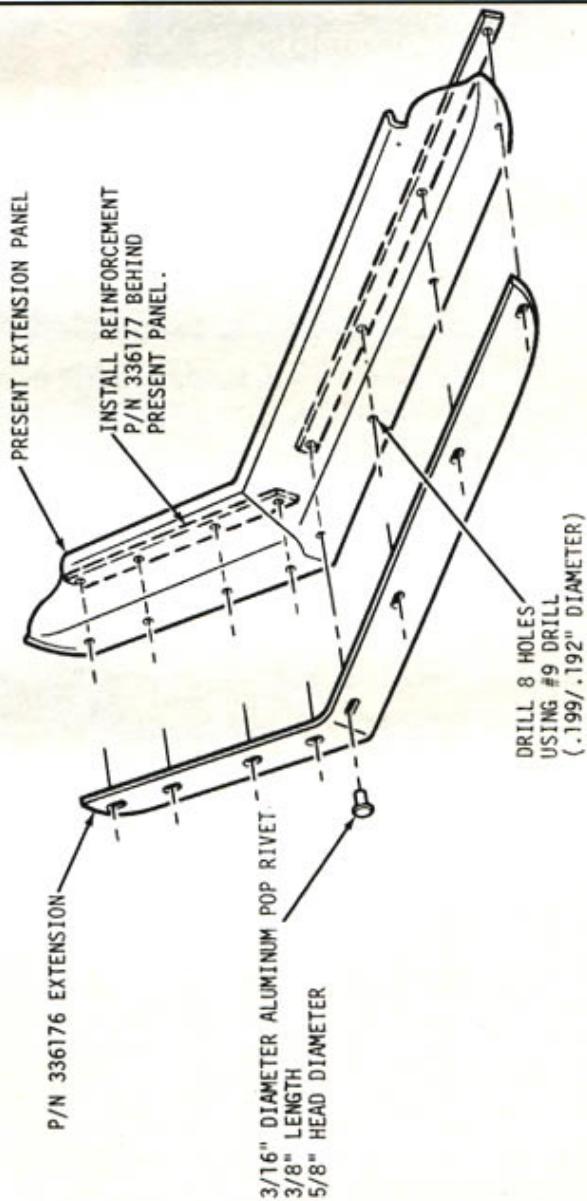
Engine overheating may be encountered on some 1970-1973 Corvettes equipped with the 454 cu. in. engine and air conditioning during high ambient temperatures when operated in heavy traffic. This condition is due to the limited amount of air flowing through the radiator at low vehicle speeds or during periods of extended idle.

To improve low speed cooling, an additional grille panel lower extension was installed in 1973 Corvettes produced after Vehicle Identification Number 1Z37Z3S410722. This extension, Part Number 336176, may be installed as illustrated on page 2 of this bulletin on early 1973 Corvettes only .
