1970 - 1973 Corvette: Service Bulletin: Engine Overheat

Model and Year: 1970 - 1973 Corvettes with 454 Cu. In. Engines and Air Conditioning

Bulletin Number: 73-T-28, Section VI

Date: May 14, 1973

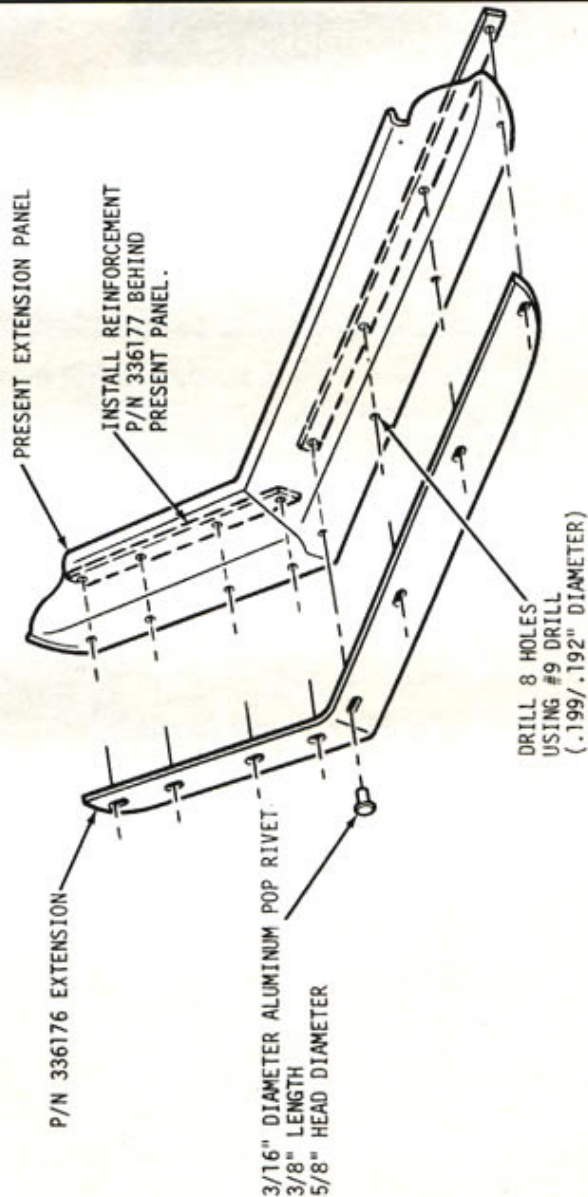
Engine overheat may be encountered on some 1970-1973 Corvettes equipped with the 454 cu. in. engine and air conditioning during high ambient temperatures when operated in heavy traffic. This condition is due to the limited amount of air flowing through the radiator at low vehicle speeds or during periods of extended idle.

To improve low speed cooling, an additional grille panel lower extension was installed in 1973 Corvettes produced after Vehicle Identification Number 1Z37Z3S410722. This extension, Part Number 336176, may be installed as illustrated on page 2 of this bulletin on early 1973 Corvettes only .
