1968 Corvette: Chevrolet Engineering Memo: Window Service Update

Subject: Window Service Update
Model and Year: 1968 Corvette
Source: Chevrolet Engineering Memo - Mr. G. H. Tyler of Chevrolet Engineering
Page Number: NA
Date: March 1968

MISC . Information from Mr. G. H. Tyler of Chevrolet Engineering

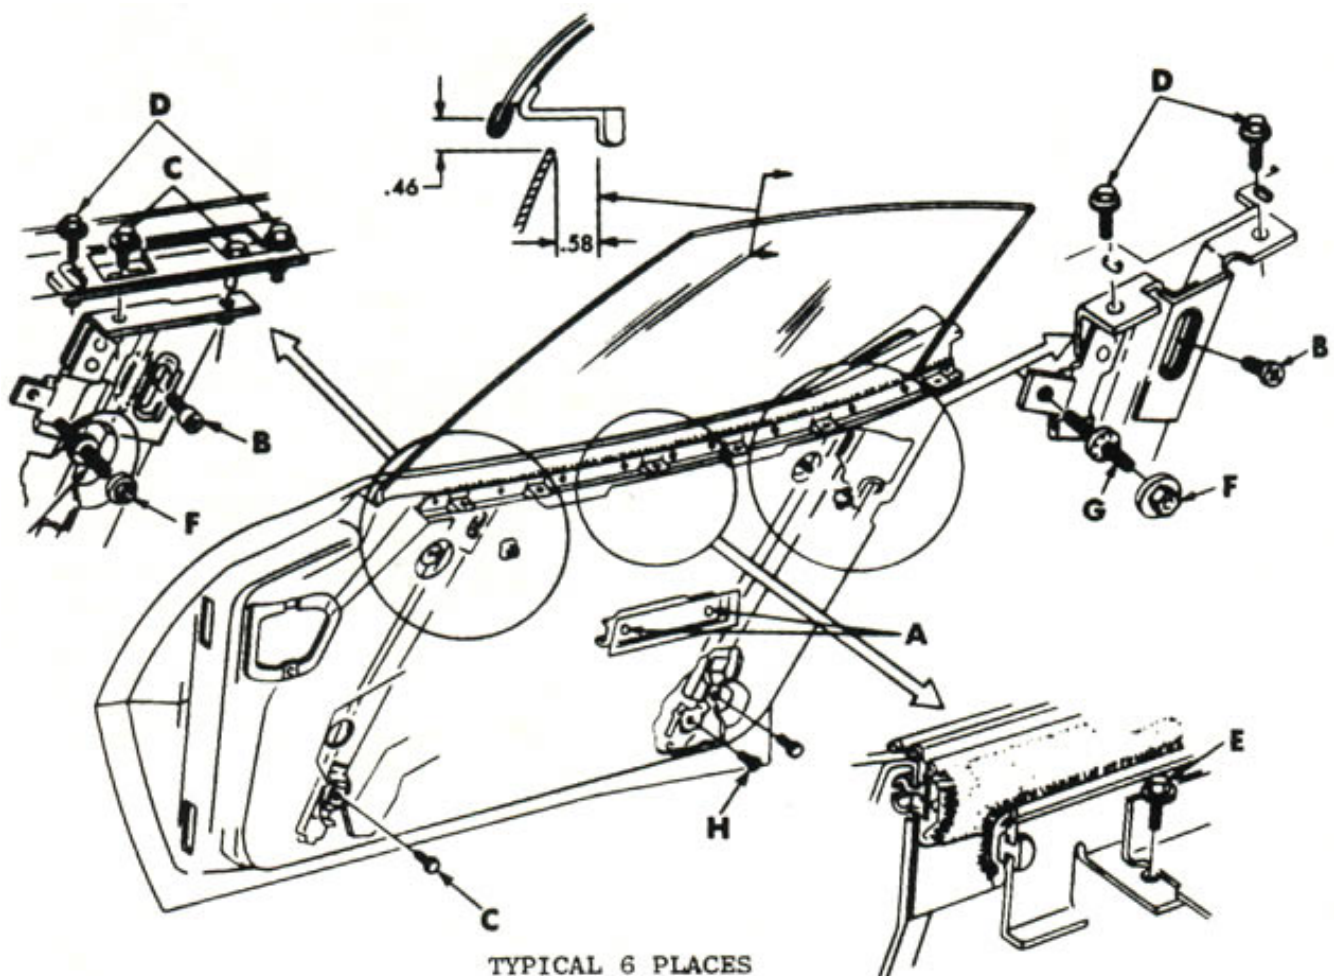
The adjustment procedure for 1968 Corvette door window glass has been revised as of this date. Items No. 3 and 4 have been revised.

1. Loosen bolts (A) and adjust the fore and aft tilt of the door window glass by rotating until a constant gap, or relationship, is obtained between the front edge of glass and the windshield pillar. Retighten bolts (A).
2. Loosen the front and rear stop screws (B) and roll glass up until top edge is .46 below roof rail. Move front and rear stops to contact the window rollers. Retighten screws (B).
3. Loosen the 3 bolts (C) and front nut (F) and slide door glass forward so that the front edge is .44 from and parallel to the windshield pillar. Retighten bolts (C).
4. Loosen bolts (D), (E) and rear nut (F). move bailey weatherstrip outboard so outer nylon pads are in contact with door outer panel reinforcement. Retighten bolts (E). move glass run channel so the top

of the glass is .58 from the vertical flange of the roof rail (move the glass run channel outboard to move the upper edge of glass inboard, move the glass run channel inboard to move the upper edge of glass outboard.) Retighten bolts (D).

5. Turn adjusting screw (G) so the front and rear inner nylon pads are in light contact with the wedges. Tighten nuts (F).
6. Loosen screw (H) and roll glass down until top edge is flush with door outer panel. Move stop to contact the window roller. Retighten screw (H).
7. Install and adjust windshield pillar weatherstrip, front rail weatherstrip, center rail weatherstrip, and rear rail weatherstrip to seal on glass.

Above procedure pertains to Assembly Plant operation. For Service, remove weatherstrip, weatherstrip retainer and door trim panel prior to glass adjustment.
