1968 Corvette: Chevrolet Engineering Memo: Window Service Update

Subject: Window Service Update

Model and Year: 1968 Corvette

Date: March 1968

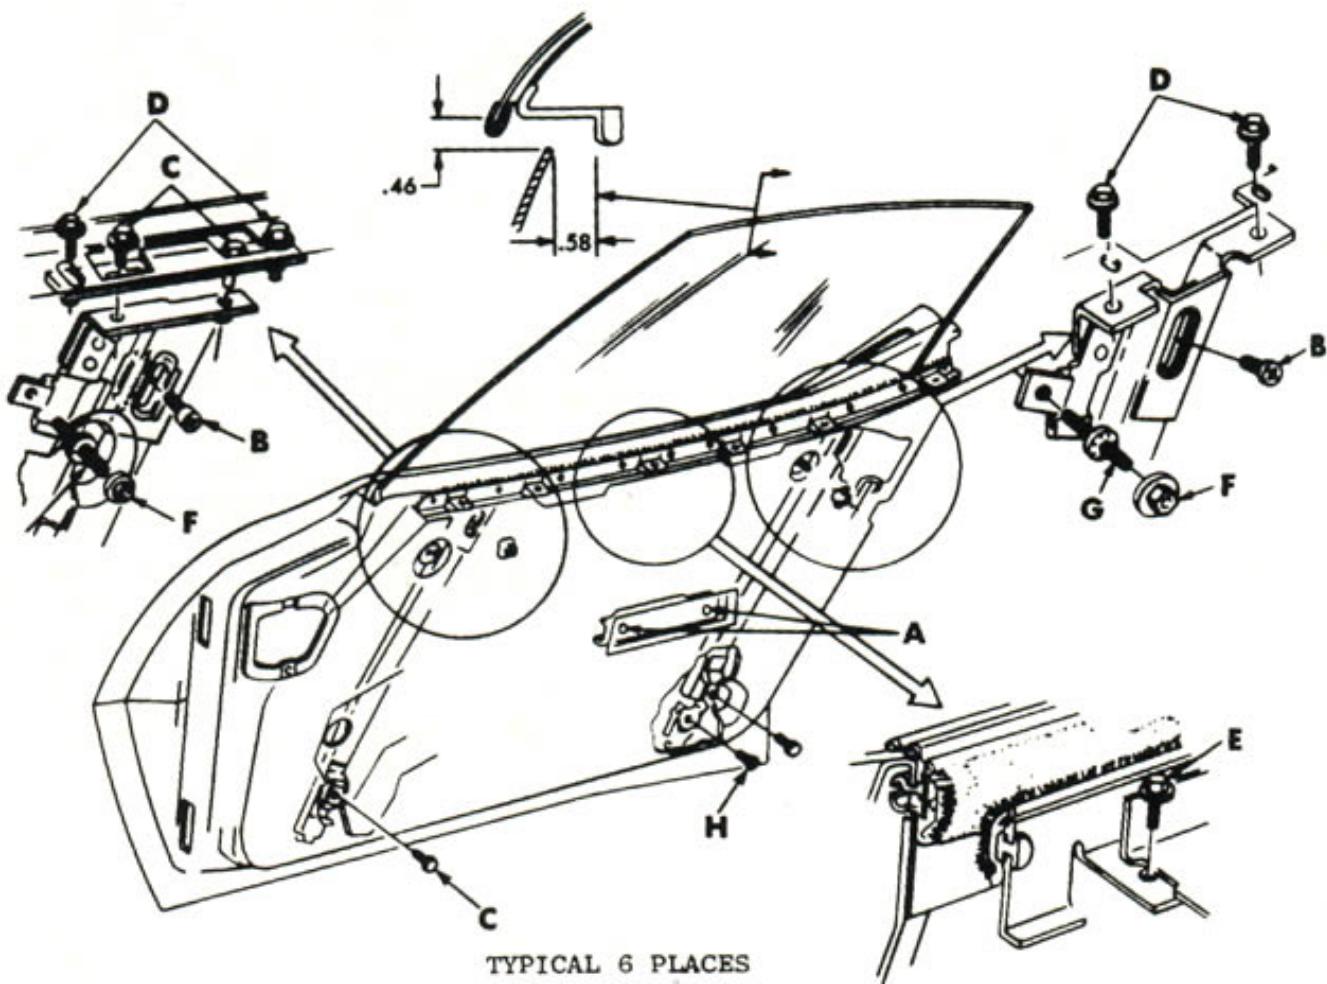
The adjustment procedure for 1968 Corvette door window glass has been revised as of this date. Items No. 3 and 4 have been revised.

1. Loosen bolts (A) and adjust the fore and aft tilt of the door window glass by rotating until a constant gap, or relationship, is obtained between the front edge of glass and the windshield pillar. Retighten bolts (A).
2. Loosen the front and rear stop screws (B) and roll glass up until top edge is .46 below roof rail. Move front and rear stops to contact the window rollers. Retighten screws (B).
3. Loosen the 3 bolts (C) and front nut (F) and slide door glass forward so that the front edge is .44 from and parallel to the windshield pillar. Retighten bolts (C).
4. Loosen bolts (D), (E) and rear nut (F). move bailey weatherstrip outboard so outer nylon pads are in contact with door outer panel reinforcement. Retighten bolts (E). move glass run channel so the top

of the glass is .58 from the vertical flange of the roof rail (move the glass run channel outboard to move the upper edge of glass inboard, move the glass run channel inboard to move the upper edge of glass outboard.) Retighten bolts (D).

5. Turn adjusting screw (G) so the front and rear inner nylon pads are in light contact with the wedges. Tighten nuts (F).
6. Loosen screw (H) and roll glass down until top edge is flush with door outer panel. Move stop to contact the window roller. Retighten screw (H).
7. Install and adjust windshield pillar weatherstrip, front rail weatherstrip, center rail weatherstrip, and rear rail weatherstrip to seal on glass.

Above procedure pertains to Assembly Plant operation. For Service, remove weatherstrip, weatherstrip retainer and door trim panel prior to glass adjustment.
