1968 Corvette: Chevrolet Engineering Memo: Window Service Update

Subject: Window Service Update
Model and Year: 1968 Corvette
Source: Chevrolet Engineering Memo - Mr. G. H. Tyler of Chevrolet Engineering
Page Number: NA
Date: March 1968

GLASS ADJUSTMENT PROCEDURE

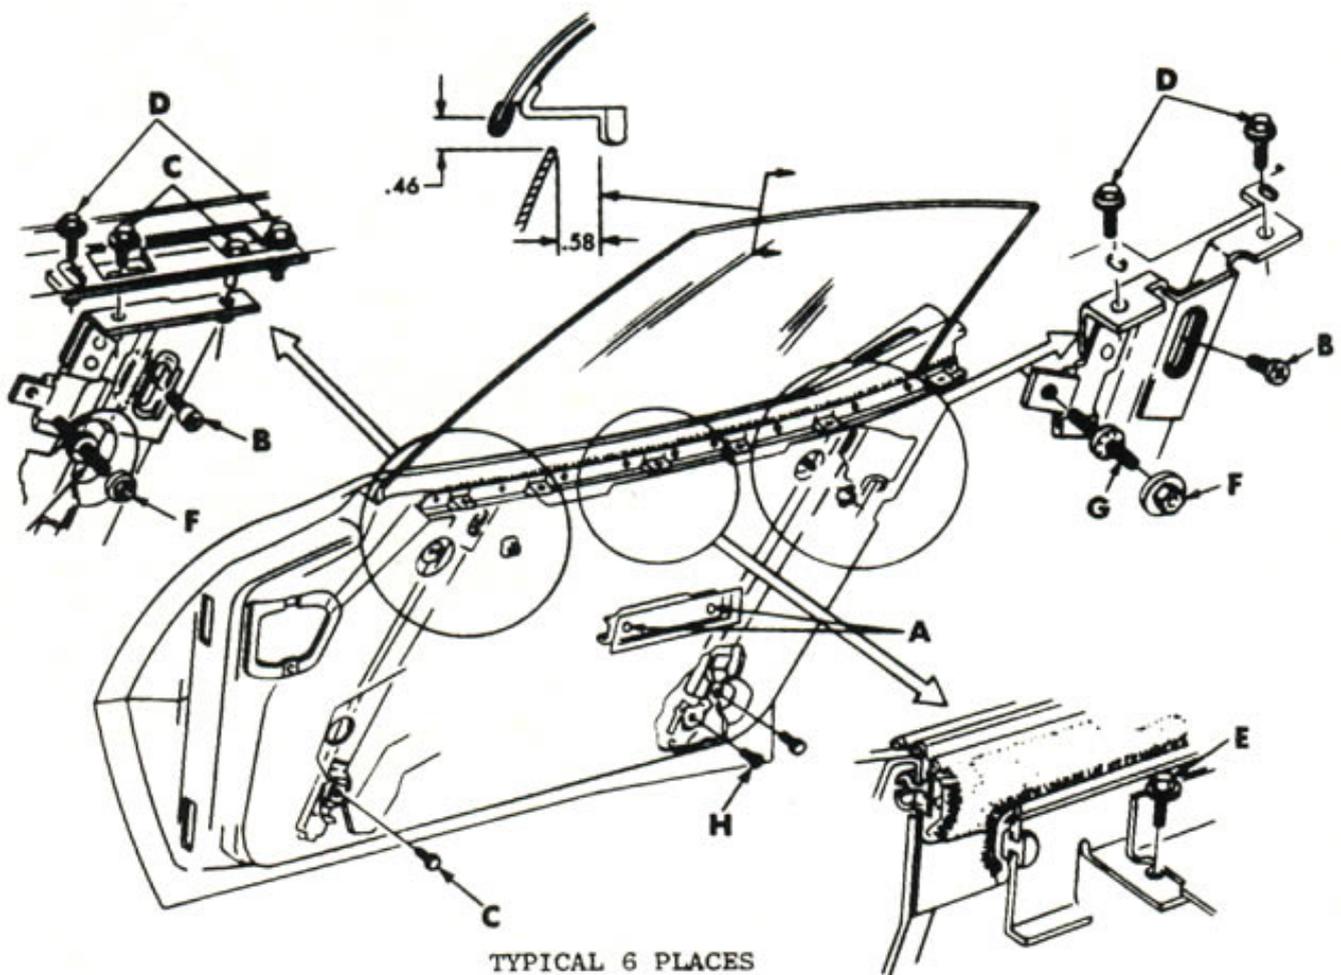
The adjustment procedure for 1968 Corvette door window glass has been revised as of this date. Items No. 3 and 4 have been revised.

1. Loosen bolts (A) and adjust the fore and aft tilt of the door window glass by rotating until a constant gap, or relationship, is obtained between the front edge of glass and the windshield pillar. Retighten bolts (A).
2. Loosen the front and rear stop screws (B) and roll glass up until top edge is .46 below roof rail. Move front and rear stops to contact the window rollers. Retighten screws (B).
3. Loosen the 3 bolts (C) and front nut (F) and slide door glass forward so that the front edge is .44 from and parallel to the windshield pillar. Retighten bolts (C).
4. Loosen bolts (D), (E) and rear nut (F). move bailey weatherstrip outboard so outer nylon pads are in contact with door outer panel reinforcement. Retighten bolts (E). move glass run channel so the top

of the glass is .58 from the vertical flange of the roof rail (move the glass run channel outboard to move the upper edge of glass inboard, move the glass run channel inboard to move the upper edge of glass outboard.) Retighten bolts (D).

5. Turn adjusting screw (G) so the front and rear inner nylon pads are in light contact with the wedges. Tighten nuts (F).
6. Loosen screw (H) and roll glass down until top edge is flush with door outer panel. Move stop to contact the window roller. Retighten screw (H).
7. Install and adjust windshield pillar weatherstrip, front rail weatherstrip, center rail weatherstrip, and rear rail weatherstrip to seal on glass.

Above procedure pertains to Assembly Plant operation. For Service, remove weatherstrip, weatherstrip retainer and door trim panel prior to glass adjustment.
