# 1984 Corvette: Service Bulletin: Generator Noise (Moan) at Idle with Air Conditioning On

**Model and Year:** 1984 Corvette

**Bulletin Number:** 84-151, Section 6D (VIy)

**Date:** June 1984

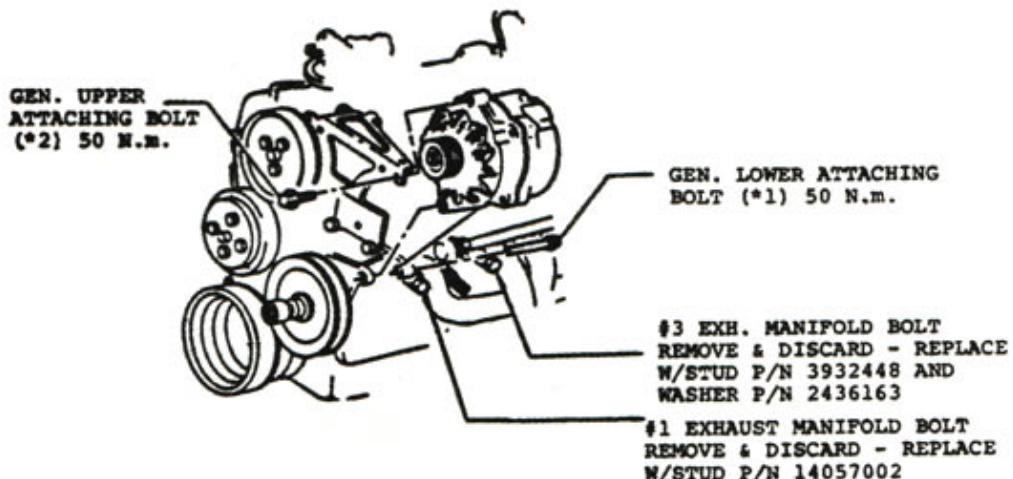
FIGURE 1

Some 1984 Corvettes may exhibit the subject noise, which is commonly defined as a "moan". This noise is induced into the generator by belt excitation when the air conditioning compressor is "on".

1. Remove the generator rear support brace. Discard the support brace, attaching nut and attaching bolt.
2. Remove and discard #1 and #3 L.H. exhaust manifold to cylinder head attaching bolts (see Figure 1).
3. Install stud, P/N 14057002, in place of discarded #1 bolt and torque to 35 N.m.
4. Install stud, P/N 3932448, and washer, P/N 2436163, in place of discarded #3 bolt and torque to 35 N.m.

5. Remove the serpentine belt from the generator pulley.
6. Loosen generator attaching bolts (2). (See Figure 1).
7. Install three (3) tubular braces on the exhaust manifold studs as shown on Figure 2 and loosely retain with attaching nuts in three (3) places.
8. Install bolt, P/N 14066303, in longer single brace and bolt, P/N 14063755, in two (2) short braces. Loosely install bolts into generator housing (see Figure 2).

9. Mandatory torque sequence (Figures 1 and 2):

- Generator lower attaching bolt 50 N.m.
- Generator upper attaching bolt 50 N.m.
- Long tubular support brace to generator, attaching bolt 35 N.m.
- Two (2) short tubular support braces to generator, attaching bolt 50 N.m.
- Three (2) tubular support braces to three (3) exhaust manifold studs, 25 N.m. three (3) attaching nuts.
