1984 Corvette: Service Bulletin: Generator Noise (Moan) at Idle with Air Conditioning On

Model and Year: 1984 Corvette

Source: Chevrolet Dealer Service Bulletin

Bulletin Number: 84-151, Section 6D (VIy)

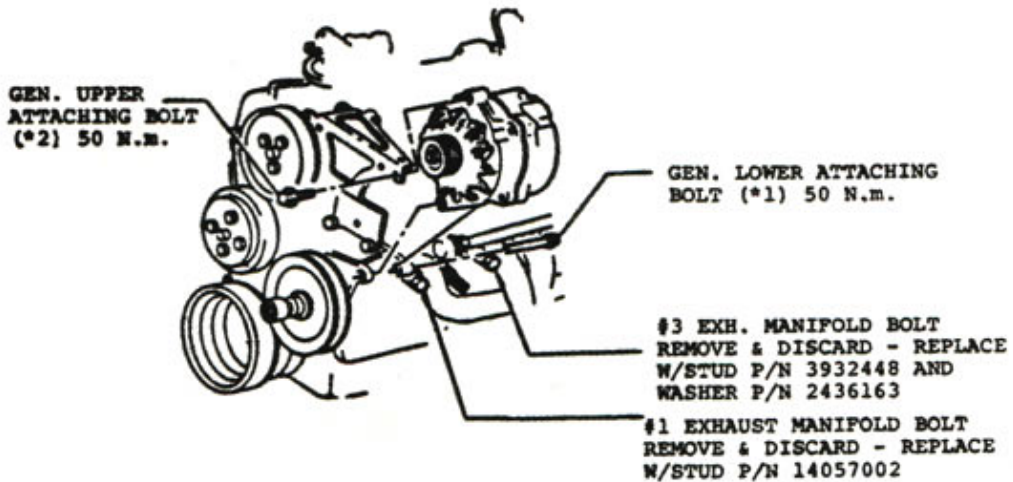
FIGURE 1

Some 1984 Corvettes may exhibit the subject noise, which is commonly defined as a "moan". This noise is induced into the generator by belt excitation when the air conditioning compressor is "on".

The following service procedure has been developed to reduce this noise by using three (3) new tubular braces and fasteners to replace the generator vibration period, which is the primary noise source.

1. Remove the generator rear support brace. Discard the support brace, attaching nut and attaching bolt.
 2. Remove and discard #1 and #3 L.H. exhaust manifold to cylinder head attaching bolts (see Figure 1).

3. Install stud, P/N 14057002, in place of discarded #1 bolt and torque to 35 N.m.
 4. Install stud, P/N 3932448, and washer, P/N 2436163, in place of discarded #3 bolt and torque to 35 N.m.

- NOTICE: Washer is to be installed on stud between stud hex and exhaust manifold.
5. Remove the serpentine belt from the generator pulley.
 6. Loosen generator attaching bolts (2). (See Figure 1).

9. Mandatory torque sequence (Figures 1 and 2):

- Generator lower attaching bolt 50 N.m.
- Generator upper attaching bolt 50 N.m.
- Long tubular support brace to generator, attaching bolt 35 N.m.
- Two (2) short tubular support braces to generator, attaching bolt 50 N.m.
- Three (2) tubular support braces to three (3) exhaust manifold studs, 25 N.m. three (3) attaching nuts.
