# 2016 Corvette: Service Bulletin: Delayed Engagement After Sitting With Engine Off

## #16-NA-014: Delayed Engagement After Sitting With Engine Off - (Jan 21, 2016)

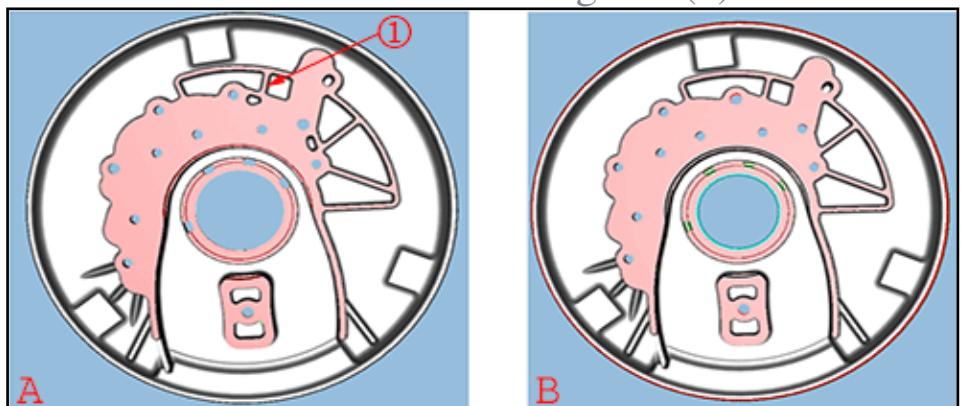
Old cover 24272660

New cover 24277964

**Note:** The casting void has been eliminated from the underside of the cover (see illustration).
