2016 Corvette: Service Bulletin: Delayed Engagement After Sitting With Engine Off

#16-NA-014: Delayed Engagement After Sitting With Engine Off - (Jan 21, 2016)

Subject: Delayed Engagement After Sitting With Engine Off

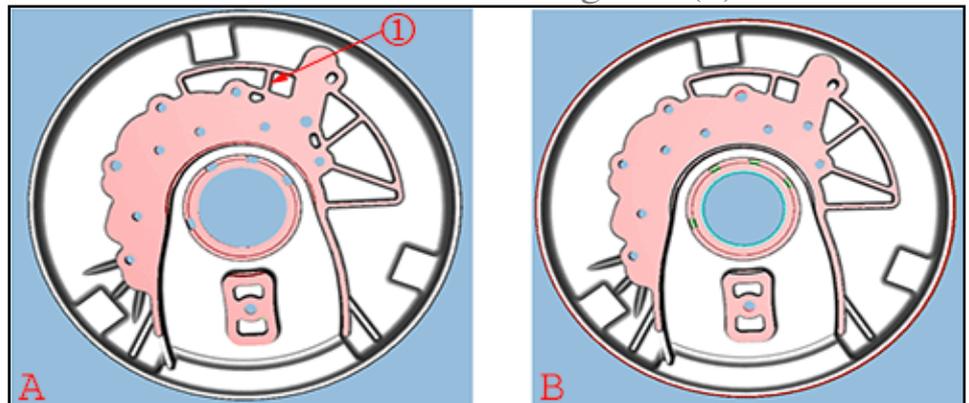
(A)

Old cover 24272660

(B)

New cover 24277964

Note: The casting void has been eliminated from the underside of the cover (see illustration).
