2016 Corvette: Service Bulletin: Delayed Engagement After Sitting With Engine Off

#16-NA-014: Delayed Engagement After Sitting With Engine Off - (Jan 21, 2016)

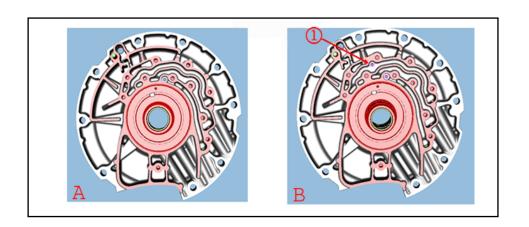
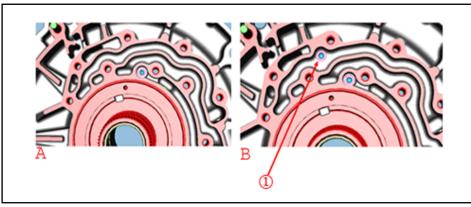
(A) Old stator support asm 242 74636/24275106/2427265 6
(B) New stator support asm 24277234

Note: The new stator shaft support assembly has a second check ball (1) added (see illustrations).

Install a new stator shaft support assembly that includes an additional check ball. Follow the instructions below to replace the stator shaft support assembly.

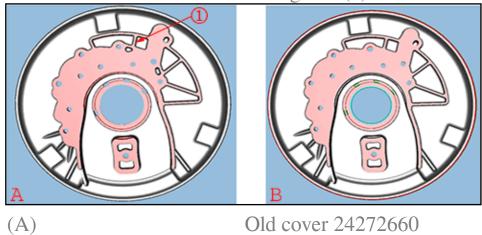
New cover 24277964

Note: The casting void has been eliminated from the underside of the cover (see illustration).
