GMC	Sierra	2014	2016			L83, L86, LV1, LV3	
	Yukon	2015	2016			L83, L86	
	Yukon Denali	2015	2016				
	Yukon XL	2015	2016				
	Yukon XL Denali	2015	2016

<i>Condition</i>	<p>Some customers may comment that the Malfunction Indicator Light (MIL) is illuminated.</p> <p>Technician may find DTC P0420 and P0430 set.</p>
<i>Cause</i>

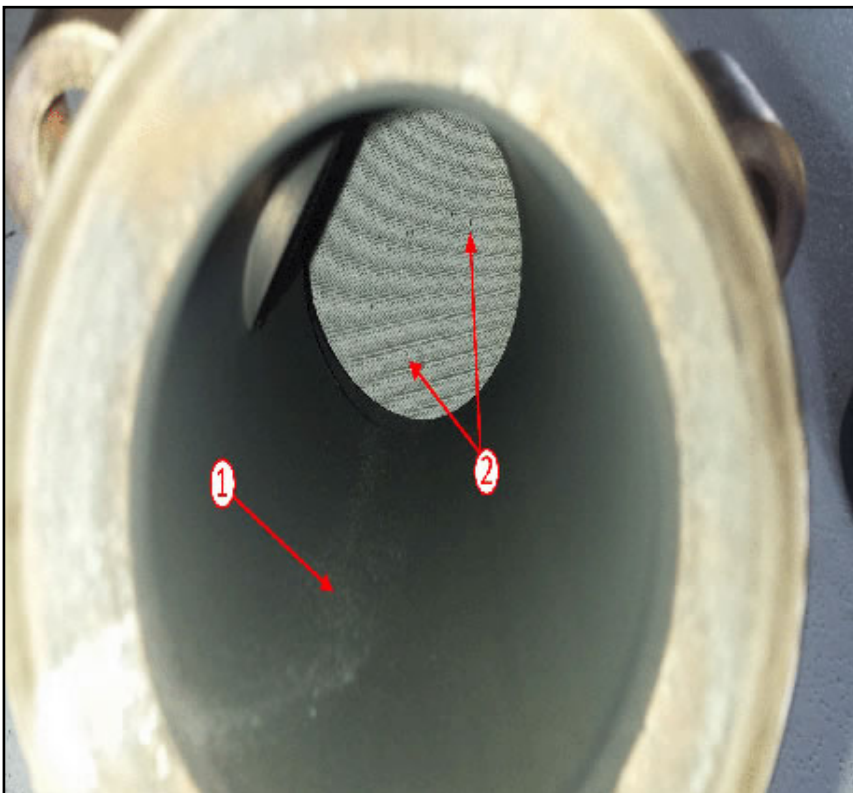
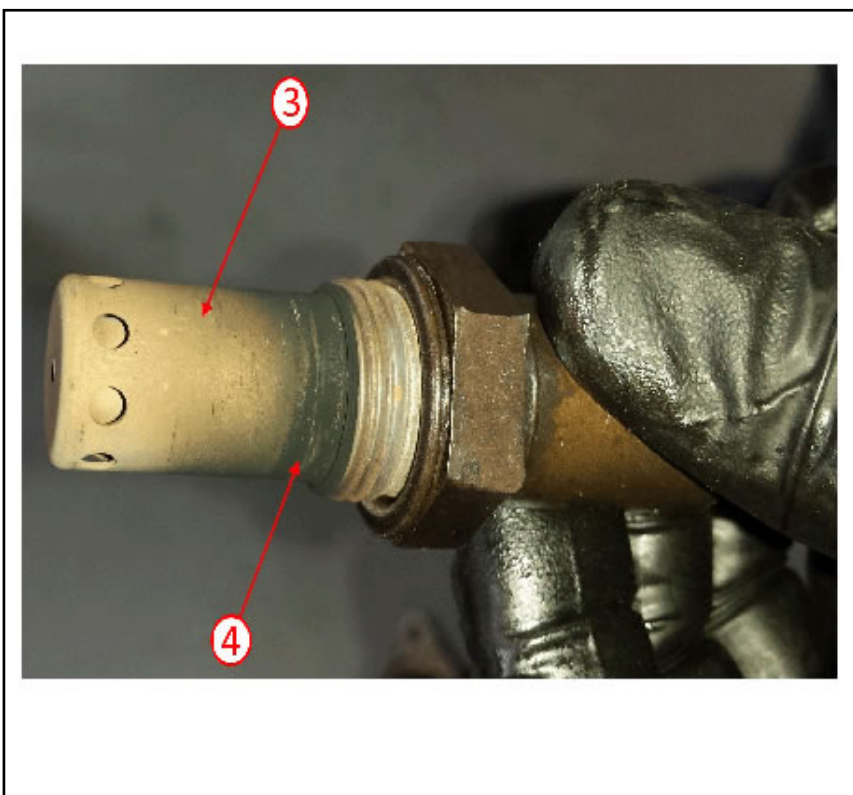
This may be caused by excessive sand and/or debris entering the air filter box and bypassing the seal of the air filter, due to not properly sealing, causing damage to the HO2 sensor element (3) and the catalytic converter to become blocked with sand and debris particles (1, 2).

Do not replace any of the parts until the air filter housing has been validated to be completely sealed.

If the condition is evident, inspection of the air box and air filter seal must be done.

Follow the Service Procedure steps in order to verify the sealing of the air filter to housing surface.

After validating the air box has been sealed, repair the P0420 and the P0430 codes *as needed*.

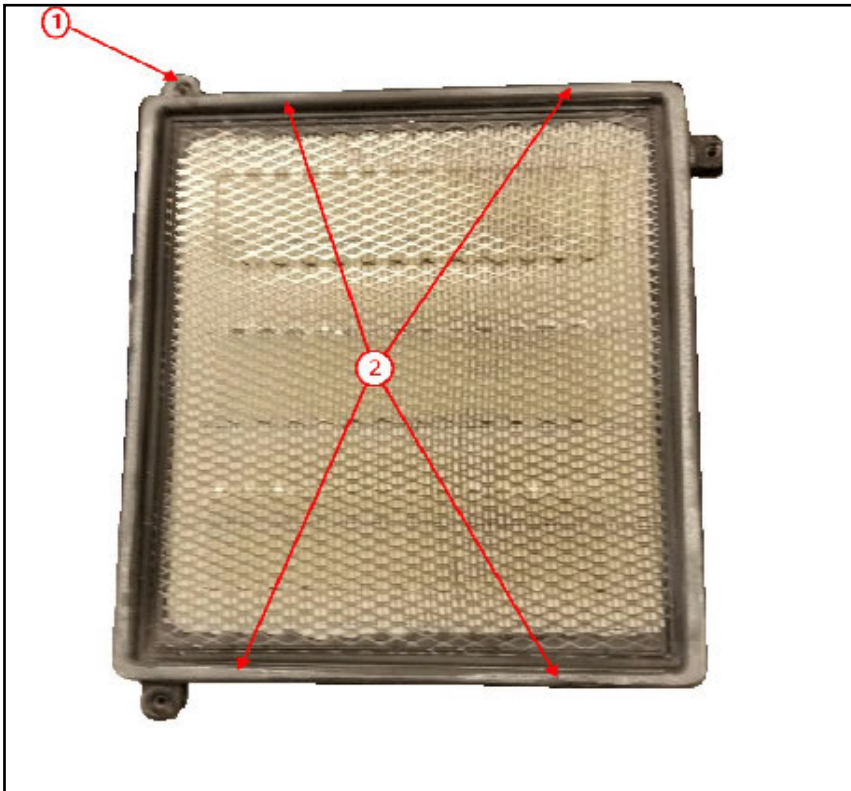
1. Inspect the all the air housing cover for any missing tabs and/or fasteners (1).
2. Remove the air filter housing cover and inspect the seal

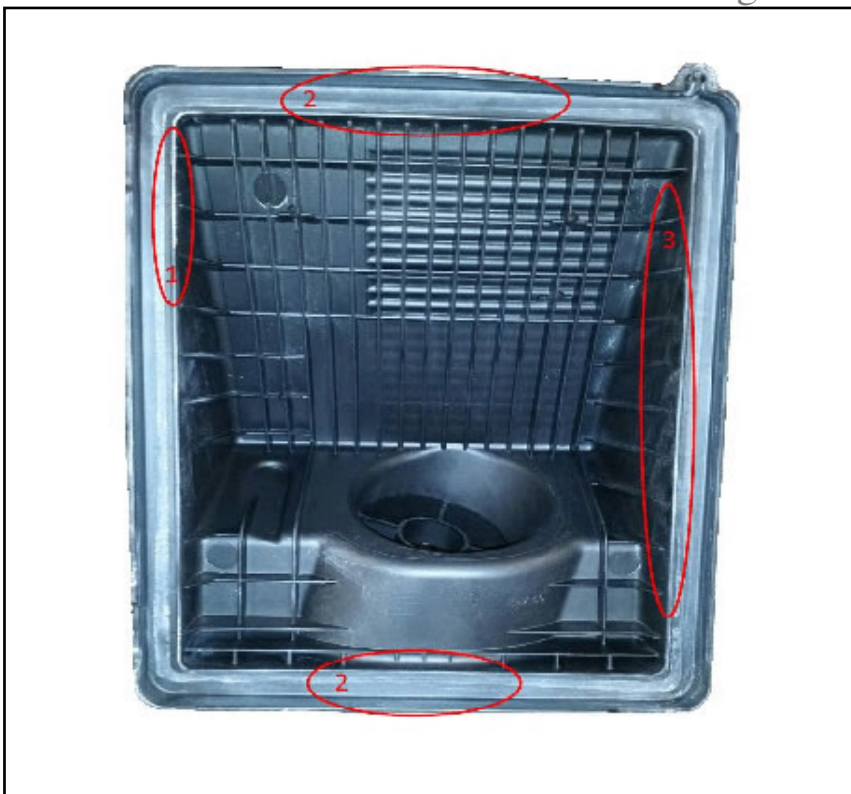
1. Inspect the air filter sealing surface for signs of not contacting the air filter seal (1, 2).
2. Inspect the air filter housing cover for dirt and/or debris bypassing the air filter (3).
3. Inspect the air cleaner outlet duct for any dirt and/or debris.
 - If dirt and debris has been found bypassing the air filter due to a faulty seal, replace the air filter as necessary.
 - If the air filter housing has been found not properly sealing, refer to the *Air Cleaner Assembly Replacement* in SI.
