GMC	Sierra	2014	2016			L83, L86, LV1, LV3	
	Yukon	2015	2016			L83, L86	
	Yukon Denali	2015	2016				
	Yukon XL	2015	2016				
	Yukon XL Denali	2015	2016

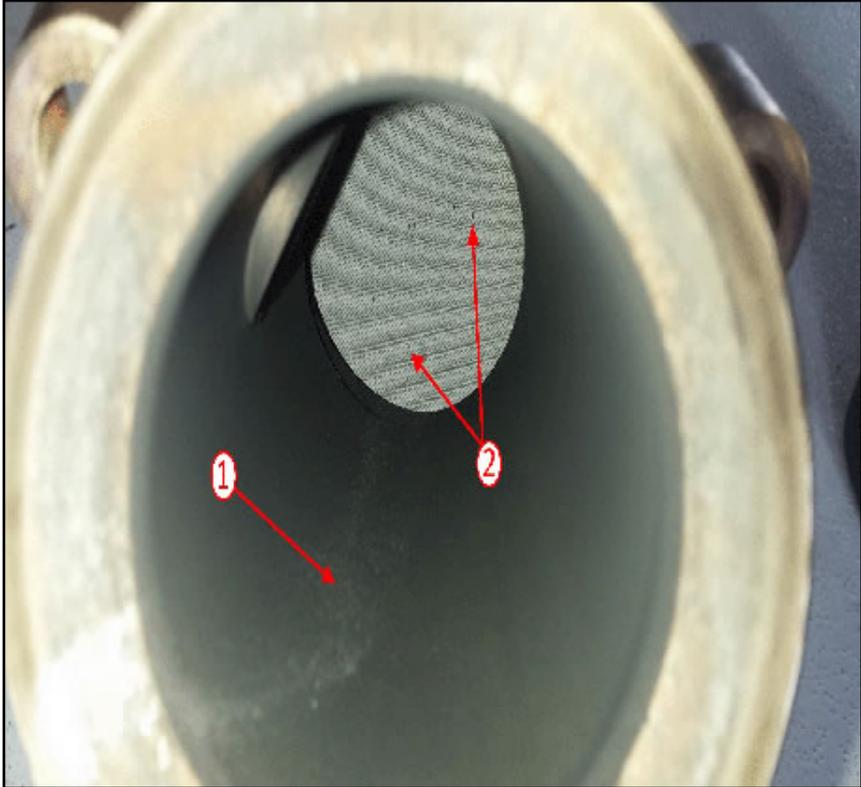
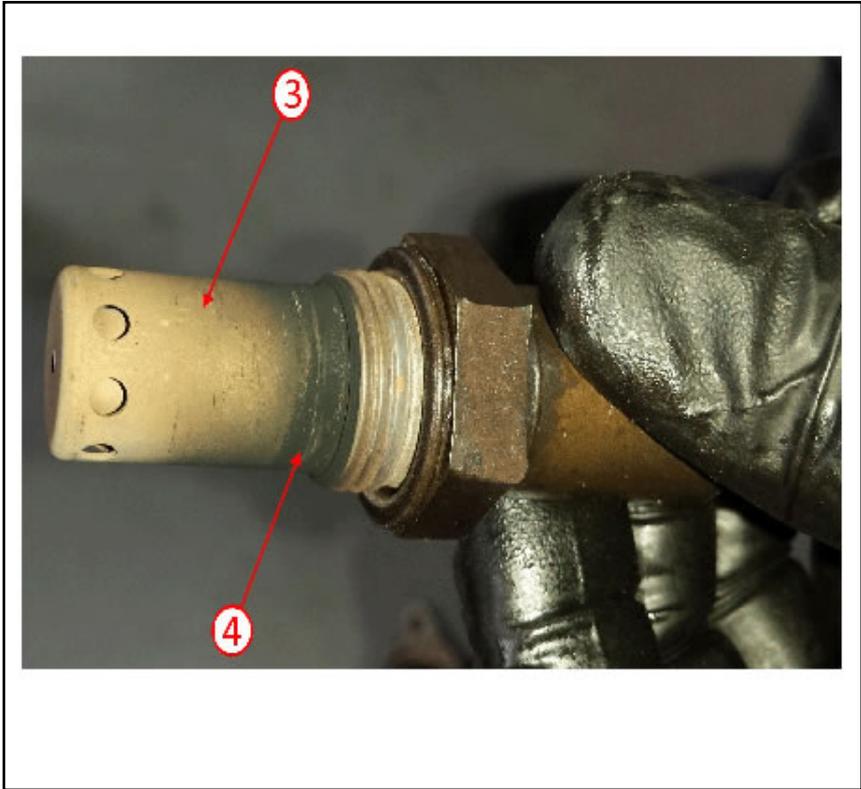
<i>Condition</i>	Some customers may comment that the Malfunction Indicator Light (MIL) is illuminated.  Technician may find DTC P0420 and P0430 set.
<i>Cause</i>

<p>This may be caused by excessive sand and/or debris entering the air filter box and bypassing the seal of the air filter, due to not properly sealing, causing damage to the HO2 sensor element (3) and the catalytic converter to become blocked with sand and debris particles (1, 2).</p>
--	--

*Do not* replace any of the parts until the air filter housing has been validated to be completely sealed.

If the condition is evident, inspection of the air box and air filter seal must be done.

Follow the Service Procedure steps in order to verify the sealing of the air filter to housing surface.

After validating the air box has been sealed, repair the P0420 and the P0430 codes *as needed*.

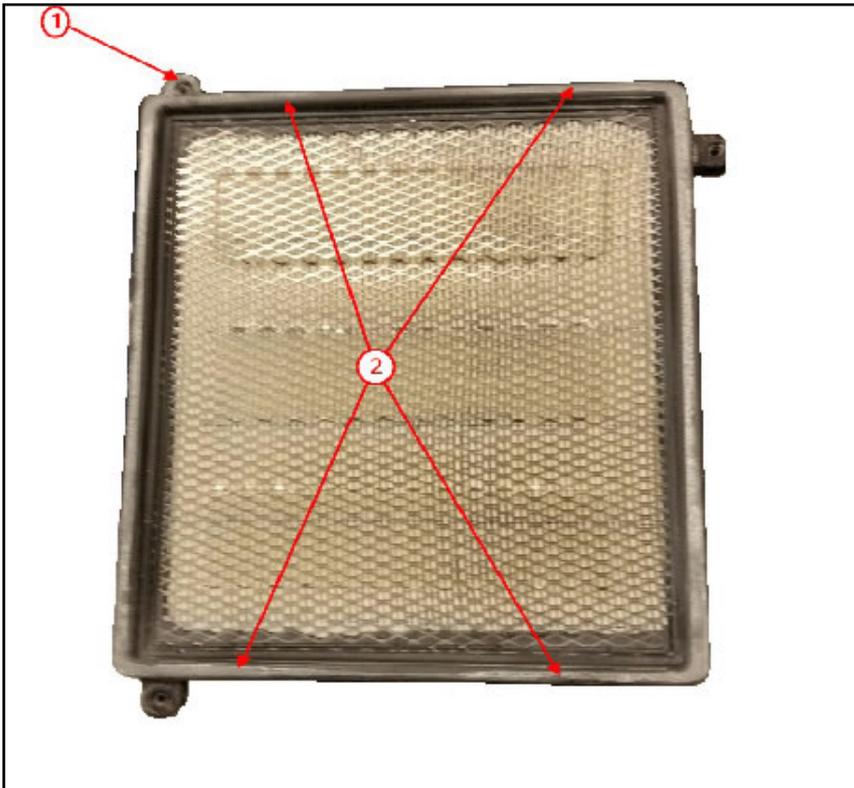
1. Inspect the all the air housing cover for any missing tabs and/or fasteners (1).
2. Remove the air filter housing cover and inspect the seal

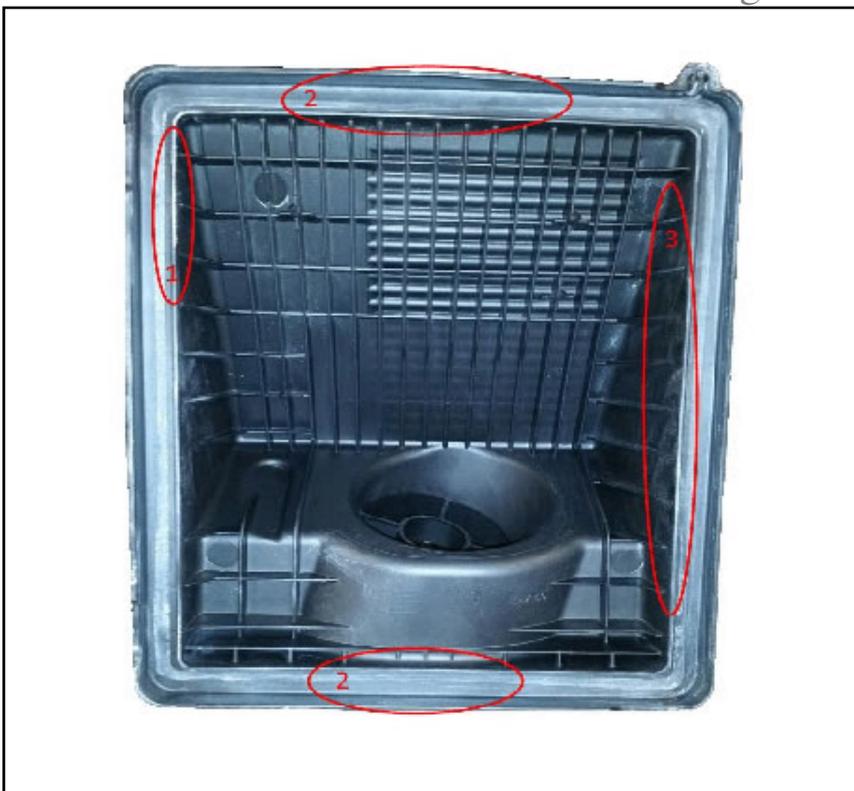
1. Inspect the air filter sealing surface for signs of not contacting the air filter seal (1, 2).
2. Inspect the air filter housing cover for dirt and/or debris bypassing the air filter (3).
3. Inspect the air cleaner outlet duct for any dirt and/or debris.
  - If dirt and debris has been found bypassing the air filter due to a faulty seal, replace the air filter as necessary.
  - If the air filter housing has been found not properly sealing, refer to the *Air Cleaner Assembly Replacement* in SI.
