GMC	Sierra	2014	2016			L83, L86, LV1, LV3	
	Yukon	2015	2016			L83, L86	
	Yukon Denali	2015	2016				
	Yukon XL	2015	2016				
	Yukon XL Denali	2015	2016

<i>Condition</i>	Some customers may comment that the Malfunction Indicator Light (MIL) is illuminated. Technician may find DTC P0420 and P0430 set.
<i>Cause</i>

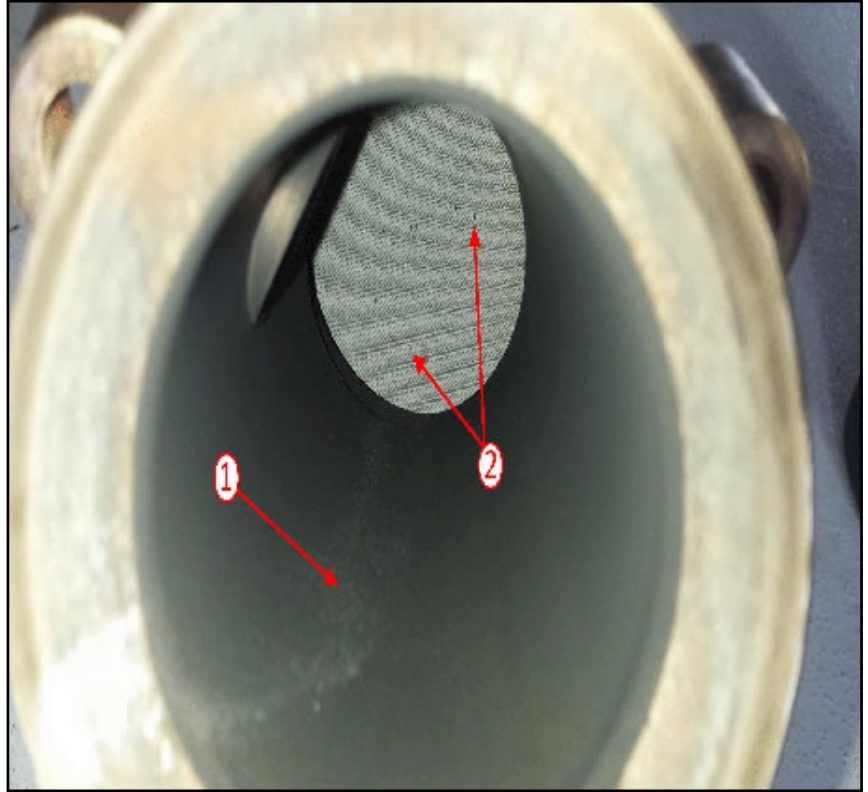
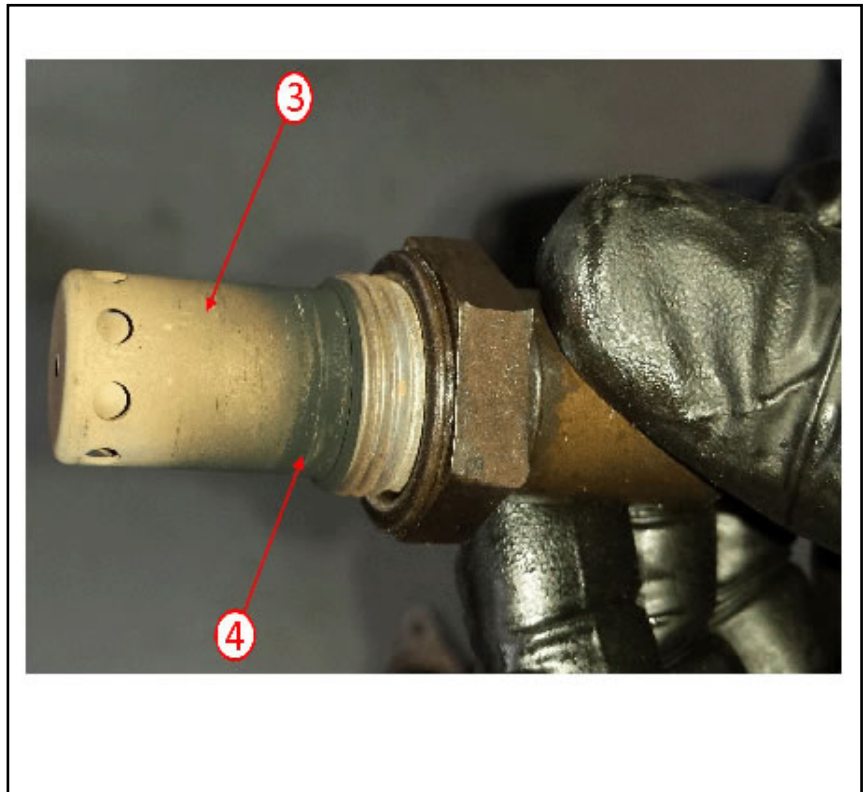
This may be caused by excessive sand and/or debris entering the air filter box and bypassing the seal of the air filter, due to not properly sealing, causing damage to the HO2 sensor element (3) and the catalytic converter to become blocked with sand and debris particles (1, 2).

Do not replace any of the parts until the air filter housing has been validated to be completely sealed.

If the condition is evident, inspection of the air box and air filter seal must be done.

Follow the Service Procedure steps in order to verify the sealing of the air filter to housing surface.

After validating the air box has been sealed, repair the P0420 and the P0430 codes *as needed*.

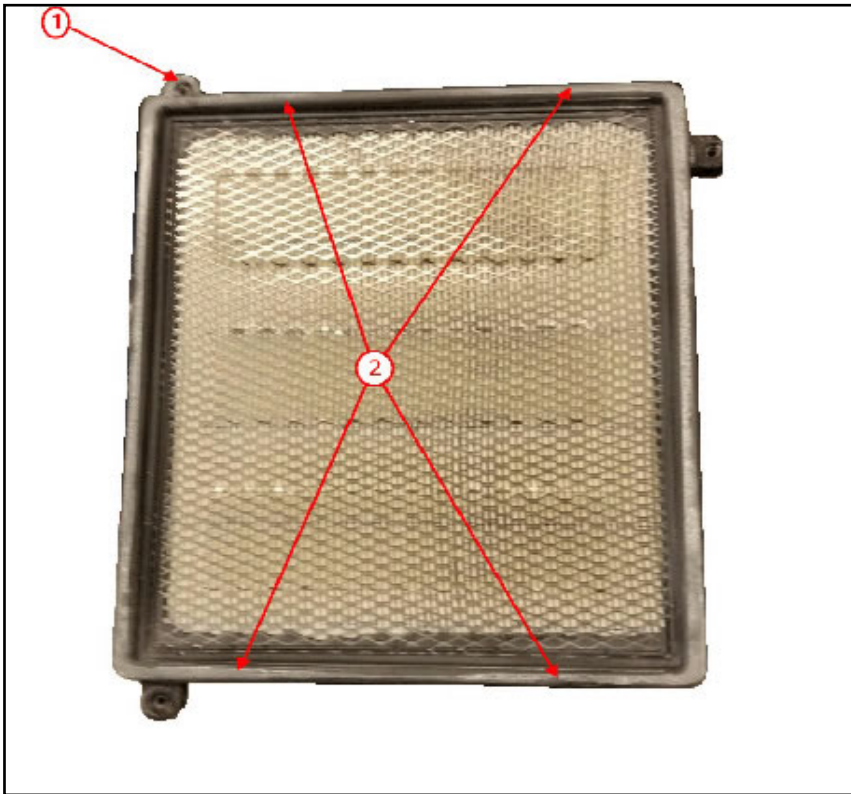
1. Inspect the all the air housing cover for any missing tabs and/or fasteners (1).
2. Remove the air filter housing cover and inspect the seal
