GMC	Sierra	2014	2016			L83, L86, LV1, LV3	
	Yukon	2015	2016			L83, L86	
	Yukon Denali	2015	2016				
	Yukon XL	2015	2016				
	Yukon XL Denali	2015	2016

<i>Condition</i>	Some customers may comment that the Malfunction Indicator Light (MIL) is illuminated. Technician may find DTC P0420 and P0430 set.
<i>Cause</i>

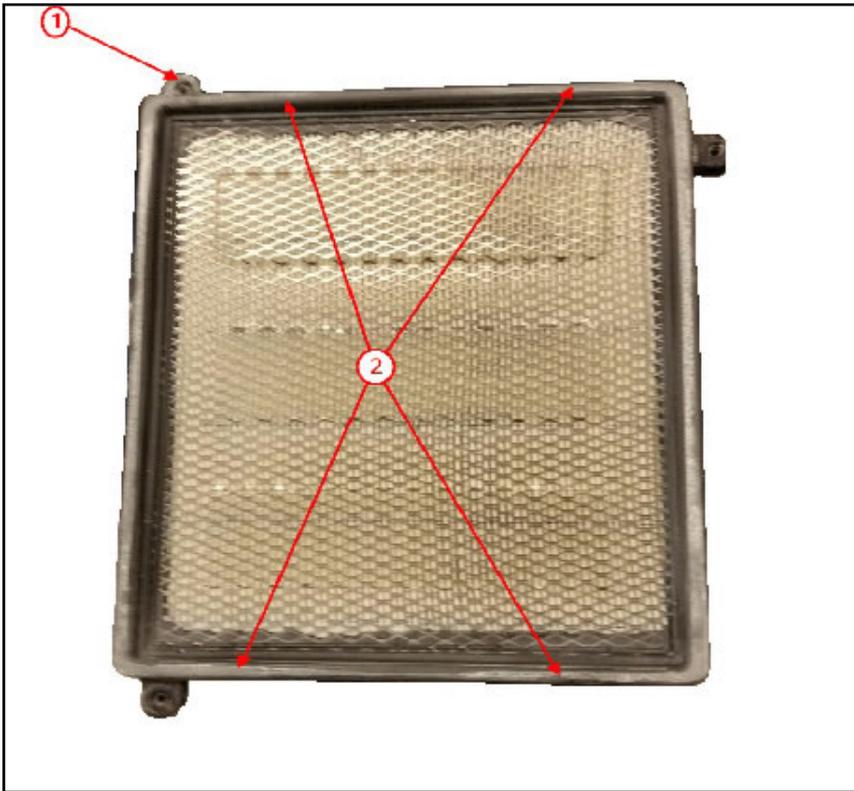
1. Inspect the all the air housing cover for any missing tabs and/or fasteners (1).
2. Remove the air filter housing cover and inspect the seal
