# 2015 - 2016 Corvette: Service Bulletin: #16-NA-014: Delayed Engagement After Sitting With Engine Off

## #16-NA-014: Delayed Engagement After Sitting With Engine Off - (Jun 28, 2016)

**Subject:** Delayed Engagement After Sitting With Engine Off

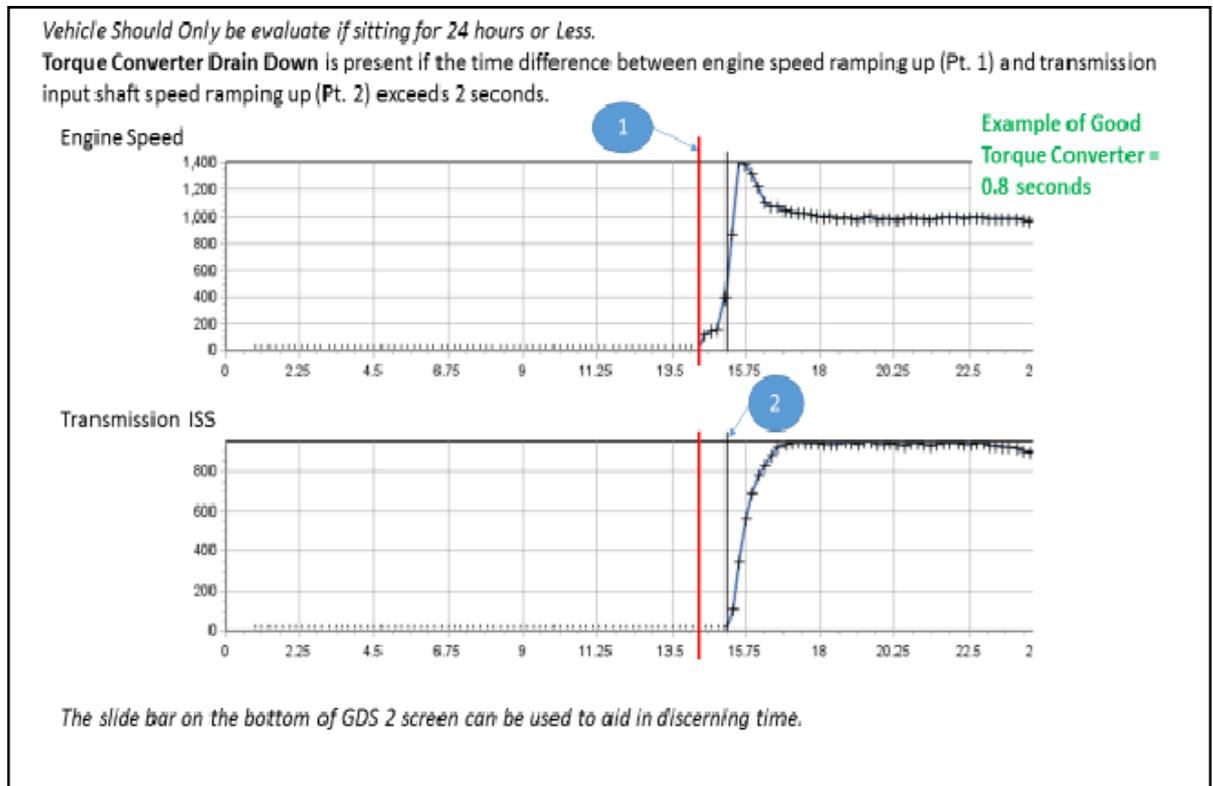
## Not Wanting to Move or Slips - Torque Converter Drain Back

This condition may be caused by the torque converter draining the transmission fluid back into the

transmission pan.

If the customer describes the condition as a long engagement with a slip/soft engagement feel and/or the vehicle not wanting to move, the condition should be considered drain back and the following procedure should be followed.

1. Using GDS and monitor engine RPM and transmission Input Speed Sensor (ISS) prior to starting the engine.
2. Start the engine with the transmission in park.
  - ISS should be equal to engine RPM in 3 seconds or less.
  - If ISS takes more than 3 seconds to equal engine RPM than follow the procedure for replacing the stator shaft support described in the service procedure below.

- *DO NOT* replace the stator shaft support on vehicles taking 3 seconds or less for turbine shaft speed to equal engine RPM.

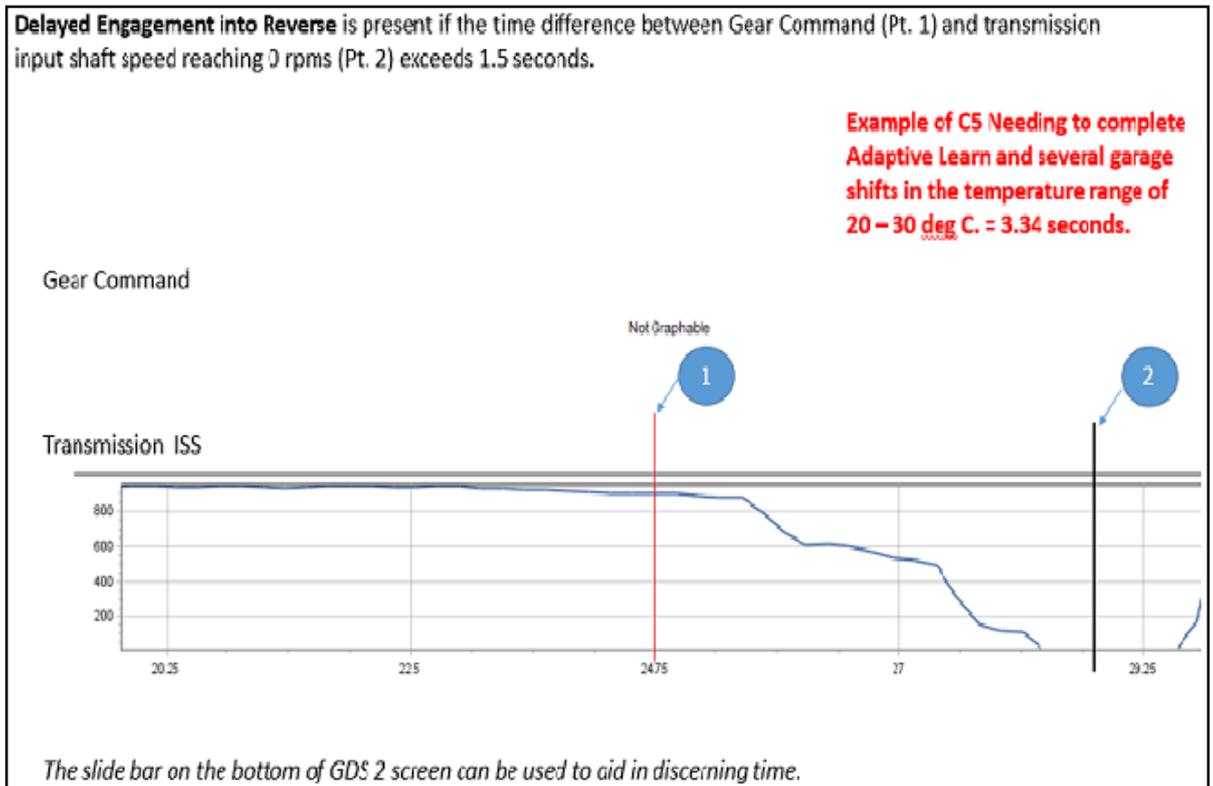
## Delayed Harsh Engagement - Clutch Slow to Fill

If the customer describes the condition as a long engagement time with a harsh or bump engagement feel when shifting the vehicle from park to drive or reverse. Using GDS and monitor engine RPM and transmission Input Speed Sensor (ISS) prior to starting the engine. Start the engine with the engine in park. ISS should equal engine RPM in 3 seconds or less. If ISS takes more than 3 seconds to equal engine RPM than follow the procedure for replacing the stator shaft support. If the ISS is equal to engine RPM in 3 seconds or less shift the vehicle from park to drive or reverse leaving the service brake applied. ISS should drop to zero “0” within 2 seconds, this is clutch

engagement time. Recording a GDS session log can be useful in diagnosing this condition.

For 2015 MY vehicles Contact GM TAC for review and additional instructions. Prior to contacting TAC record a GDS2 Session log of the delayed engagement.

For 2016 MY vehicle attempt to learn the C5 Clutch using the following procedure:

1. Allow the transmission sump temperature to rise between 20 and 30 degrees C (68 and 86 degrees F).

2. Perform 20 Park to Reverse shifts releasing the brake with each shift.

If the learn procedure does not correct the condition contact GM TAC for review and additional instructions. Prior to contacting TAC record a GDS2 Session log of the delayed engagement.

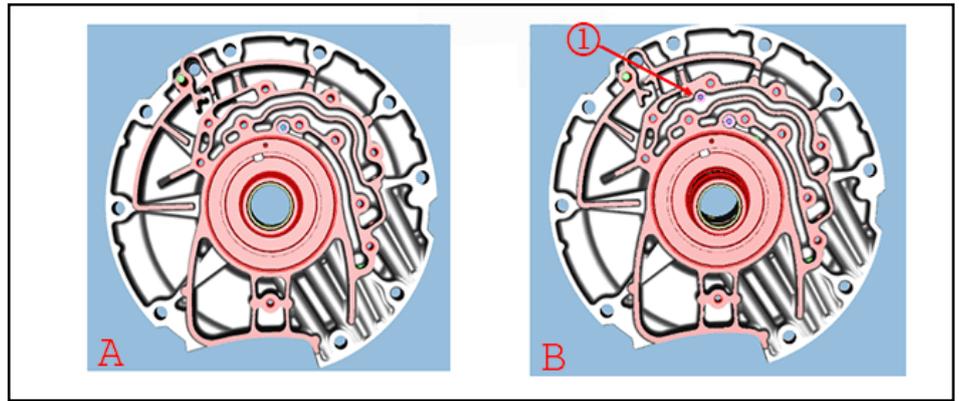
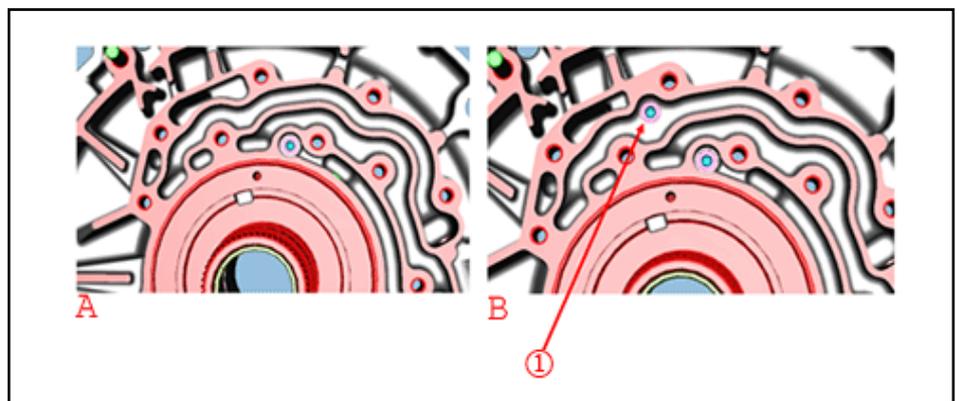
Old stator support asm

New stator support asm

**Note:** The new stator shaft support assembly has a second check ball (1) added (see illustrations).

Install a new stator shaft support assembly that includes an additional check ball. Follow the instructions below to replace the stator shaft

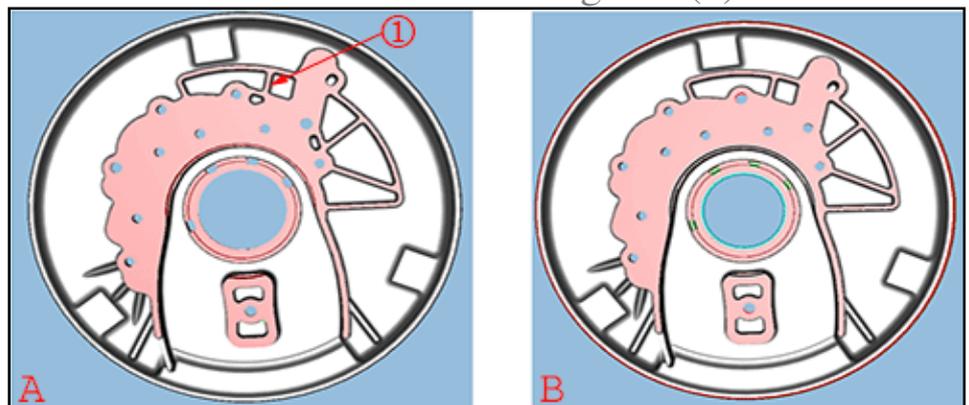
Old cover - 8L90 Only

New cover - 8L90 Only

**Note:** The casting void has been eliminated from the underside of the cover for the 8L90 only (see illustration). The 8L45 is not required.
