2015 - 2016 Corvette: Service Bulletin: #16-NA-014: Delayed Engagement After Sitting With Engine Off

#16-NA-014: Delayed Engagement After Sitting With Engine Off - (Jun 28, 2016)

Subject: Delayed Engagement After Sitting With Engine Off

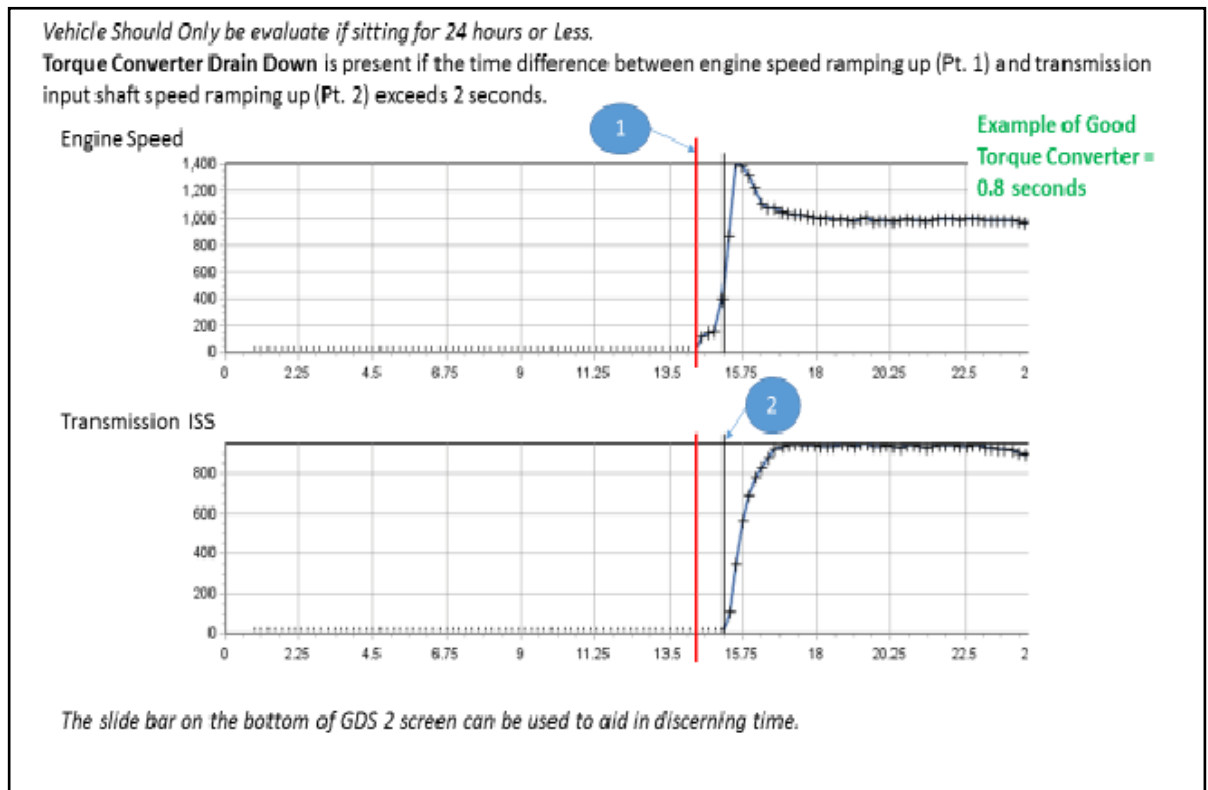
Not Wanting to Move or Slips - Torque Converter Drain Back

This condition may be caused by the torque converter draining the transmission fluid back into the

transmission pan.

If the customer describes the condition as a long engagement with a slip/soft engagement feel and/or the vehicle not wanting to move, the condition should be considered drain back and the following procedure should be followed.

1. Using GDS and monitor engine RPM and transmission Input Speed Sensor (ISS) prior to starting the engine.
2. Start the engine with the transmission in park.
 - ISS should be equal to engine RPM in 3 seconds or less.
 - If ISS takes more than 3 seconds to equal engine RPM than follow the procedure for replacing the stator shaft support described in the service procedure below.

- *DO NOT* replace the stator shaft support on vehicles taking 3 seconds or less for turbine shaft speed to equal engine RPM.

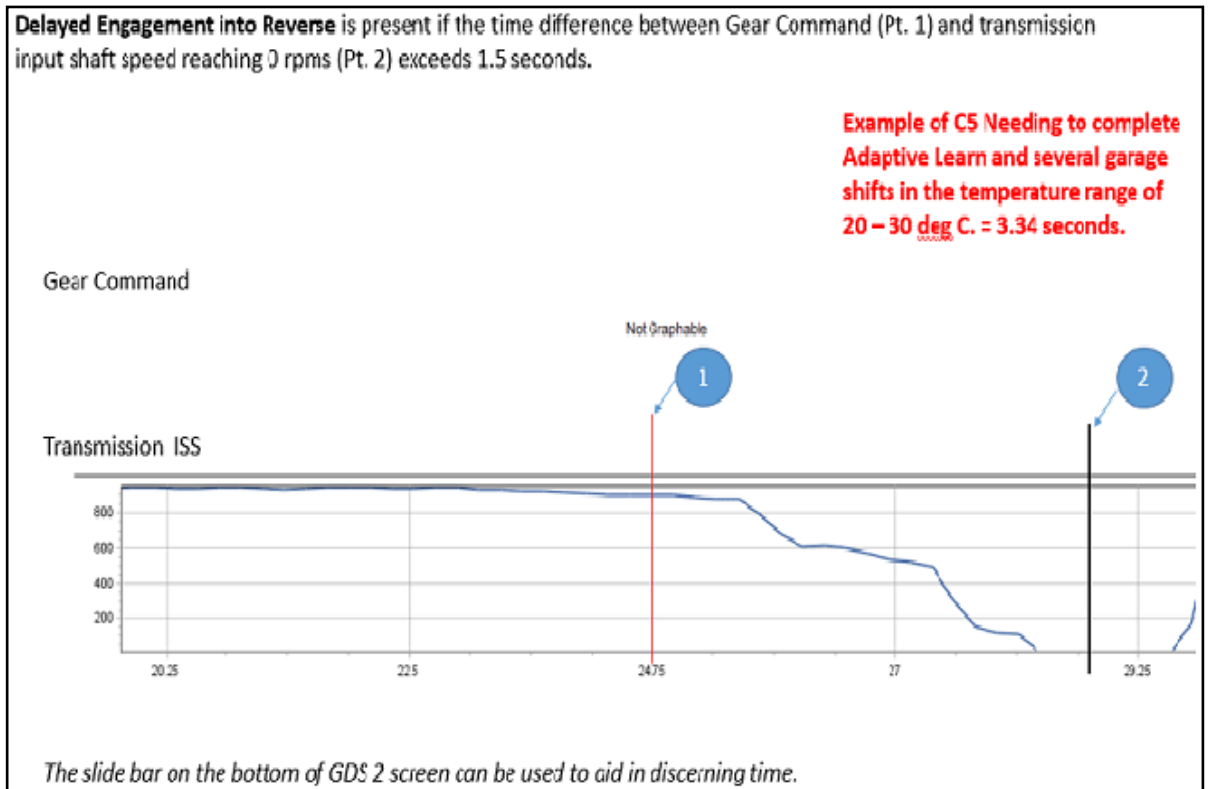
Delayed Harsh Engagement - Clutch Slow to Fill

If the customer describes the condition as a long engagement time with a harsh or bump engagement feel when shifting the vehicle from park to drive or reverse. Using GDS and monitor engine RPM and transmission Input Speed Sensor (ISS) prior to starting the engine. Start the engine with the engine in park. ISS should equal engine RPM in 3 seconds or less. If ISS takes more than 3 seconds to equal engine RPM than follow the procedure for replacing the stator shaft support. If the ISS is equal to engine RPM in 3 seconds or less shift the vehicle from park to drive or reverse leaving the service brake applied. ISS should drop to zero “0” within 2 seconds, this is clutch

engagement time. Recording a GDS session log can be useful in diagnosing this condition.

For 2016 MY vehicle attempt to learn the C5 Clutch using the following procedure:

1. Allow the transmission sump temperature to rise between 20 and 30 degrees C (68 and 86 degrees F).

2. Perform 20 Park to Reverse shifts releasing the brake with each shift.

If the learn procedure does not correct the condition contact GM TAC for review and additional instructions. Prior to contacting TAC record a GDS2 Session log of the delayed engagement.

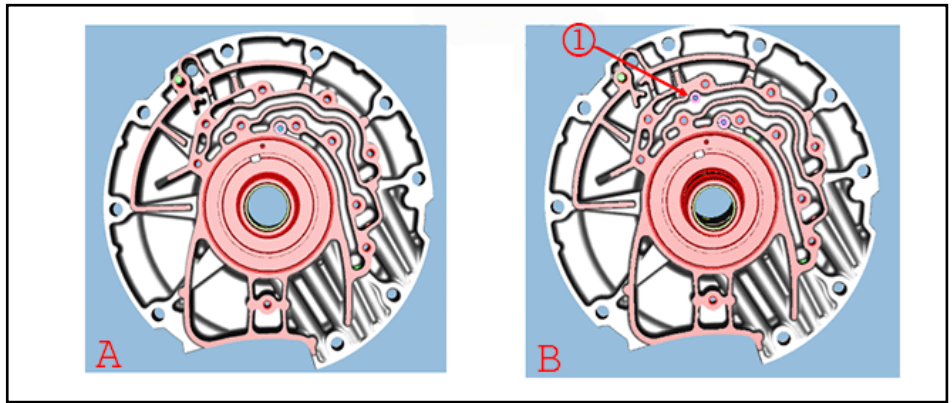
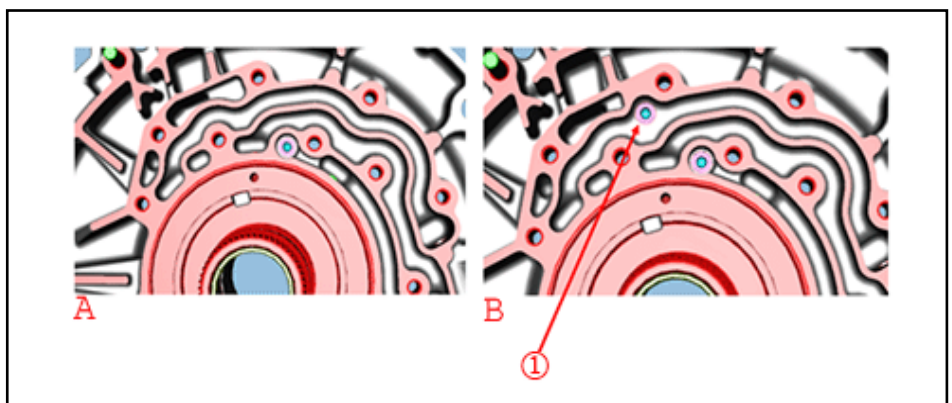
Old stator support asm

New stator support asm

Note: The new stator shaft support assembly has a second check ball (1) added (see illustrations).

Install a new stator shaft support assembly that includes an additional check ball. Follow the instructions below to replace the stator shaft

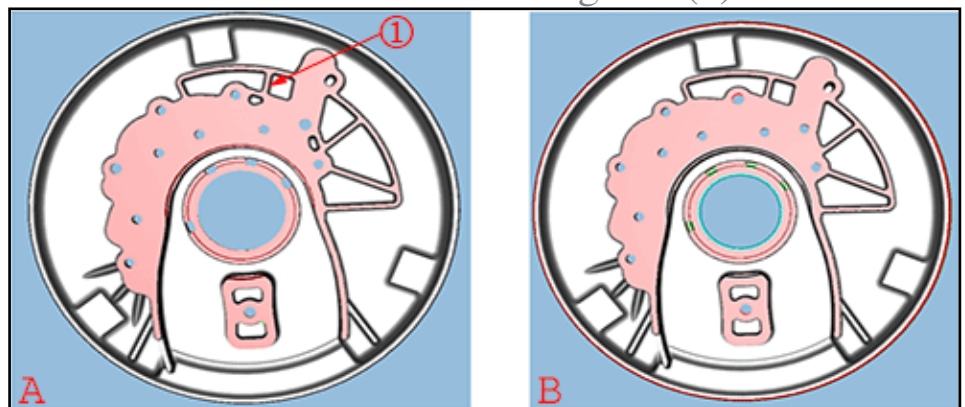
Old cover - 8L90 Only

New cover - 8L90 Only

Note: The casting void has been eliminated from the underside of the cover for the 8L90 only (see illustration). The 8L45 is not required.
