2015 - 2016 Corvette: Service Bulletin: #16-NA-014: Delayed Engagement After Sitting With Engine Off

#16-NA-014: Delayed Engagement After Sitting With Engine Off - (Jun 28, 2016)

Subject: Delayed Engagement After Sitting With Engine Off

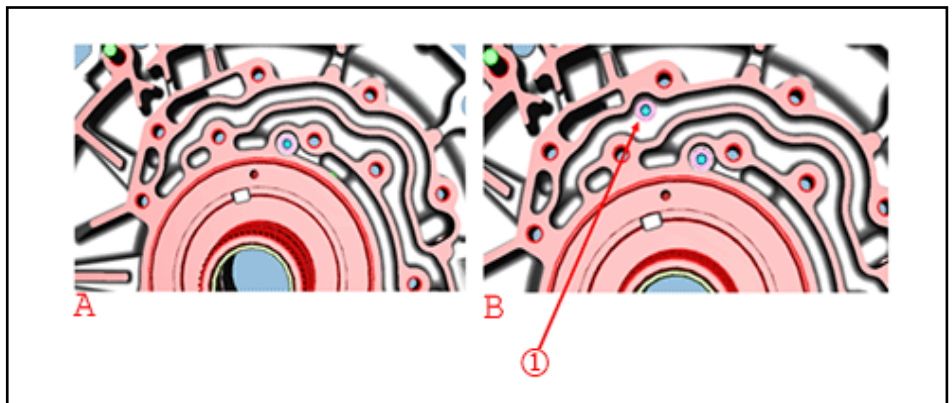
Old stator support asm

New stator support asm

Note: The new stator shaft support assembly has a second check ball (1) added (see illustrations).

Install a new stator shaft support assembly that includes an additional check ball. Follow the instructions below to replace the stator shaft
