2015 - 2016 Corvette: Service Bulletin: #16-NA-014: Delayed Engagement After Sitting With Engine Off

#16-NA-014: Delayed Engagement After Sitting With Engine Off - (Jun 28, 2016)

Delayed Engagement After Sitting With Engine Off

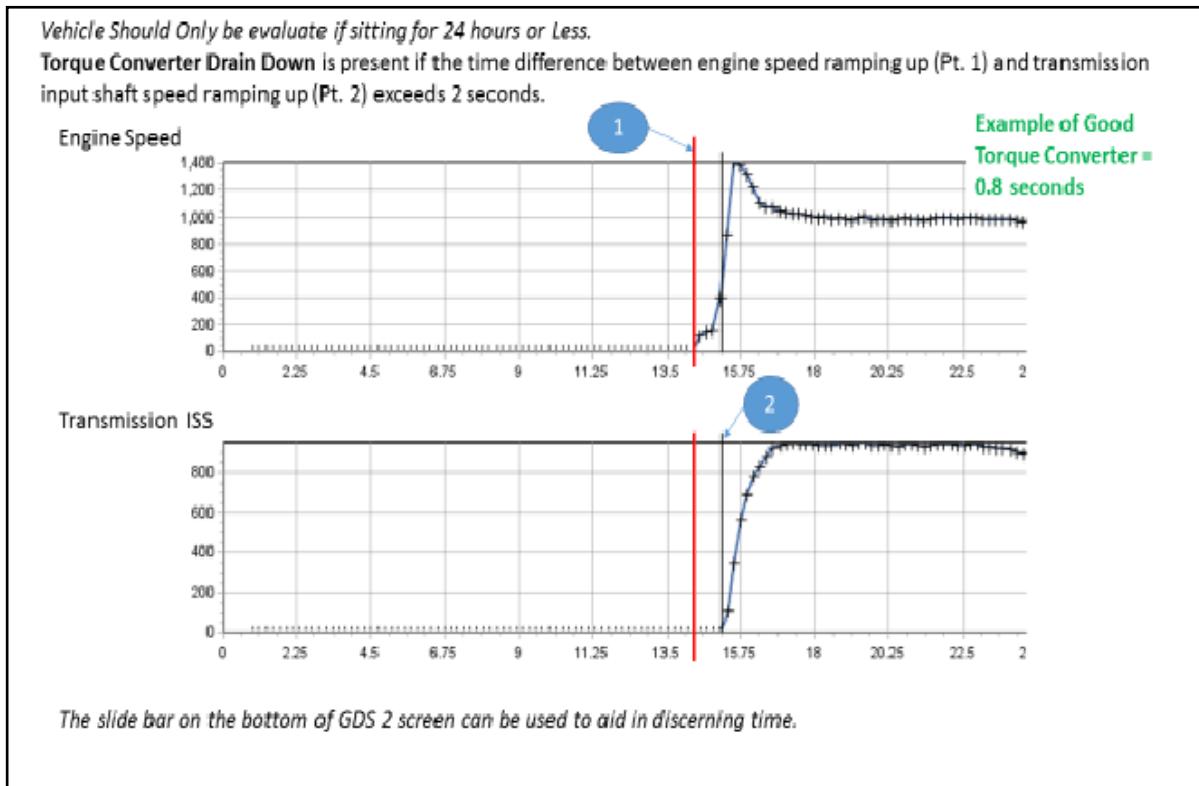
Not Wanting to Move or Slips - Torque Converter Drain Back

This condition may be caused by the torque converter draining the transmission fluid back into the

If the customer describes the condition as a long engagement with a slip/soft engagement feel and/or the vehicle not wanting to move, the condition should be considered drain back and the following procedure should be followed.

1. Using GDS and monitor engine RPM and transmission Input Speed Sensor (ISS) prior to starting the engine.
2. Start the engine with the transmission in park.
 - ISS should be equal to engine RPM in 3 seconds or less.
 - If ISS takes more than 3 seconds to equal engine RPM than follow the procedure for replacing the stator shaft support described in the service procedure below.

- *DO NOT* replace the stator shaft support on vehicles taking 3 seconds or less for turbine shaft speed to equal engine RPM.

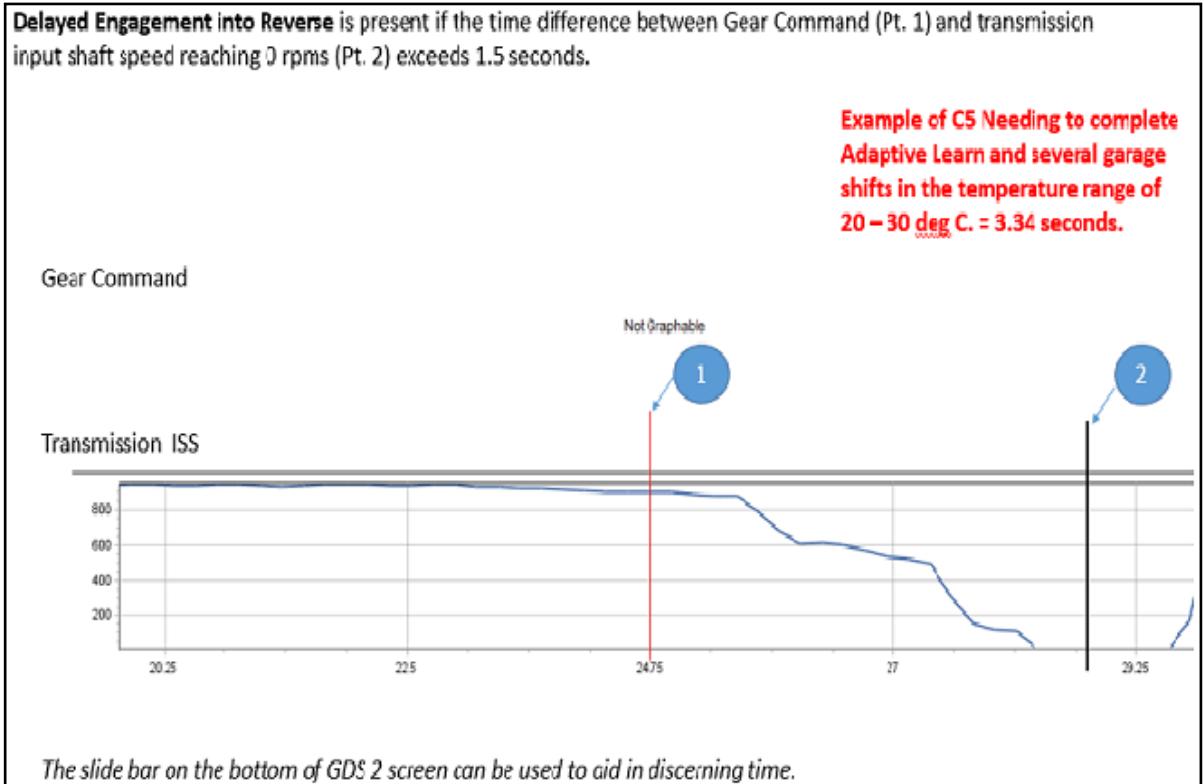
Delayed Harsh Engagement - Clutch Slow to Fill

If the customer describes the condition as a long engagement time with a harsh or bump engagement feel when shifting the vehicle from park to drive or reverse. Using GDS and monitor engine RPM and transmission Input Speed Sensor (ISS) prior to starting the engine. Start the engine with the engine in park. ISS should equal engine RPM in 3 seconds or less. If ISS takes more than 3 seconds to equal engine RPM than follow the procedure for replacing the stator shaft support. If the ISS is equal to engine RPM in 3 seconds or less shift the vehicle from park to drive or reverse leaving the service brake applied. ISS should drop to zero “0” within 2 seconds, this is clutch

engagement time. Recording a GDS session log can be useful in diagnosing this condition.

For 2015 MY vehicles Contact GM TAC for review and additional instructions. Prior to contacting TAC record a GDS2 Session log of the delayed engagement.

For 2016 MY vehicle attempt to learn the C5 Clutch using the following procedure:

1. Allow the transmission sump temperature to rise between 20 and 30 degrees C (68 and 86 degrees F).

2. Perform 20 Park to Reverse shifts releasing the brake with each shift.

If the learn procedure does not correct the condition contact GM TAC for review and additional instructions. Prior to contacting TAC record a GDS2 Session log of the delayed engagement.

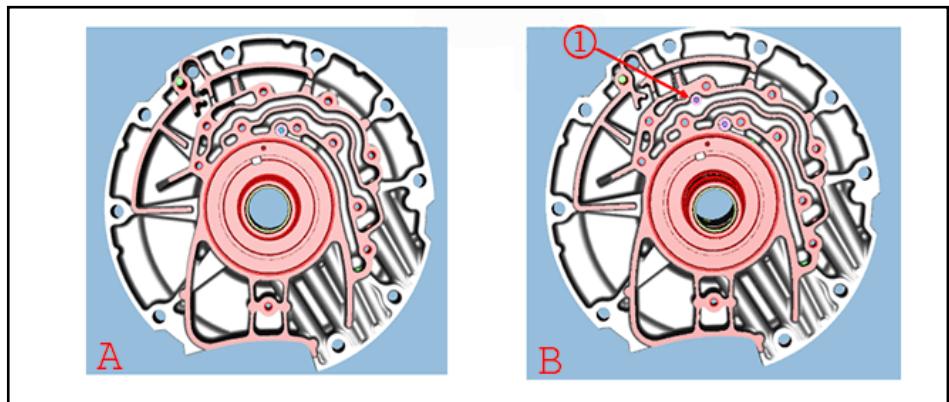
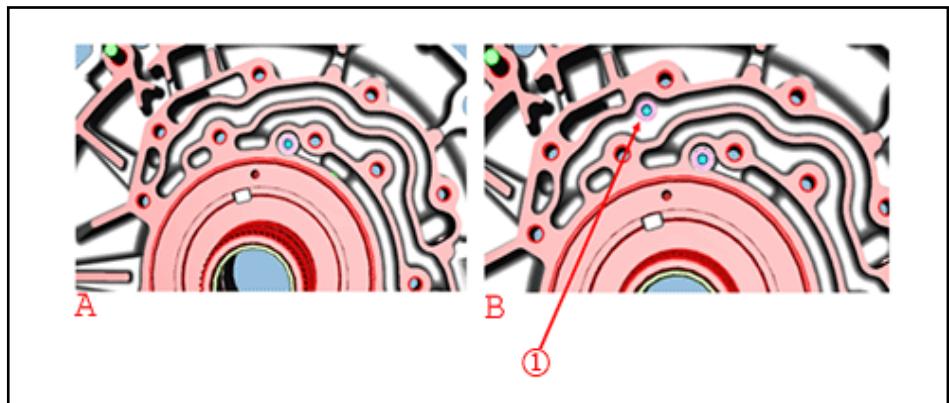
Old stator support asm

New stator support asm

Note: The new stator shaft support assembly has a second check ball (1) added (see illustrations).

Install a new stator shaft support assembly that includes an additional check ball. Follow the instructions below to replace the stator shaft

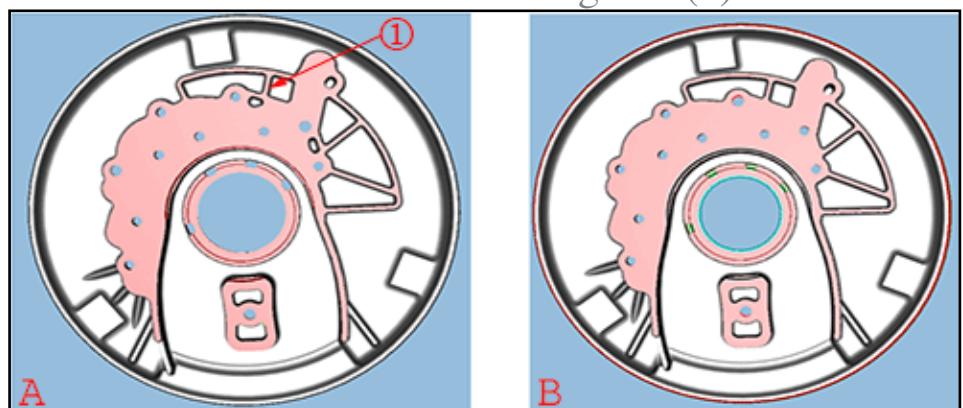
Old cover - 8L90 Only

New cover - 8L90 Only

Note: The casting void has been eliminated from the underside of the cover for the 8L90 only (see illustration). The 8L45 is not required.
