2014 - 2016 Corvette: Service Bulletin: #16-NA-250: Slow Cranking, Dead Battery and/or No Start

#16-NA-250: Slow Cranking, Dead Battery and/or No Start - (Aug 8, 2016)

Subject: Slow Cranking, Dead Battery and/or
No Start

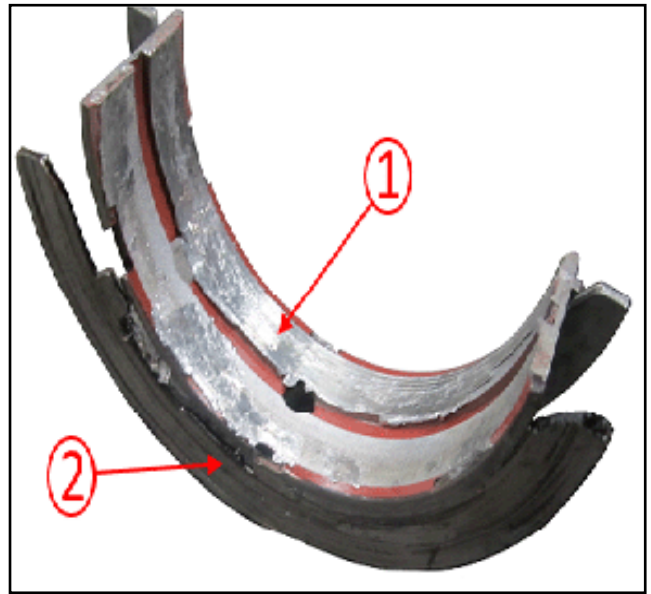
This may be caused by excessive pressure to the engine crankshaft thrust bearing (1), by forward pressure from a mis-aligned driveline support assembly.

If the driveline support assembly has been removed from a previous vehicle repair, it is required that the propeller shaft hub clamp (Automatic Transmission) or input shaft front bearing (Manual Transmission) be realigned. Follow the procedures outlined in SI.
