2014 - 2016 Corvette: Service Bulletin: #16-NA-250: Slow Cranking, Dead Battery and/or No Start

#16-NA-250: Slow Cranking, Dead Battery and/or No Start - (Aug 8, 2016)

Subject: Slow Cranking, Dead Battery and/or
No Start

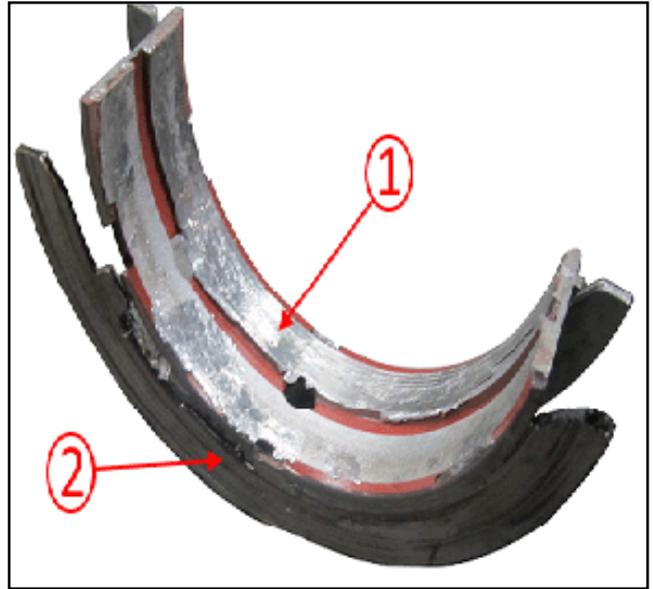
This may be caused by excessive pressure to the engine crankshaft thrust bearing (1), by forward pressure from a mis-aligned driveline support assembly.

If the driveline support assembly has been removed from a previous vehicle repair, it is required that the propeller shaft hub clamp (Automatic Transmission) or input shaft front bearing (Manual Transmission) be realigned. Follow the procedures outlined in SI.

Failure to properly align the driveline support assembly may result in warranty claims being debited for improper workmanship.
