**2015 - 2016 Corvette: Service Bulletin:
 #16-NA-107: DTC U0184 Set, Radio Inoperative,
 Blue Screen, AM Clipping Noise, HD On/Off
 Status Not Retained in Stations, Time Lag on
 Transitions, No Audio with Internal Amp, Park
 Assist Symbol Position Wrong i**

#16-NA-107: DTC U0184 Set, Radio Inoperative, Blue Screen, AM Clipping Noise, HD On/Off Status Not Retained in Stations, Time Lag on Transitions, No Audio with Internal Amp, Park Assist Symbol Position Wrong in Rear View Camera - (Sep 8, 2016)

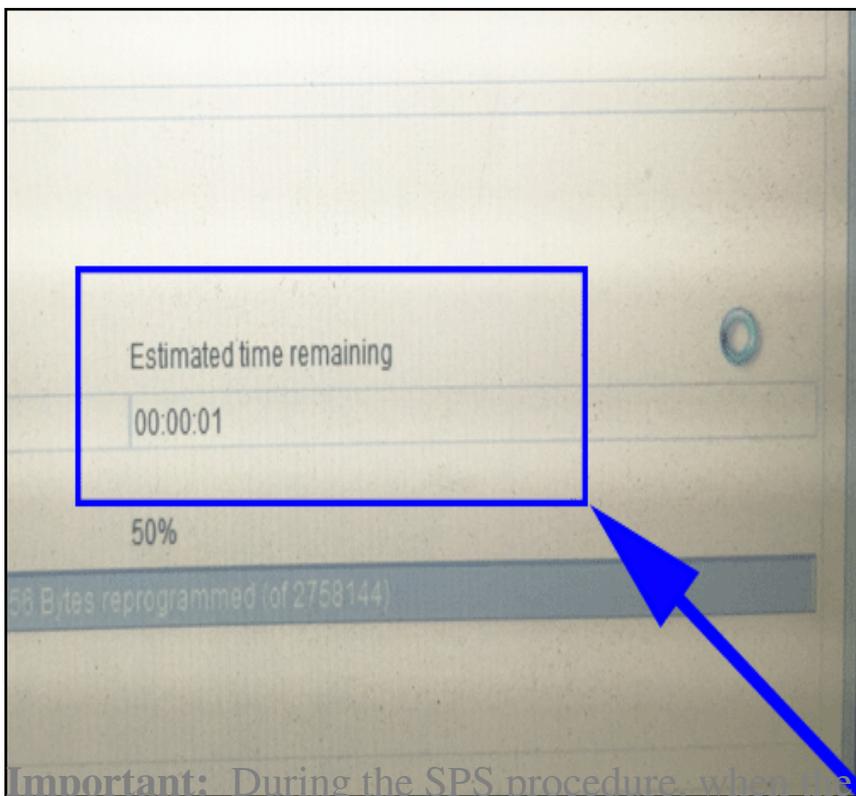
| <i>Condition</i> | <p>Some customers may comment on one or more of the following conditions based on the RPOs:</p> <ul style="list-style-type: none"> • Radio is inoperative (IO3 or IO6) • Screen is blue (IO3) • AM clipping noise in talk stations (All RPO's) • Watchdog timer implementation against blank display, GMLAN lost communication DTC U0184 (IO3 or IO6) • HD on/off status not retained when HD station is selected (All RPO's) • GPS compass is pointed to North only (IO6) • No audio with internal amp due to amp IC erroneously staying in sleep state (UQ3) • Time lag on transition |

| | <p>between Rear View Camera and normal display (IO3)</p> <ul style="list-style-type: none"> • Park Assist symbol position is wrong in Rear View Camera (IO3) |
| <i>Cause</i> | This may be caused by a software calibration within the radio. |

If you encounter a vehicle with the above concern, reprogram the radio with the latest calibrations. Refer to the proper SPS radio reprogramming procedure in SI.

Important: During the SPS procedure, when the estimated time remaining reaches 00:00:01, it may take a few minutes to complete the reprogramming. Be sure to wait until the reprogramming is completed.

Important: You may have U0184 set in multiple modules and no communication with the radio. Please cycle power to the radio and recheck for communication. Update radio software if radio now communicates.
