# **2014 - 2016 Corvette: Service Bulletin: #PI1116A: Door Rattle Noise from Outside of Vehicle During High Radio Volume or High Bass Levels - (Sep 14, 2016)**

<b>Subject:</b>	Door Rattle Noise from Outside of Vehicle During High Radio Volume or High Bass Levels
<b>Models:</b>	2014-2016 Chevrolet Corvette
<b>Attention:</b>	This PI also applies to any of the above models that may be Export from North America vehicles.

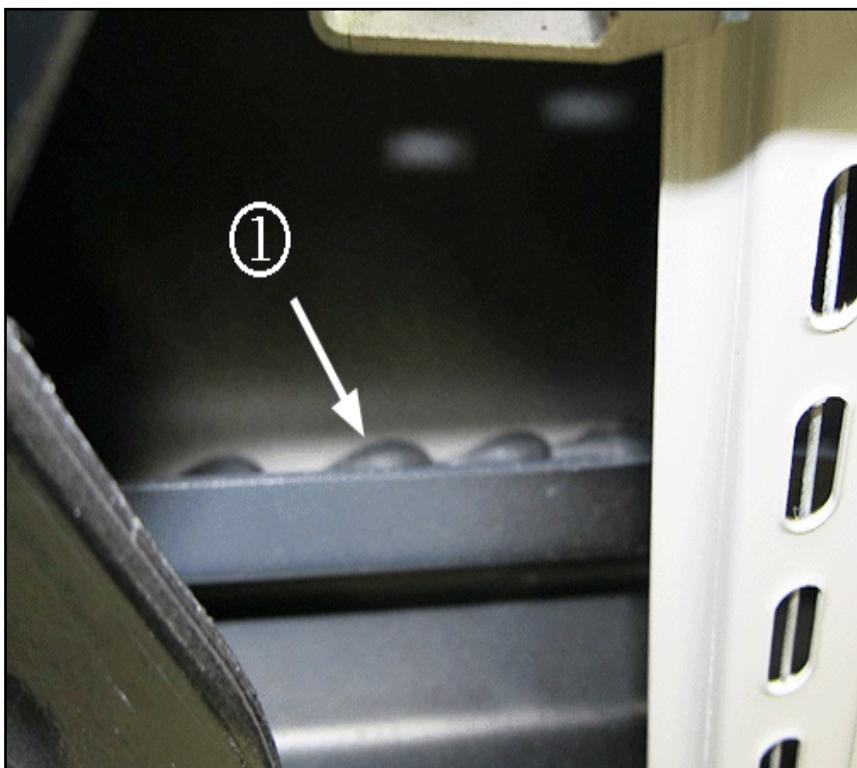
The cause of this condition may be voids in adhesive (1), leaving gaps between the inner door beam and the door skin.

Inspect the front side door beam and door skin gap for voids and add a bead of butyl ribbon sealer in those areas following the steps below:

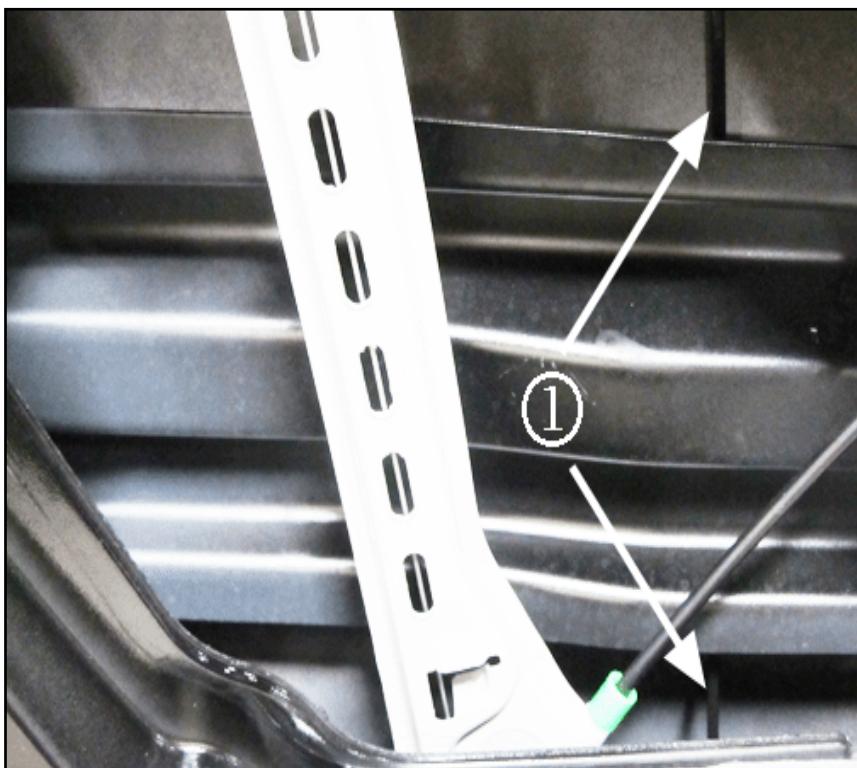
The graphic above shows an example in which a tie strap (1) was passed through a 15-20 cm (6-8 in) length gap where the adhesive was missing towards the center of the door.

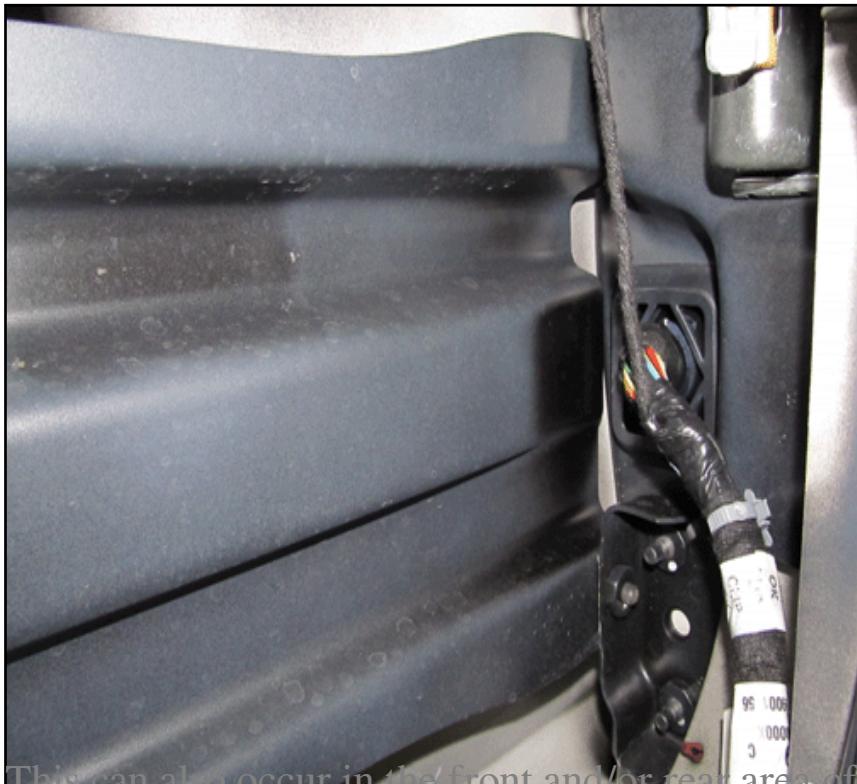
This can also occur in the front and/or rear area of the door beam; with the condition sometimes more evident in the front area (shown above) where the radio speaker is mounted.
