2014 - 2016 Corvette: Service Bulletin: #PI1116A: Door Rattle Noise from Outside of Vehicle During High Radio Volume or High Bass Levels - (Sep 14, 2016)

Subject:	Door Rattle Noise from Outside of Vehicle During High Radio Volume or High Bass Levels
Models:	2014-2016 Chevrolet Corvette
Attention:	This PI also applies to any of the above models that may be Export from North America vehicles.

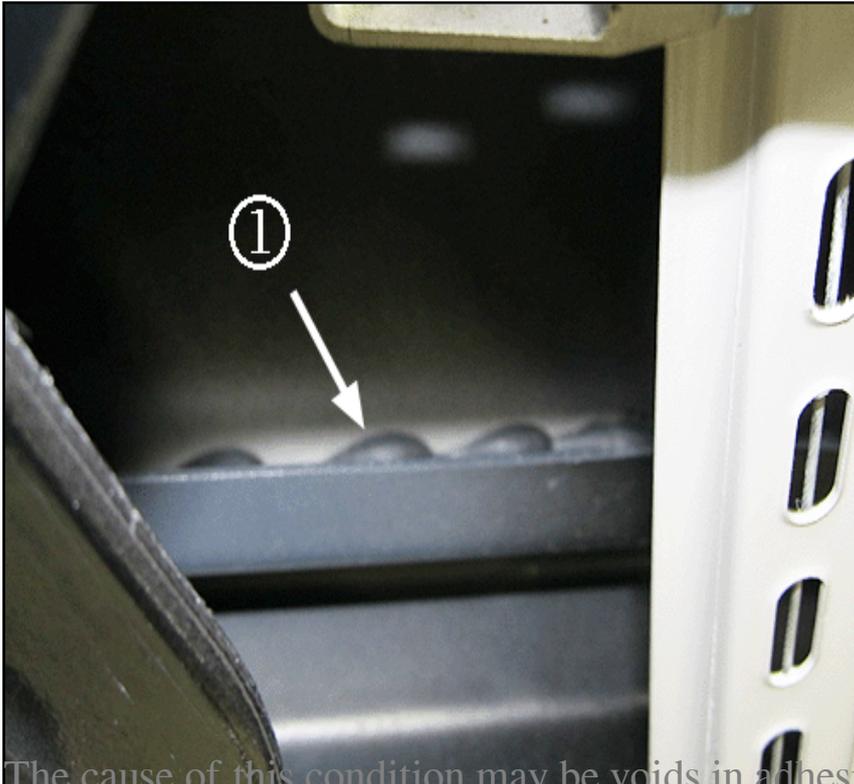
The cause of this condition may be voids in adhesive (1), leaving gaps between the inner door beam and the door skin.

Inspect the front side door beam and door skin gap for voids and add a bead of butyl ribbon sealer in those areas following the steps below:

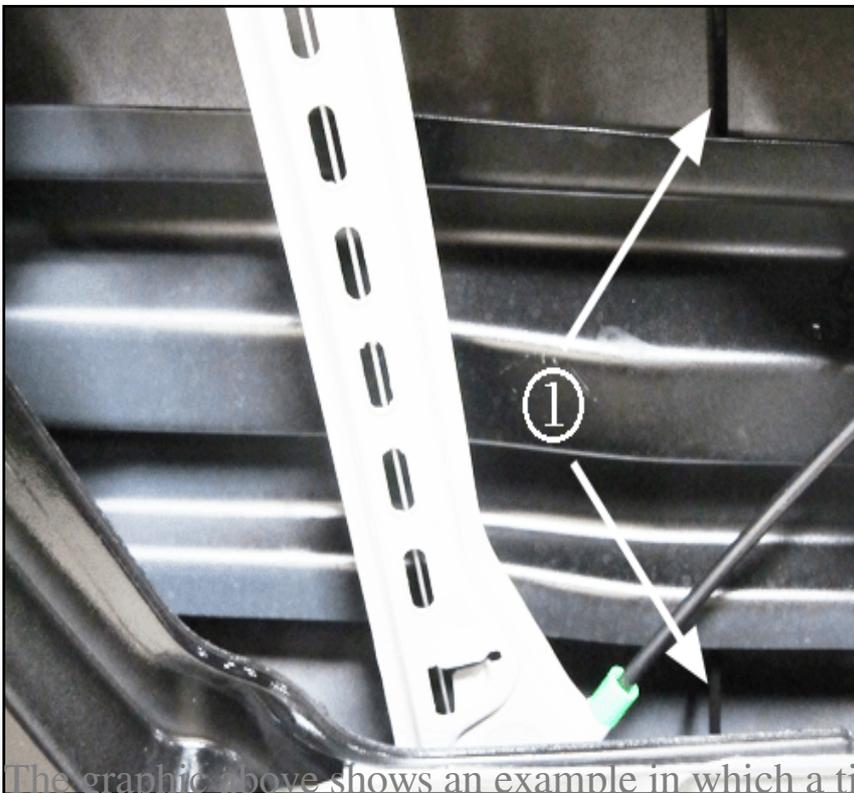
The graphic above shows an example in which a tie strap (1) was passed through a 15-20 cm (6-8 in) length gap where the adhesive was missing towards the center of the door.

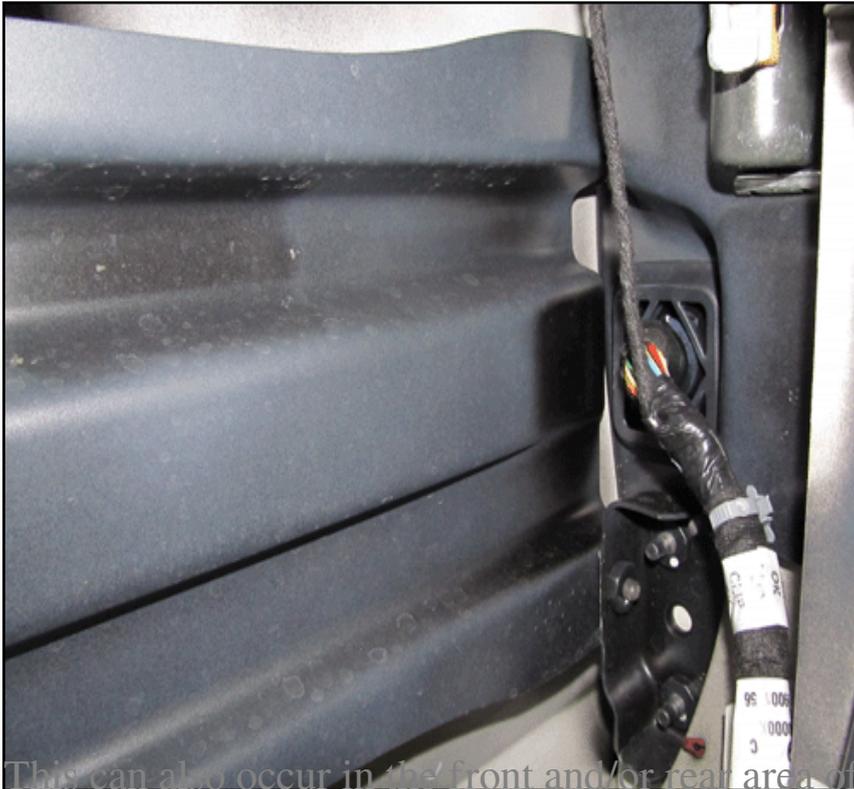
This can also occur in the front and/or rear area of the door beam; with the condition sometimes more evident in the front area (shown above) where the radio speaker is mounted.
