# 2014 - 2016 Corvette: GM TechLink: Updated Corvette Driveline Support Assembly Replacement Procedure

## Updated Corvette Driveline Support Assembly Replacement Procedure

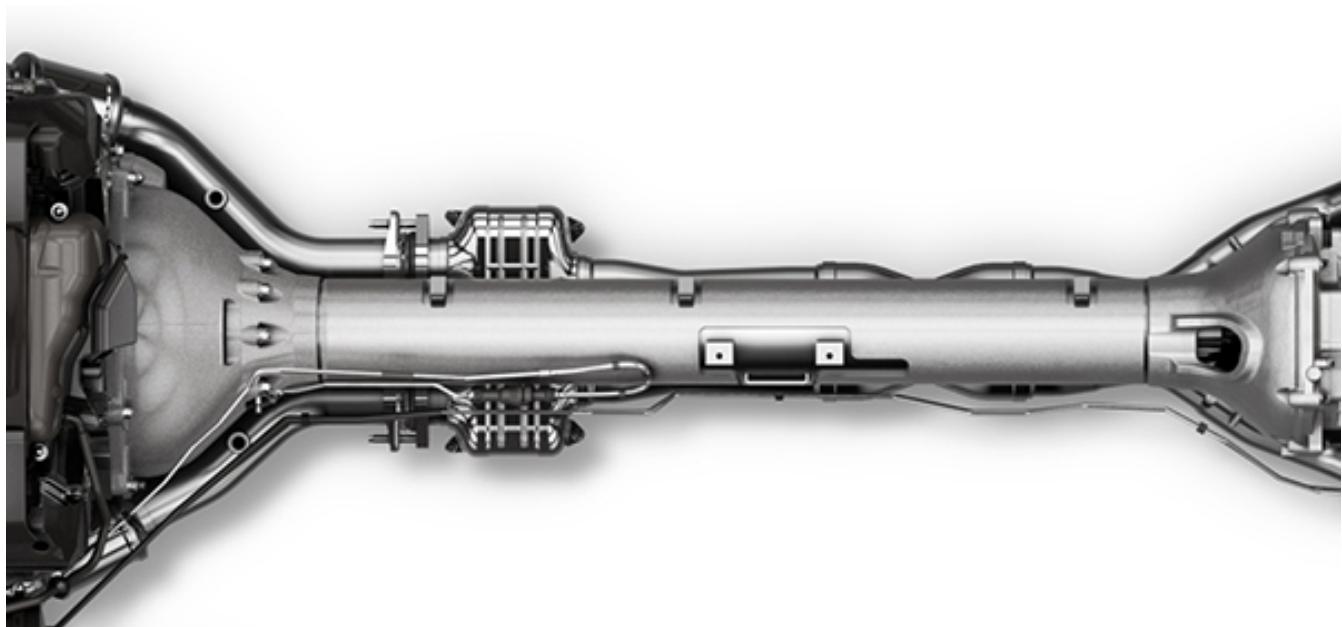
**Fig. 1**

Slow engine cranking, a dead battery or a no start condition on 2014-2016 Corvette models equipped with an automatic transmission may be caused by a misaligned driveline support assembly (Fig. 1). The misaligned assembly can cause excessive pressure and damage to the engine crankshaft thrust bearing. (Fig. 2, #1)

If the driveline support assembly has been removed for a previous vehicle repair, the propeller shaft hub clamp must be realigned. Failure to properly align the driveline support assembly may push the crankshaft forward, removing any end play. The damaged thrust bearing typically fails approximately 3,000–5,000 miles (4,000–8,000 km) after the repair when the driveline support assembly was removed.
