2014 - 2016 Corvette: GM TechLink: Updated Corvette Driveline Support Assembly Replacement Procedure

Updated Corvette Driveline Support Assembly Replacement Procedure

- **Source:** GM TechLink - August 2016

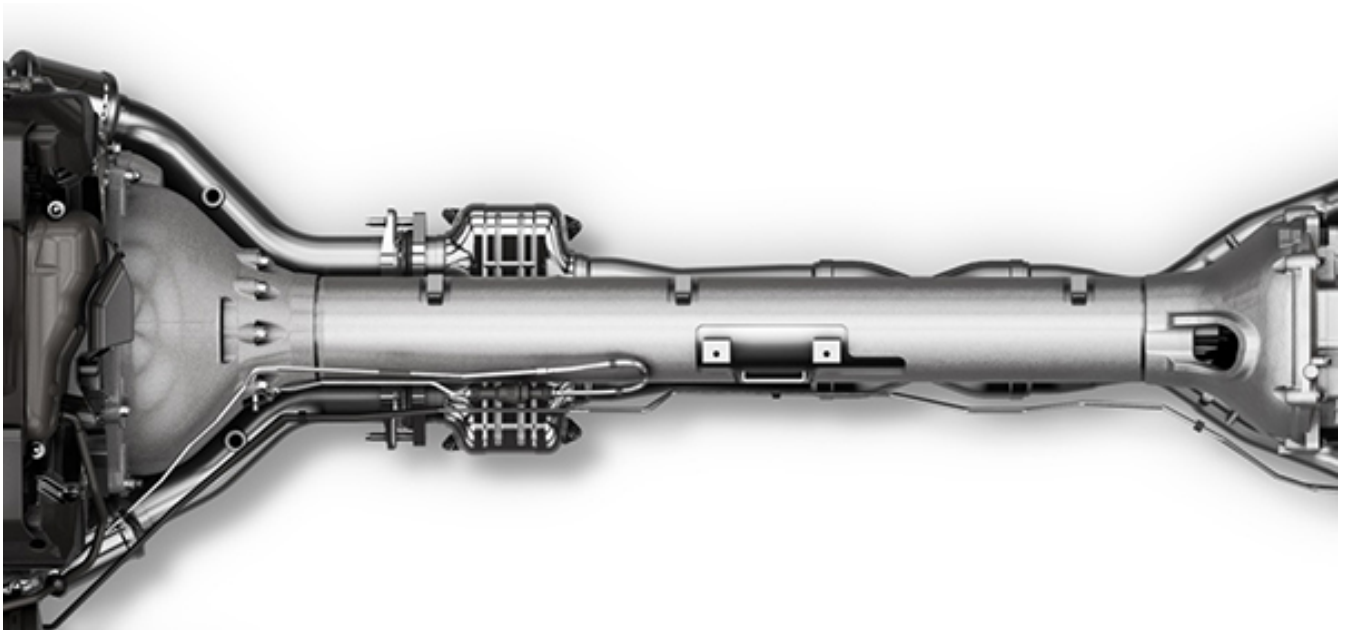
Fig. 1

Slow engine cranking, a dead battery or a no start condition on 2014-2016 Corvette models equipped with an automatic transmission may be caused by a misaligned driveline support assembly (Fig. 1). The misaligned assembly can cause excessive pressure and damage to the engine crankshaft thrust bearing. (Fig. 2, #1)

If the driveline support assembly has been removed for a previous vehicle repair, the propeller shaft hub clamp must be realigned. Failure to properly align the driveline support assembly may push the crankshaft forward, removing any end play. The damaged thrust bearing typically fails approximately 3,000–5,000 miles (4,000–8,000 km) after the repair when the driveline support assembly was removed.

The Service Information procedure for driveline support assembly replacement was recently updated for vehicles with an automatic transmission (Doc. I.D. #3462804).
