2014 - 2016 Corvette: GM TechLink: Updated Corvette Driveline Support Assembly Replacement Procedure

Updated Corvette Driveline Support Assembly Replacement Procedure

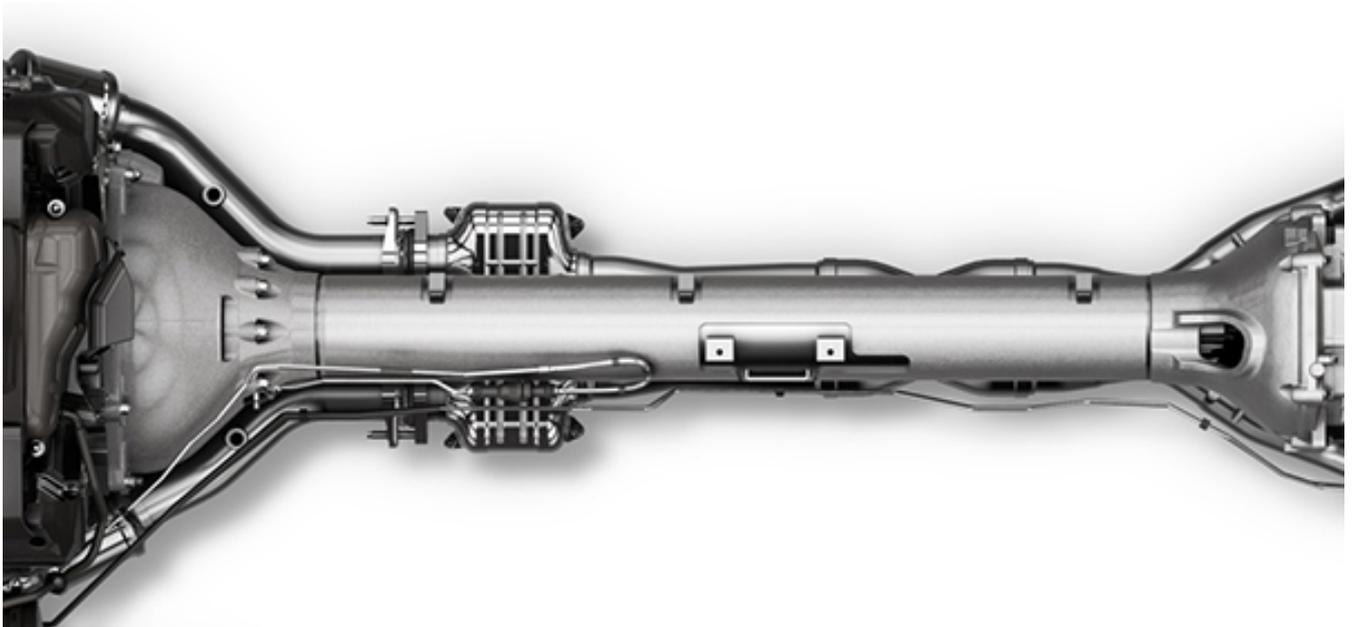
Fig. 1

Slow engine cranking, a dead battery or a no start condition on 2014-2016 Corvette models equipped with an automatic transmission may be caused by a misaligned driveline support assembly (Fig. 1). The misaligned assembly can cause excessive pressure and damage to the engine crankshaft thrust bearing. (Fig. 2, #1)

If the driveline support assembly has been removed for a previous vehicle repair, the propeller shaft hub clamp must be realigned. Failure to properly align the driveline support assembly may push the crankshaft forward, removing any end play. The damaged thrust bearing typically fails approximately 3,000–5,000 miles (4,000–8,000 km) after the repair when the driveline support assembly was removed.

The Service Information procedure for driveline support assembly replacement was recently updated for vehicles with an automatic transmission (Doc. I.D. #3462804).
