2014 - 2016 Corvette: GM TechLink: Updated Corvette Driveline Support Assembly Replacement Procedure

Updated Corvette Driveline Support Assembly Replacement Procedure

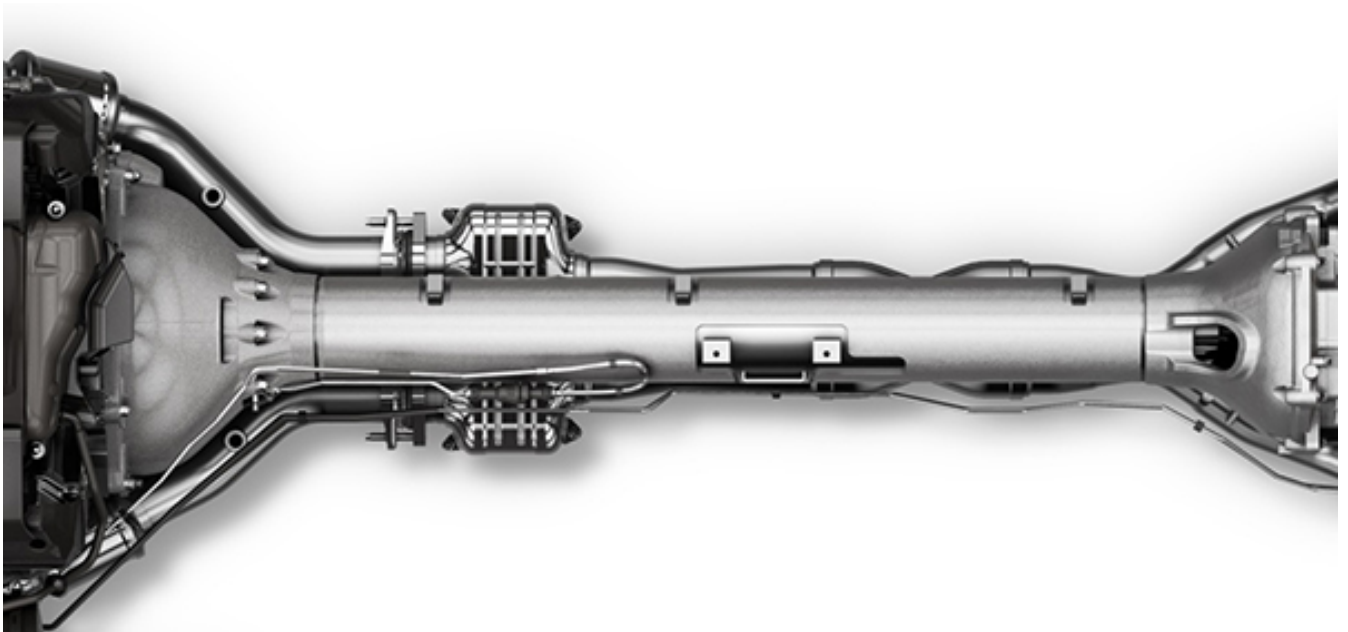
Fig. 1

Slow engine cranking, a dead battery or a no start condition on 2014-2016 Corvette models equipped with an automatic transmission may be caused by a misaligned driveline support assembly (Fig. 1). The misaligned assembly can cause excessive pressure and damage to the engine crankshaft thrust bearing. (Fig. 2, #1)

If the driveline support assembly has been removed for a previous vehicle repair, the propeller shaft hub clamp must be realigned. Failure to properly align the driveline support assembly may push the crankshaft forward, removing any end play. The damaged thrust bearing typically fails approximately 3,000–5,000 miles (4,000–8,000 km) after the repair when the driveline support assembly was removed.

The Service Information procedure for driveline support assembly replacement was recently updated for vehicles with an automatic transmission (Doc. I.D. #3462804).

The updated procedure includes tightening the propeller shaft hub clamp bolt (Fig. 3) to 130 Nm (96 lb.-ft.). Measure crankshaft end play with a dial gauge. (Fig. 4)
