# 2017 Corvette: GM TechLink: 3rd Gear Condition on Manual Transmission

**GM TechLink**

**November 23, 2016**

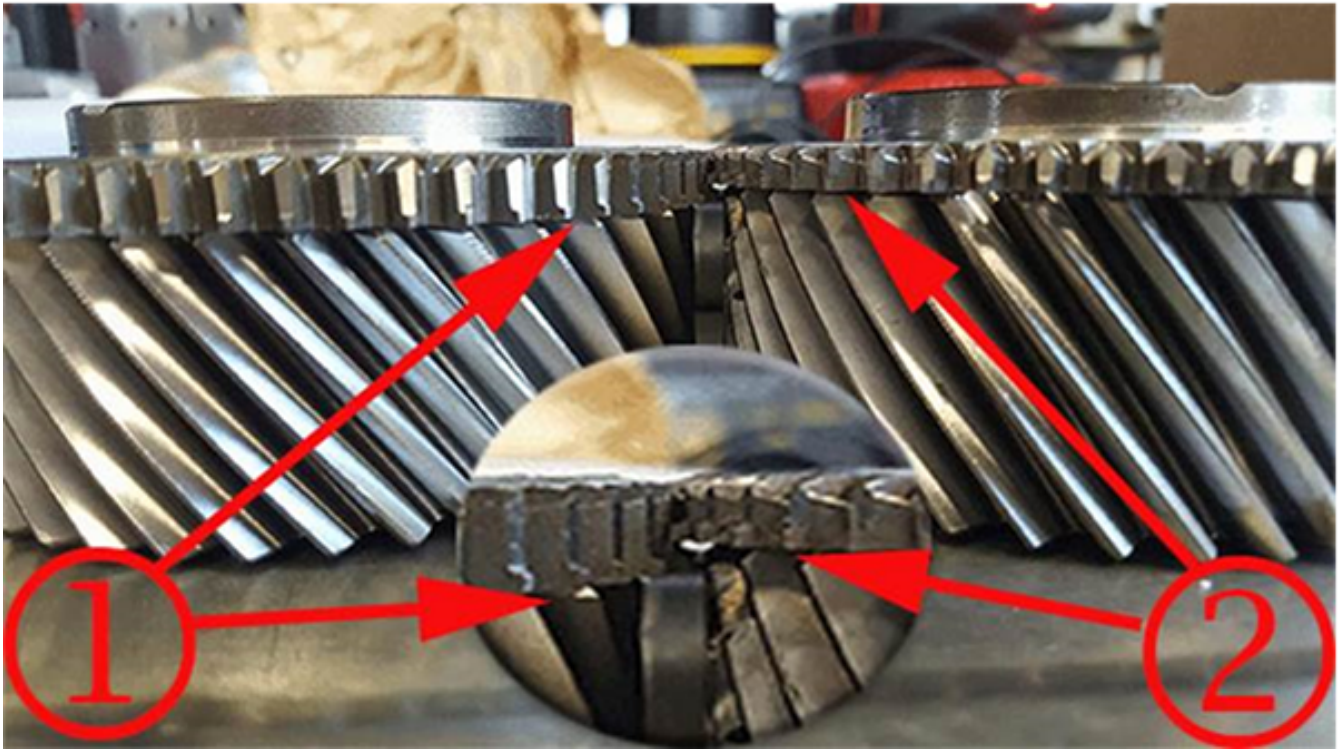
Some 2017 Camaro and ATS-V models equipped with a 6-speed transmission (RPO MM6, MG9) and 2017 Corvette models equipped with a 7-speed transmission (RPO MEP, MEK) may hop out of 3rd gear due to a mis-machined gear. These vehicles will have very low mileage or the condition may be noticed during PDI.

If the transmission does not hop out of 3rd gear, shift back to 2nd gear and repeat the shifting and accelerating procedure 10 times. If the transmission does not hop out of 3rd gear, the transmission has the correctly machined gear. (Fig. 14, #1) If the hop out of 3rd gear is verified, there is a mis-machined gear (Fig. 14, #2) and the 3rd speed gear, synchronizer and shift collar should be replaced.
