2017 Corvette: GM TechLink: 3rd Gear Condition on Manual Transmission

3rd Gear Condition on Manual Transmission

GM TechLink

November 23, 2016

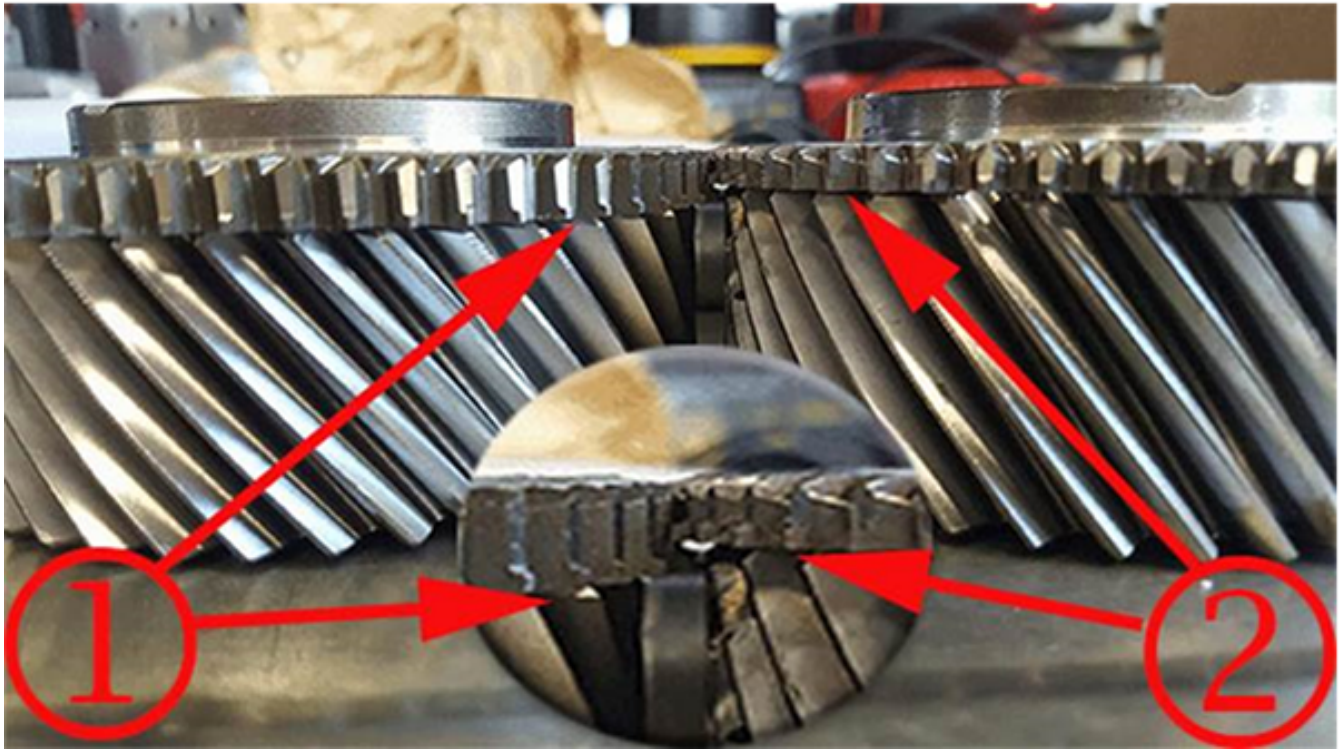
Some 2017 Camaro and ATS-V models equipped with a 6-speed transmission (RPO MM6, MG9) and 2017 Corvette models equipped with a 7-speed transmission (RPO MEP, MEK) may hop out of 3rd gear due to a mis-machined gear. These vehicles will have very low mileage or the condition may be noticed during PDI.

If the transmission does not hop out of 3rd gear, shift back to 2nd gear and repeat the shifting and accelerating procedure 10 times. If the transmission does not hop out of 3rd gear, the transmission has the correctly machined gear. (Fig. 14, #1) If the hop out of 3rd gear is verified, there is a mis-machined gear (Fig. 14, #2) and the 3rd speed gear, synchronizer and shift collar should be replaced.
