2015 - 2017 Corvette: Service Bulletin: Shake and/or Shudder During Light Throttle Acceleration Between 25 and 80 MPH (40 and 128 KM/H) at a Steady State

#16-NA-175: Shake and/or Shudder During Light Throttle Acceleration Between 25 and 80 MPH (40 and 128 KM/H) at a Steady State - (Feb 27, 2017)

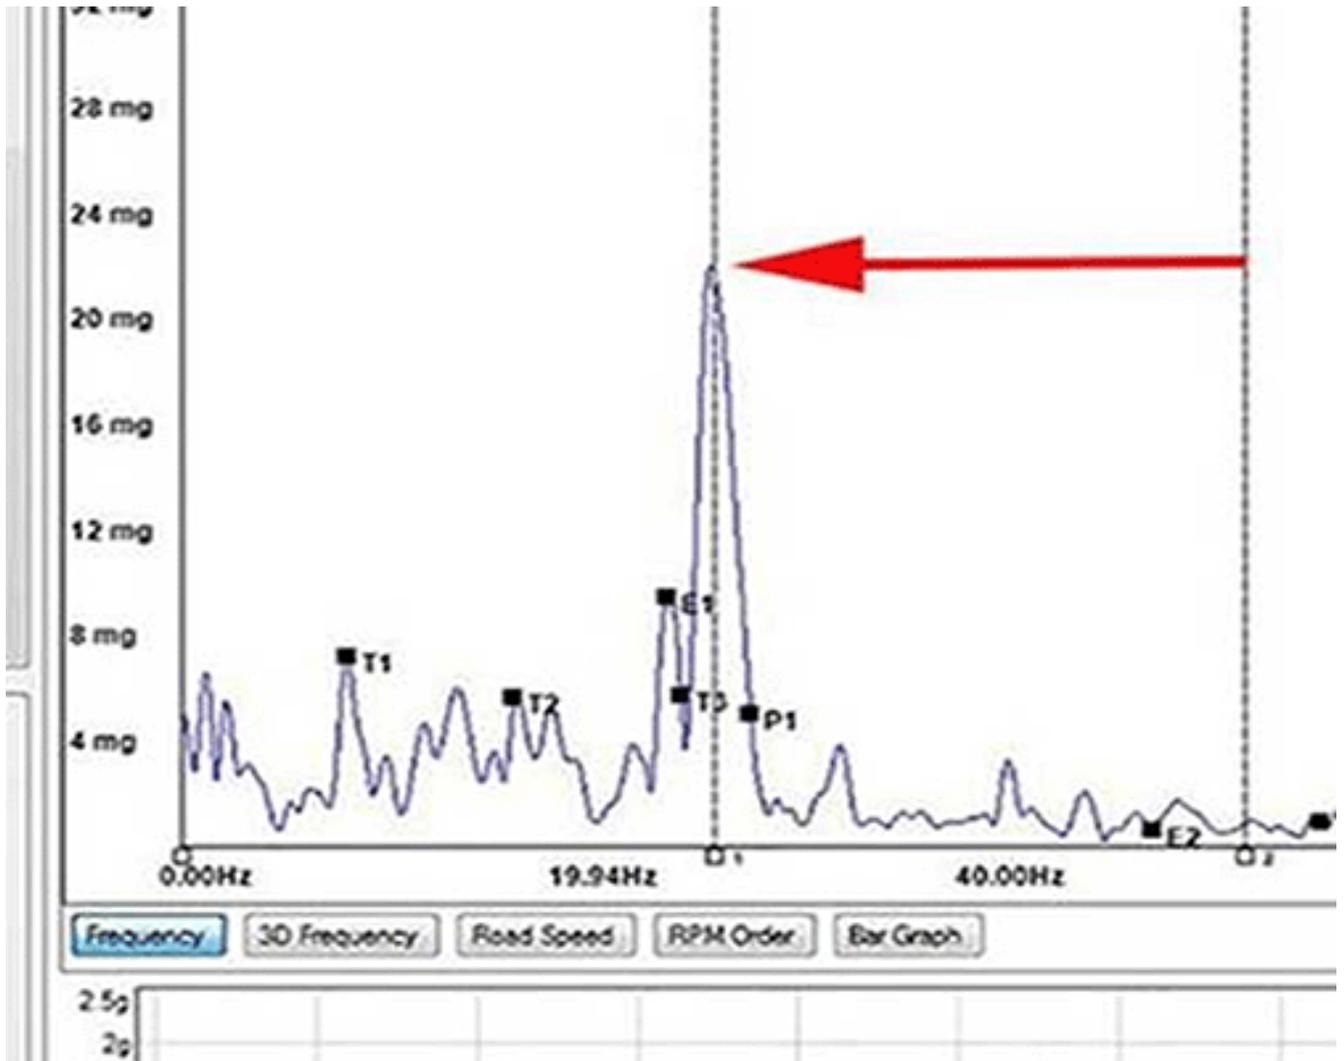
To confirm TCC shudder record the PICO scope data while driving in 8th gear in the application specific condition above. Minimize extraneous vibration input by testing on a smooth road and correct any other known vehicle vibration issues (tires, brakes, etc.) before conducting test. If TCC Shudder is present, a vibration peak will appear (highlighted by arrow below) within +/-2 Hz of the frequency listed in the table above. TCC Shudder vibration frequency should remain constant in 8th gear as indicated in the above table. If the vibration frequency follows vehicle speed or engine speed, then it is NOT TCC Shudder.

In the above illustration, frequency and default view have been selected.
