2016 - 2017 Corvette: Service Bulletin: #17-NA-025: Repeated Radio/display Resets, Volume Control Inoperative, Waiting for Update Media Message, Voice Command For Calling Bluetooth Phone Contacts Inoperative, Service Rear Vision System Message, Radi

**#17-NA-025: Repeated Radio/display Resets, Volume Control
Inoperative, Waiting for Update Media Message, Voice Command
For Calling Bluetooth Phone Contacts Inoperative, Service Rear
Vision System Message, Radio Turns On Unwanted At Startup,
and/or Navigation Radio Destination State Defaults To WV - (Mar
3, 2017)**

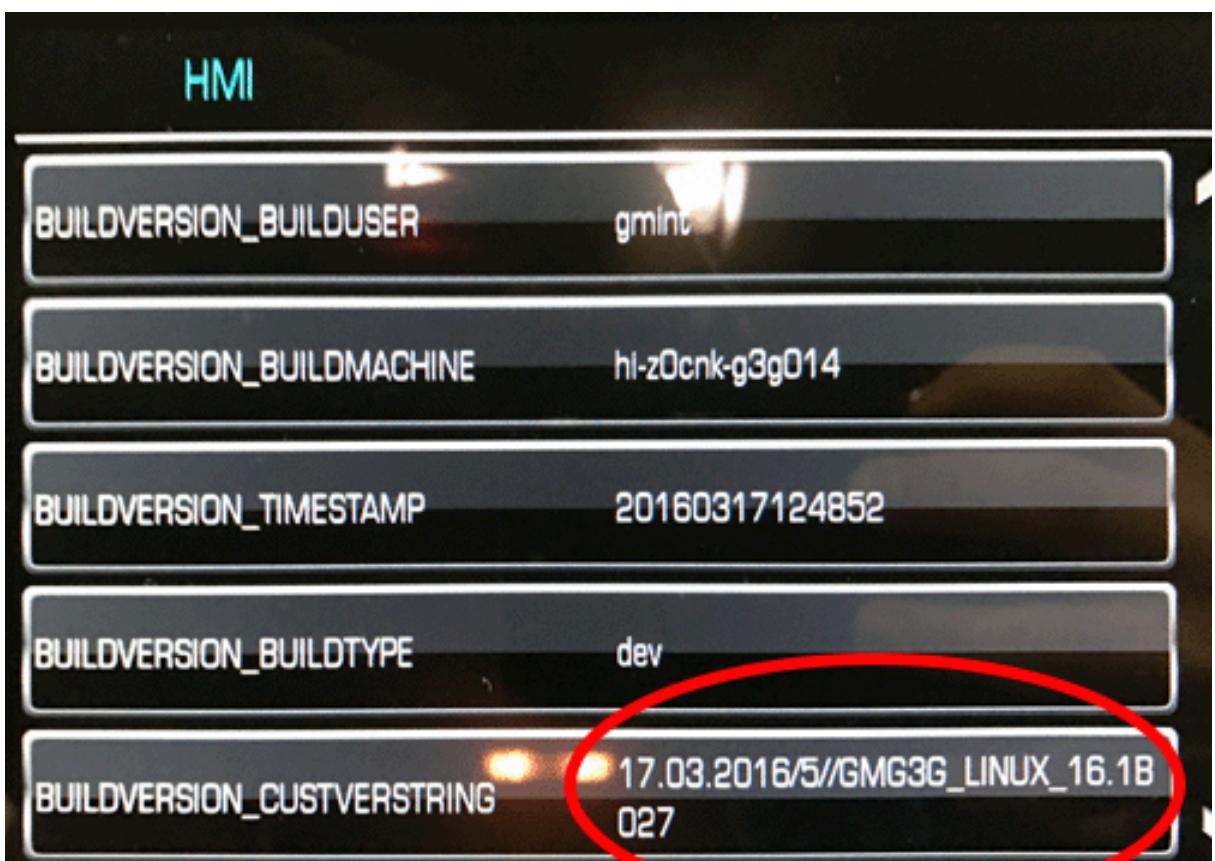
- 2016 Models - 15.1A044
- 2016 Models - 15.1A052
- 2016 Models - 15.2B033
- 2017 Models - 16.1B027

If the software is one of the following, ~~reprogram the Human Machine Interface Control Module~~. Refer to *Human Machine Interface Control Module Programming and Setup* in SI.

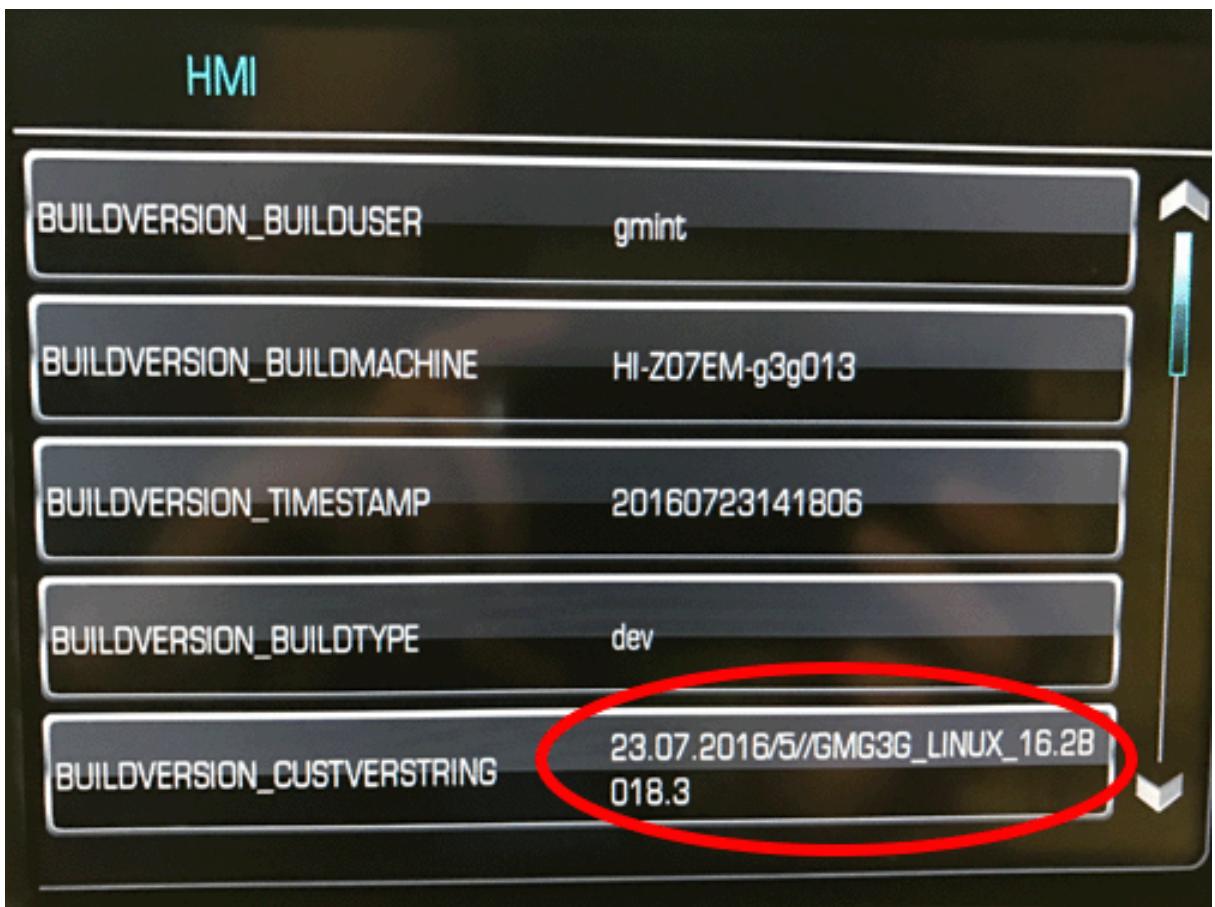
- 2017 Models - 16.2B018
- 2017 Models - 16.3B020

If the software is one of the following, refer to SI for further diagnosis.
