# 2016 - 2017 Corvette: Service Bulletin: #17-NA-025: Repeated Radio/display Resets, Volume Control Inoperative, Waiting for Update Media Message, Voice Command For Calling Bluetooth Phone Contacts Inoperative, Service Rear Vision System Message, Radi

**#17-NA-025: Repeated Radio/display Resets, Volume Control Inoperative, Waiting for Update Media Message, Voice Command For Calling Bluetooth Phone Contacts Inoperative, Service Rear Vision System Message, Radio Turns On Unwanted At Startup, and/or Navigation Radio Destination State Defaults To WV - (Mar 3, 2017)**

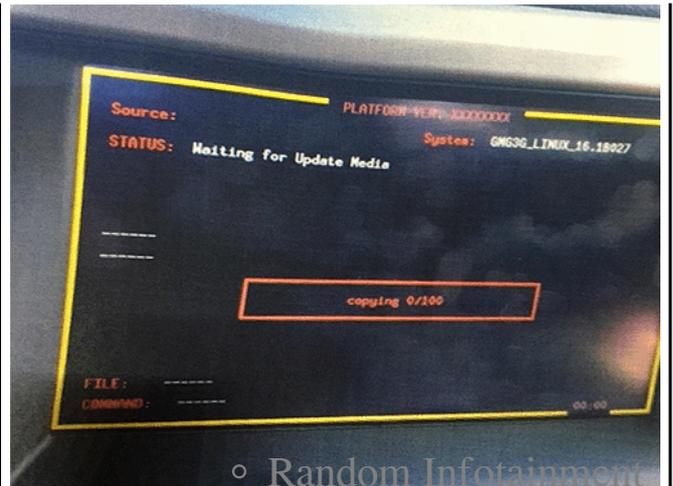
#### o Random Infotainment

system display resets while driving, screen temporarily goes blank and then returns after approximately 5 seconds.

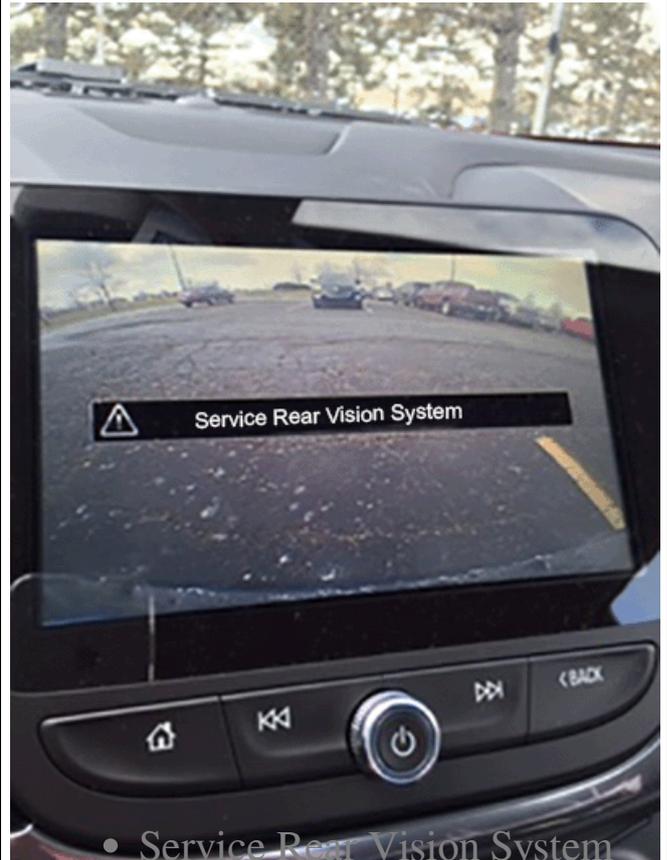
- Service Rear Vision System

Message displayed.
