**2016 - 2017 Corvette: Service Bulletin:  
 #17-NA-025: Repeated Radio/display Resets,  
 Volume Control Inoperative, Waiting for Update  
 Media Message, Voice Command For Calling  
 Bluetooth Phone Contacts Inoperative, Service  
 Rear Vision System Message, Radi**

**#17-NA-025: Repeated Radio/display Resets, Volume Control Inoperative, Waiting for Update Media Message, Voice Command For Calling Bluetooth Phone Contacts Inoperative, Service Rear Vision System Message, Radio Turns On Unwanted At Startup, and/or Navigation Radio Destination State Defaults To WV - (Mar 3, 2017)**

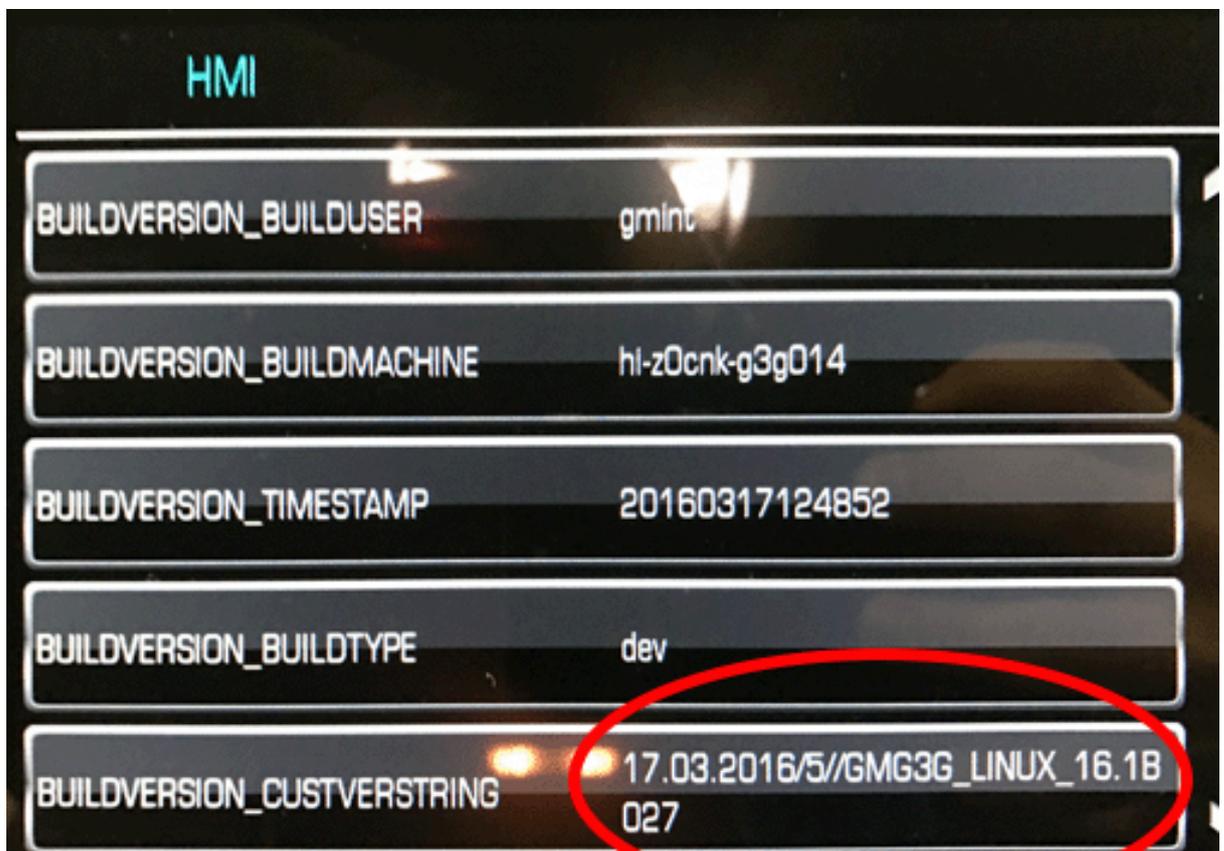
Once in Development Screen press HMI and document the Buildversion-Custverstring

If the software is one of the following, reprogram the Human Machine Interface Control Module. Refer to *Human Machine Interface Control Module Programming and Setup* in SI.

- 2016 Models - 15.1A044
- 2016 Models - 15.1A052
- 2016 Models - 15.2B033
- 2017 Models - 16.1B027
