# 2016 - 2017 Corvette: Service Bulletin:

## #17-NA-025: Repeated Radio/display Resets, Volume Control Inoperative, Waiting for Update Media Message, Voice Command For Calling Bluetooth Phone Contacts Inoperative, Service Rear Vision System Message, Radi

**#17-NA-025: Repeated Radio/display Resets, Volume Control Inoperative, Waiting for Update Media Message, Voice Command For Calling Bluetooth Phone Contacts Inoperative, Service Rear Vision System Message, Radio Turns On Unwanted At Startup, and/or Navigation Radio Destination State Defaults To WV - (Mar 3, 2017)**

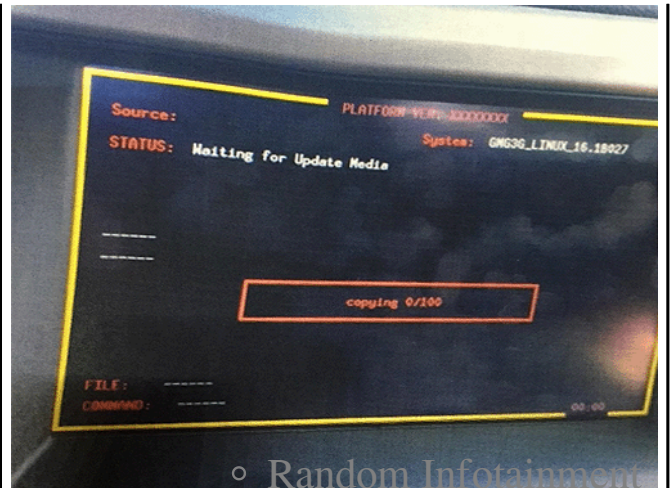
#### ◦ Random Infotainment

system display resets while driving, screen temporarily goes blank and then returns after approximately 5 seconds.

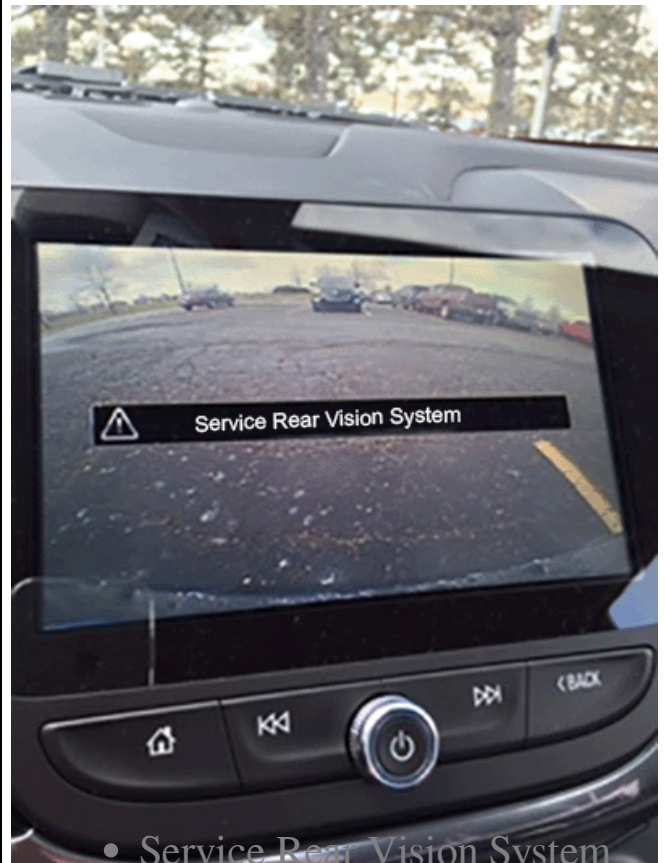
- Service Rear Vision System

Message displayed.
