2016 - 2017 Corvette: Service Bulletin: #17-NA-025: Repeated Radio/display Resets, Volume Control Inoperative, Waiting for Update Media Message, Voice Command For Calling Bluetooth Phone Contacts Inoperative, Service Rear Vision System Message, Radi

#17-NA-025: Repeated Radio/display Resets, Volume Control Inoperative, Waiting for Update Media Message, Voice Command For Calling Bluetooth Phone Contacts Inoperative, Service Rear Vision System Message, Radio Turns On Unwanted At Startup, and/or Navigation Radio Destination State Defaults To WV - (Mar 3, 2017)

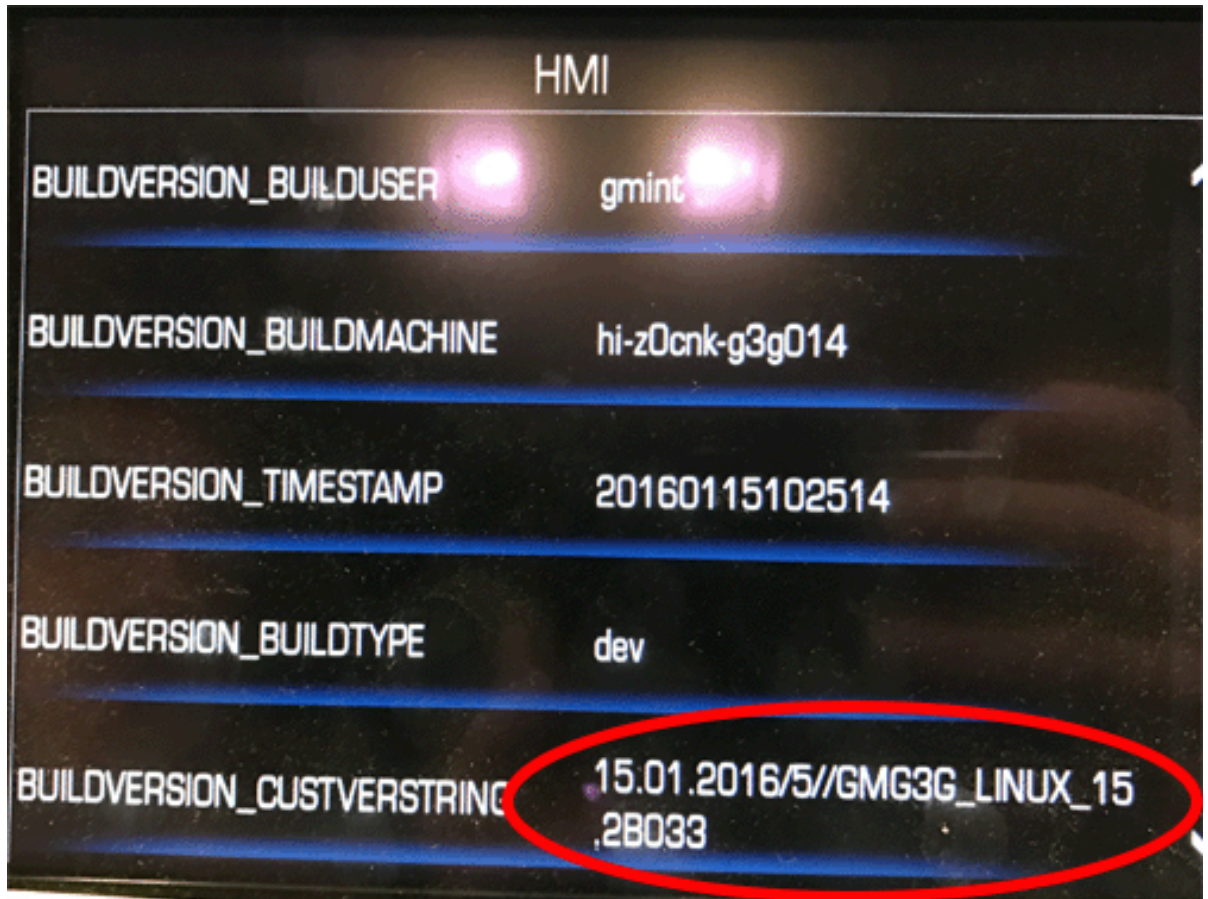
If you encounter a vehicle with the above concern, check the HMI build version.

Verify the HMI build version by completing the following:

To verify the HMI build version, on the radio, push the following button combination together (refer to chart below), then select HMI from the onboard development screen.

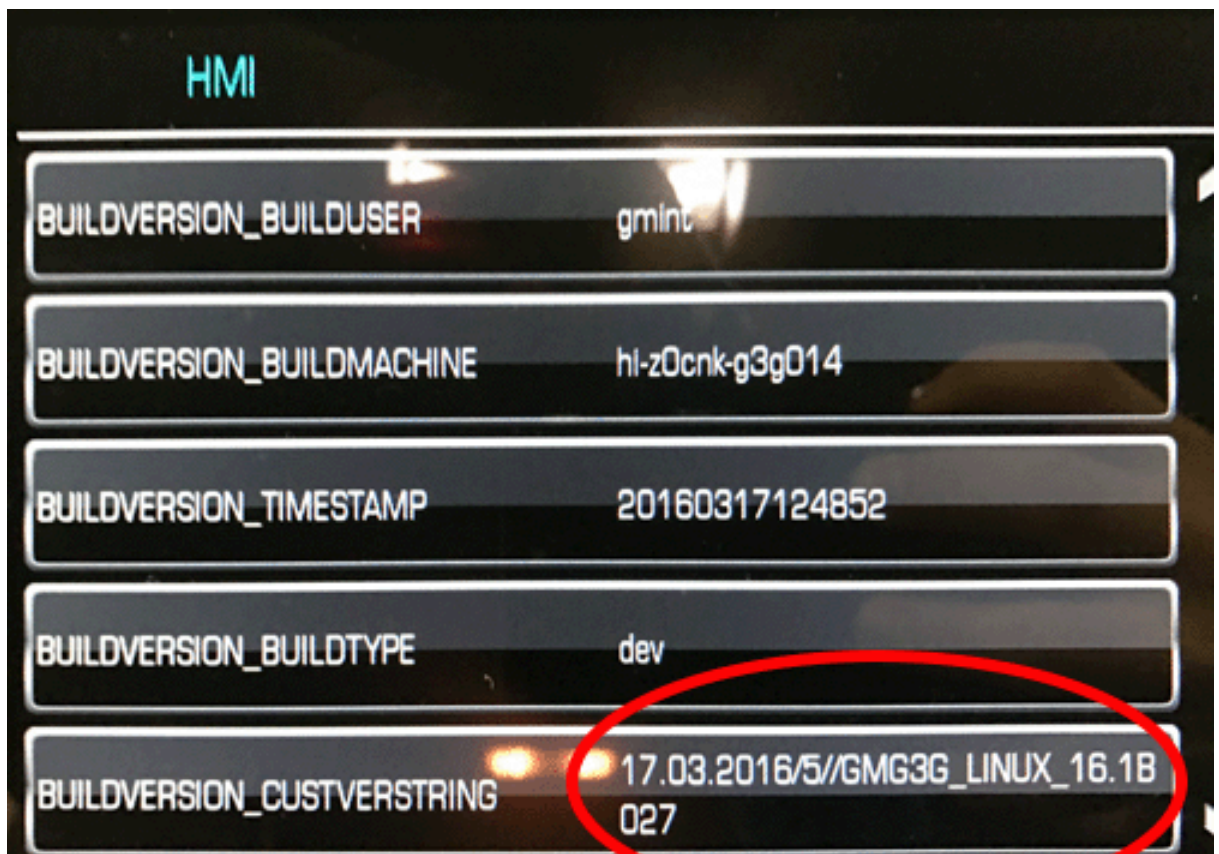
Once in Development Screen press HMI and document the Buildversion-Custverstring

If the software is one of the following, reprogram the Human Machine Interface Control Module. Refer to *Human Machine Interface Control Module Programming and Setup* in SI.

- 2016 Models - 15.1A044
- 2016 Models - 15.1A052
- 2016 Models - 15.2B033
- 2017 Models - 16.1B027
