1970 - 1973 Corvette: Service Bulletin: Overheating - 454 Cu.In. Engine with Air Conditioning

**Chevrolet
Dealer
Service
Technical
Bulletin**

73-T-28

Subject: ENGINE OVERHEAT - 1970-1973
CORVETTES WITH 454 CU. IN.
ENGINES AND AIR CONDITIONING

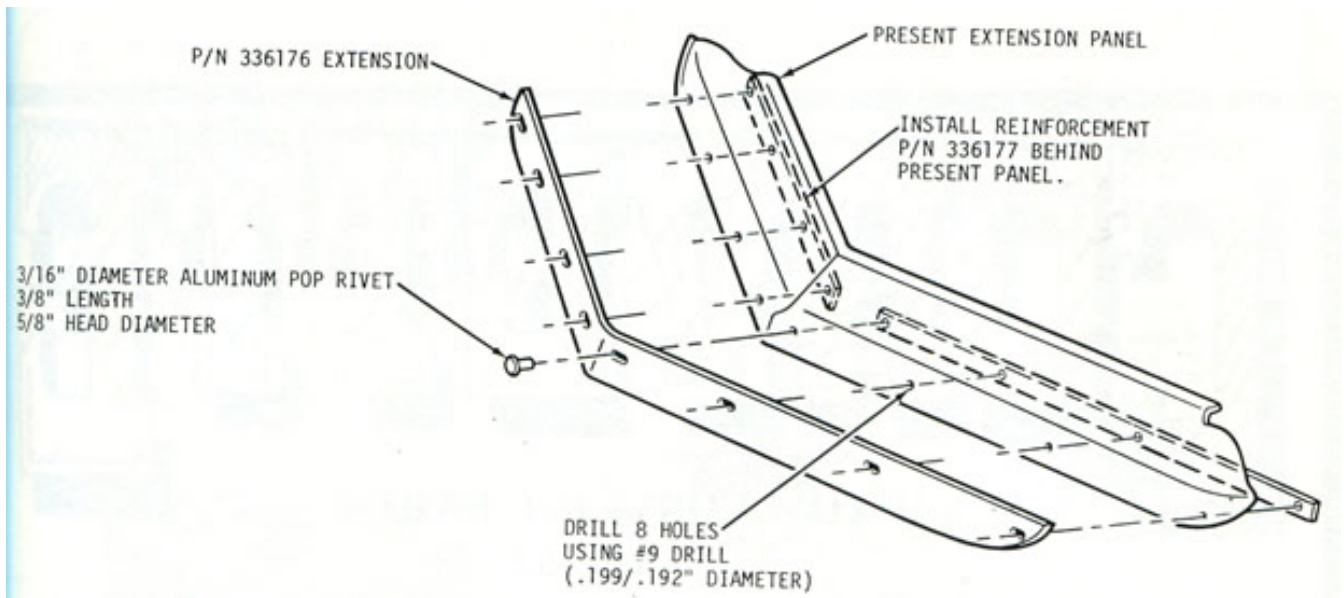
Engine overheat may be encountered on some 1970-1973 Corvettes equipped with the 454 cu. in. engine and air conditioning during high ambient temperatures when operated in heavy traffic. This condition is due to the limited amount of air flowing through the radiator at low vehicle speeds or during periods of extended idle.

To improve low speed cooling, an additional grille panel lower extension was installed in 1973 Corvettes produced after Vehicle Identification Number 1Z37Z3S410722. This extension, Part Number 336176, may be installed as illustrated on page 2 of this bulletin on early 1973 Corvettes only.
