**1970 - 1973 Corvette: Service Bulletin:  
Overheating - 454 Cu.In. Engine with Air  
Conditioning**

**Chevrolet  
 Dealer  
 Service  
 Technical  
 Bulletin**

73-T-28

Subject: ENGINE OVERHEAT - 1970-1973  
 CORVETTES WITH 454 CU. IN.  
 ENGINES AND AIR CONDITIONING

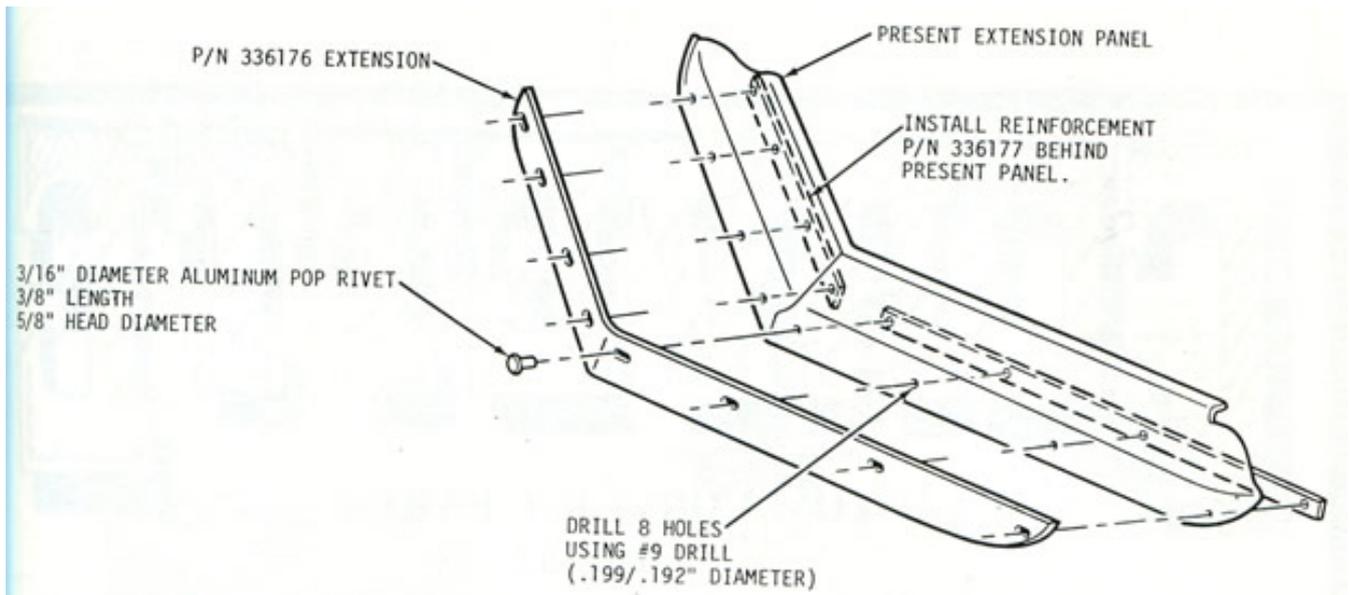
Engine overheat may be encountered on some 1970-1973 Corvettes equipped with the 454 cu. in. engine and air conditioning during high ambient temperatures when operated in heavy traffic. This condition is due to the limited amount of air flowing through the radiator at low vehicle speeds or during periods of extended idle.

To improve low speed cooling, an additional grille panel lower extension was installed in 1973 Corvettes produced after Vehicle Identification Number 1Z37Z3S410722. This extension, Part Number 336176, may be installed as illustrated on page 2 of this bulletin on early 1973 Corvettes only.
