1970 - 1973 Corvette: Service Bulletin: Overheating - 454 Cu.In. Engine with Air Conditioning

Chevrolet Dealer Service Technical Bulletin

73-T-28

Subject: ENGINE OVERHEAT - 1970-1973
CORVETTES WITH 454 CU. IN.
ENGINES AND AIR CONDITIONING

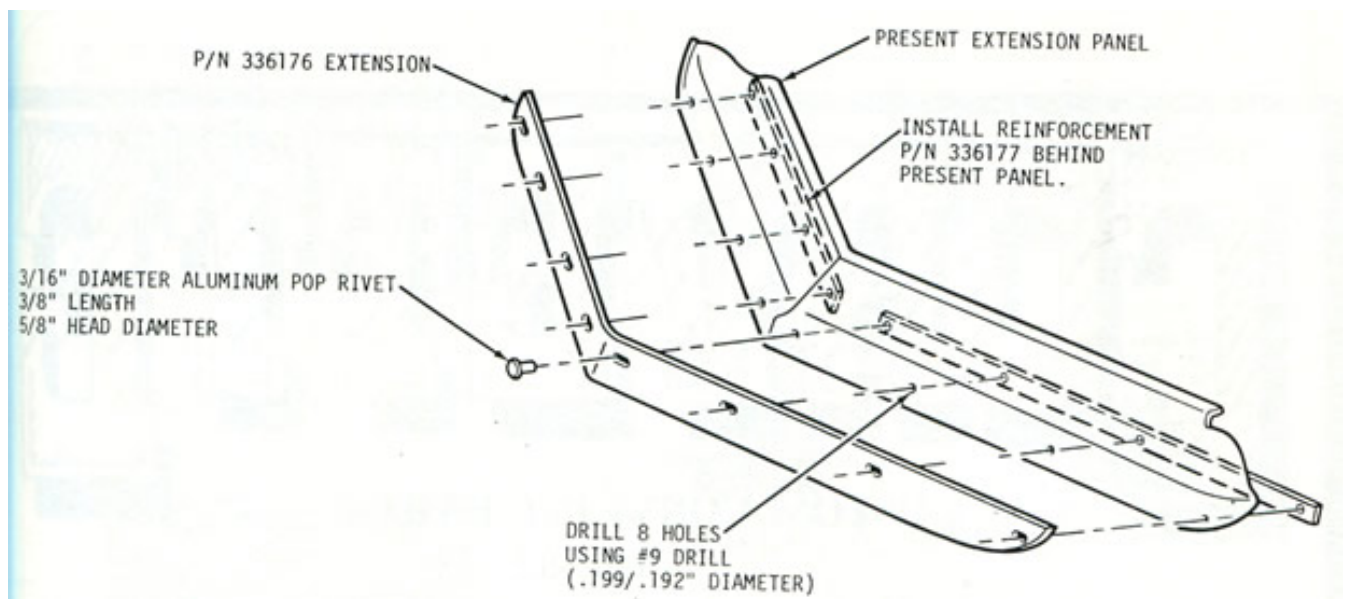
Engine overheat may be encountered on some 1970-1973 Corvettes equipped with the 454 cu. in. engine and air conditioning during high ambient temperatures when operated in heavy traffic. This condition is due to the limited amount of air flowing through the radiator at low vehicle speeds or during periods of extended idle.

To improve low speed cooling, an additional grille panel lower extension was installed in 1973 Corvettes produced after Vehicle Identification Number 1Z37Z3S410722. This extension, Part Number 336176, may be installed as illustrated on page 2 of this bulletin on early 1973 Corvettes only.
