1970 - 1973 Corvette: Service Bulletin: Overheating - 454 Cu.In. Engine with Air Conditioning

73-T-28

Subject: ENGINE OVERHEAT - 1970-1973
CORVETTES WITH 454 CU. IN.
ENGINES AND AIR CONDITIONING

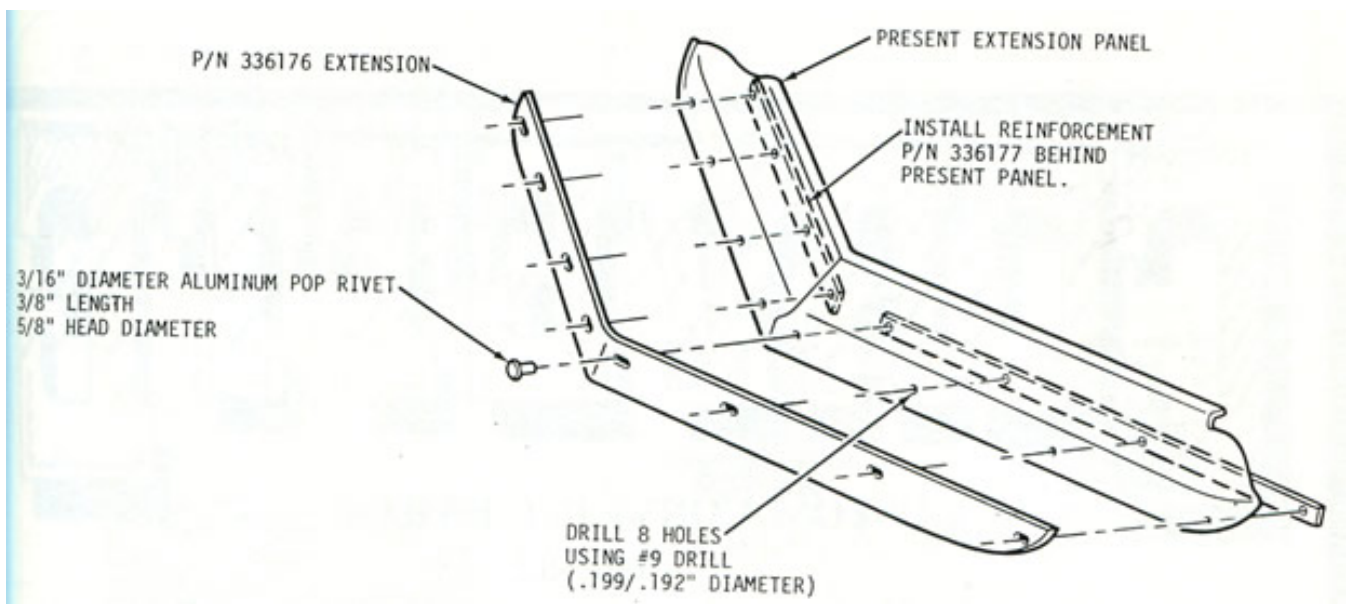
Engine overheat may be encountered on some 1970-1973 Corvettes equipped with the 454 cu. in. engine and air conditioning during high ambient temperatures when operated in heavy traffic. This condition is due to the limited amount of air flowing through the radiator at low vehicle speeds or during periods of extended idle.

To improve low speed cooling, an additional grille panel lower extension was installed in 1973 Corvettes produced after Vehicle Identification Number 1Z37Z3S410722. This extension, Part Number 336176, may be installed as illustrated on page 2 of this bulletin on early 1973 Corvettes only.
