1970 - 1973 Corvette: Service Bulletin: Overheating - 454 Cu.In. Engine with Air Conditioning

73-T-28

Subject: ENGINE OVERHEAT - 1970-1973
CORVETTES WITH 454 CU. IN.
ENGINES AND AIR CONDITIONING

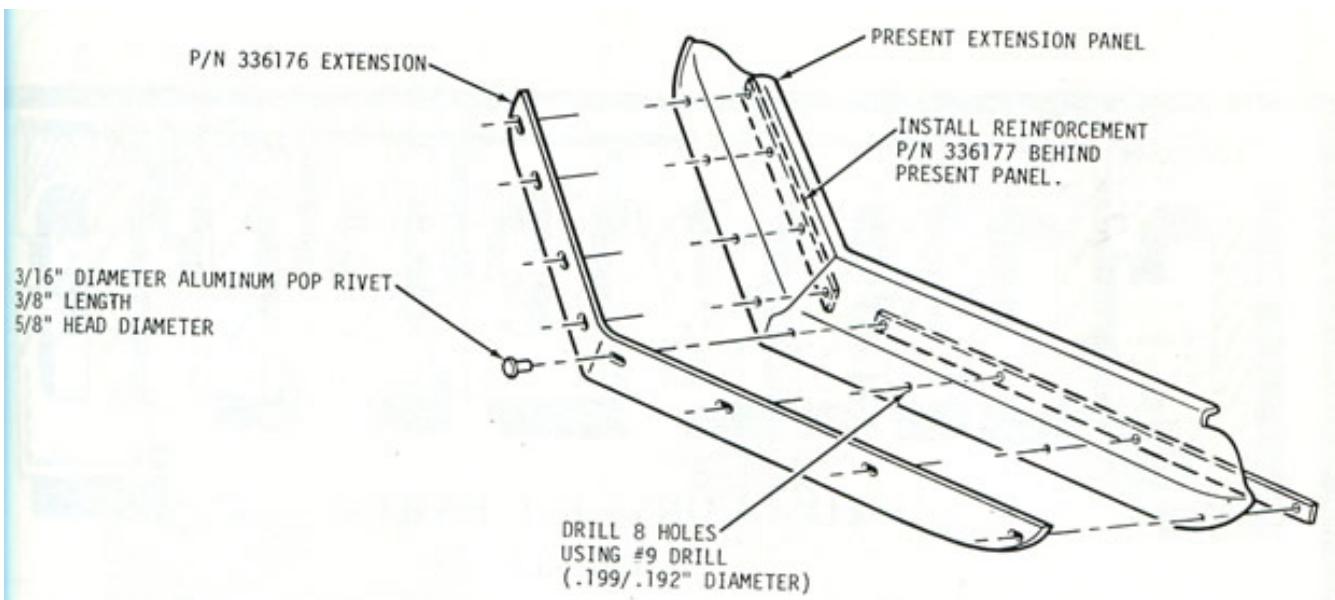
Engine overheat may be encountered on some 1970-1973 Corvettes equipped with the 454 cu. in. engine and air conditioning during high ambient temperatures when operated in heavy traffic. This condition is due to the limited amount of air flowing through the radiator at low vehicle speeds or during periods of extended idle.

To improve low speed cooling, an additional grille panel lower extension was installed in 1973 Corvettes produced after Vehicle Identification Number 1Z3723S410722. This extension, Part Number 336176, may be installed as illustrated on page 2 of this bulletin on early 1973 Corvettes only.
