| Chevrolet | Suburban | 2015-2017 | All | All | 5.3L L83 | All |

| <i>Condition</i> | <p>A vehicle may have a concern of DTC P050D setting along with a P0300 after a cold start up.</p> <p>White smoke and/or coolant odor may come from exhaust for an extended period of time at cold start</p> |

| <i>Cause</i> | Coolant getting into the cylinders |

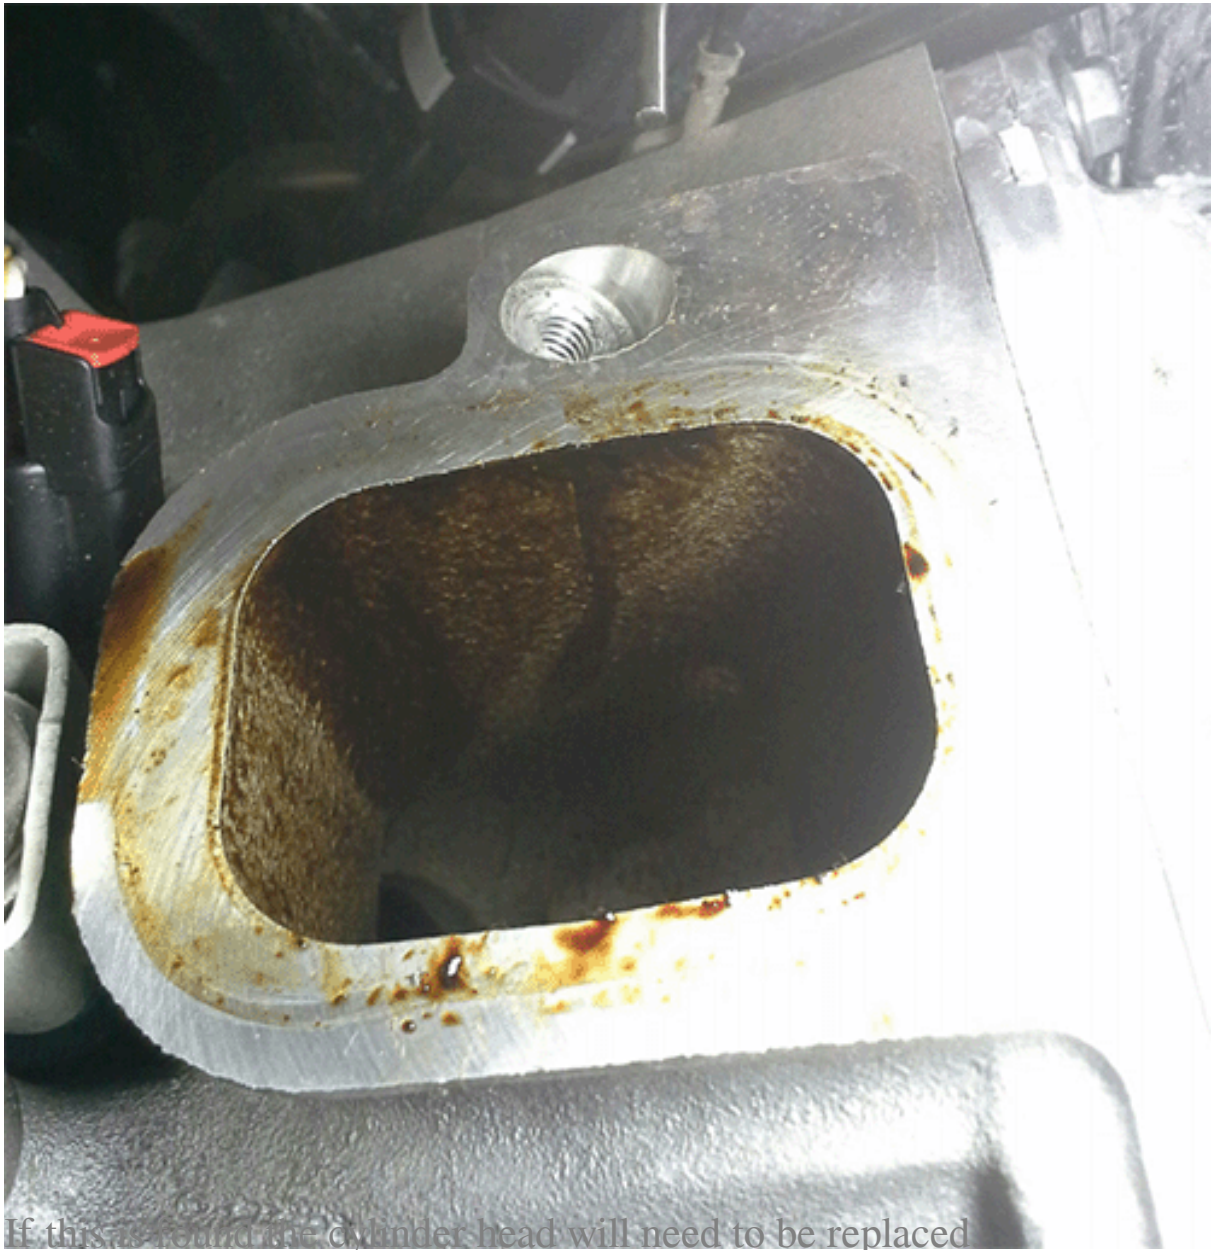
If the head casting line is the concern the intake port will be wet with a coolant oil mix.

If this is found the cylinder head will need to be replaced

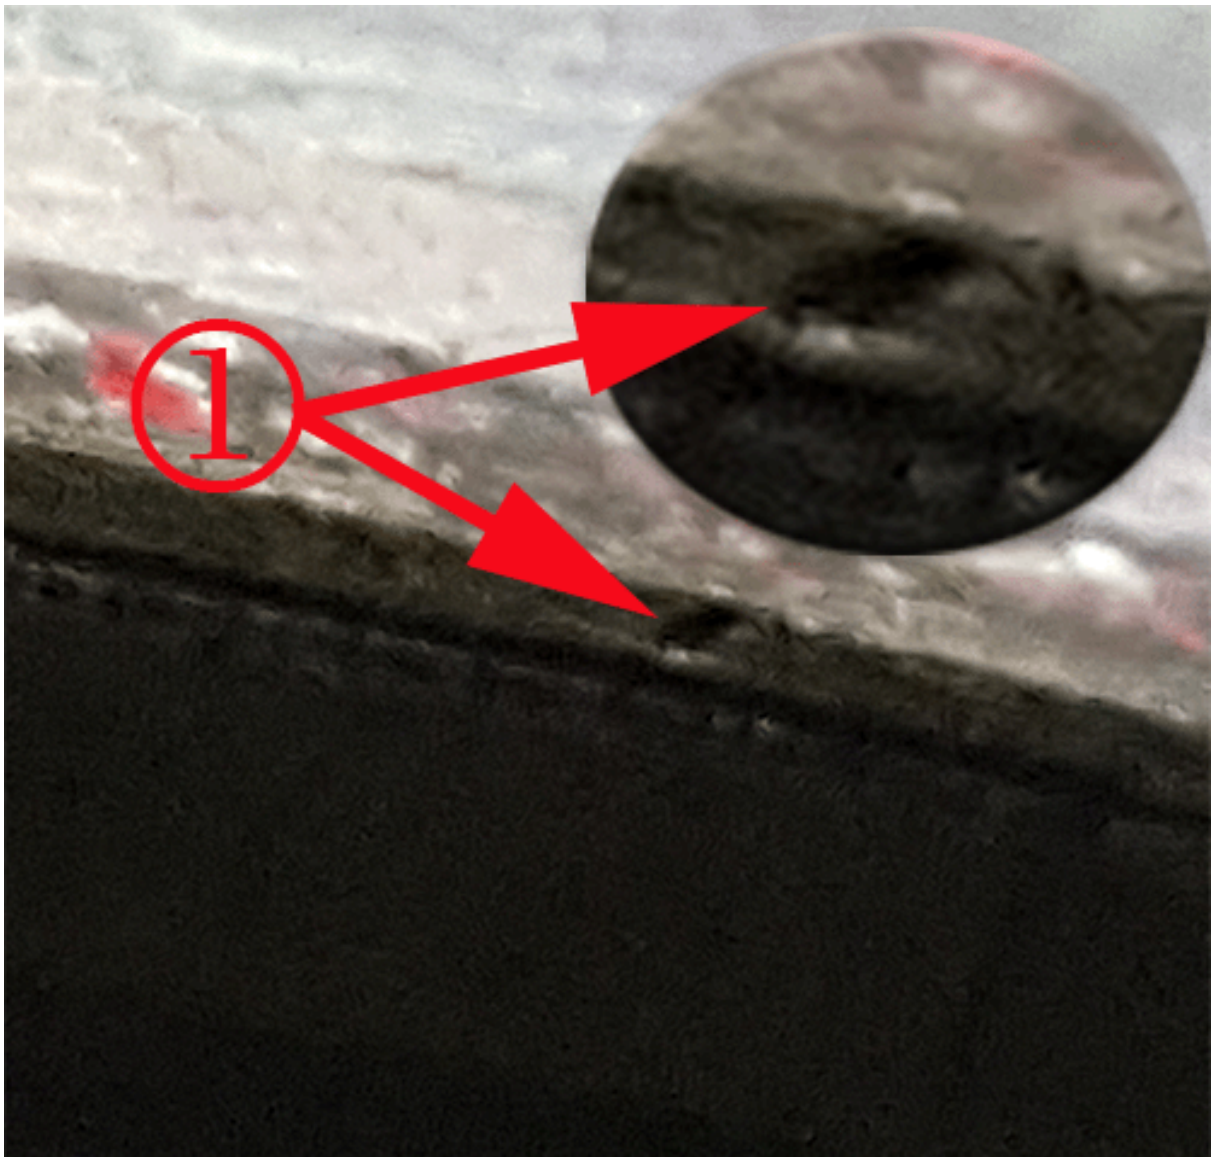
For coolant entry at the liner to deck face casting of the cylinder bore.

It is hard to see the actual source (pin hole) but it usually streams down the liner so that you can see it with a borescope. (Sometimes) The top of the piston will be steam cleaned.

Do not confuse residual fuel on the piston crown / surface as coolant. Some fuel residue may be present and can be mistaken as coolant (reason for the cooling system Dye to be added). Use black light to confirm the liquid is coolant. If this concern is present, do not replace the cylinder head because that will not repair this concern. Call PQC per the latest version of 02-07-30-029, if required, reference this PI and replace the engine.
