Chevrolet	Suburban	2015-2017	All	All	5.3L L83	All
Chevrolet	Tahoe	2015-2017	All	All	4.3L, 5.3L, 6.2L L83, L86, LV1, LV3	All
GMC	Sierra 1500	2014-2017	All	All	4.3L, 5.3L, 6.2L L83, L86, LV1, LV3	All
GMC	Yukon Models	2015-2017	All	All	5.3L, 6.2L L83, L86	All

<i>Involved Region or Country</i>	North America
<i>Additional RPO/s:</i>	N/A
<i>Condition</i>	<p>A vehicle may have a concern of DTC P050D setting along with a P0300 after a cold start up.</p> <p>White smoke and/or coolant odor may come from exhaust for an extended period of time at cold start</p>

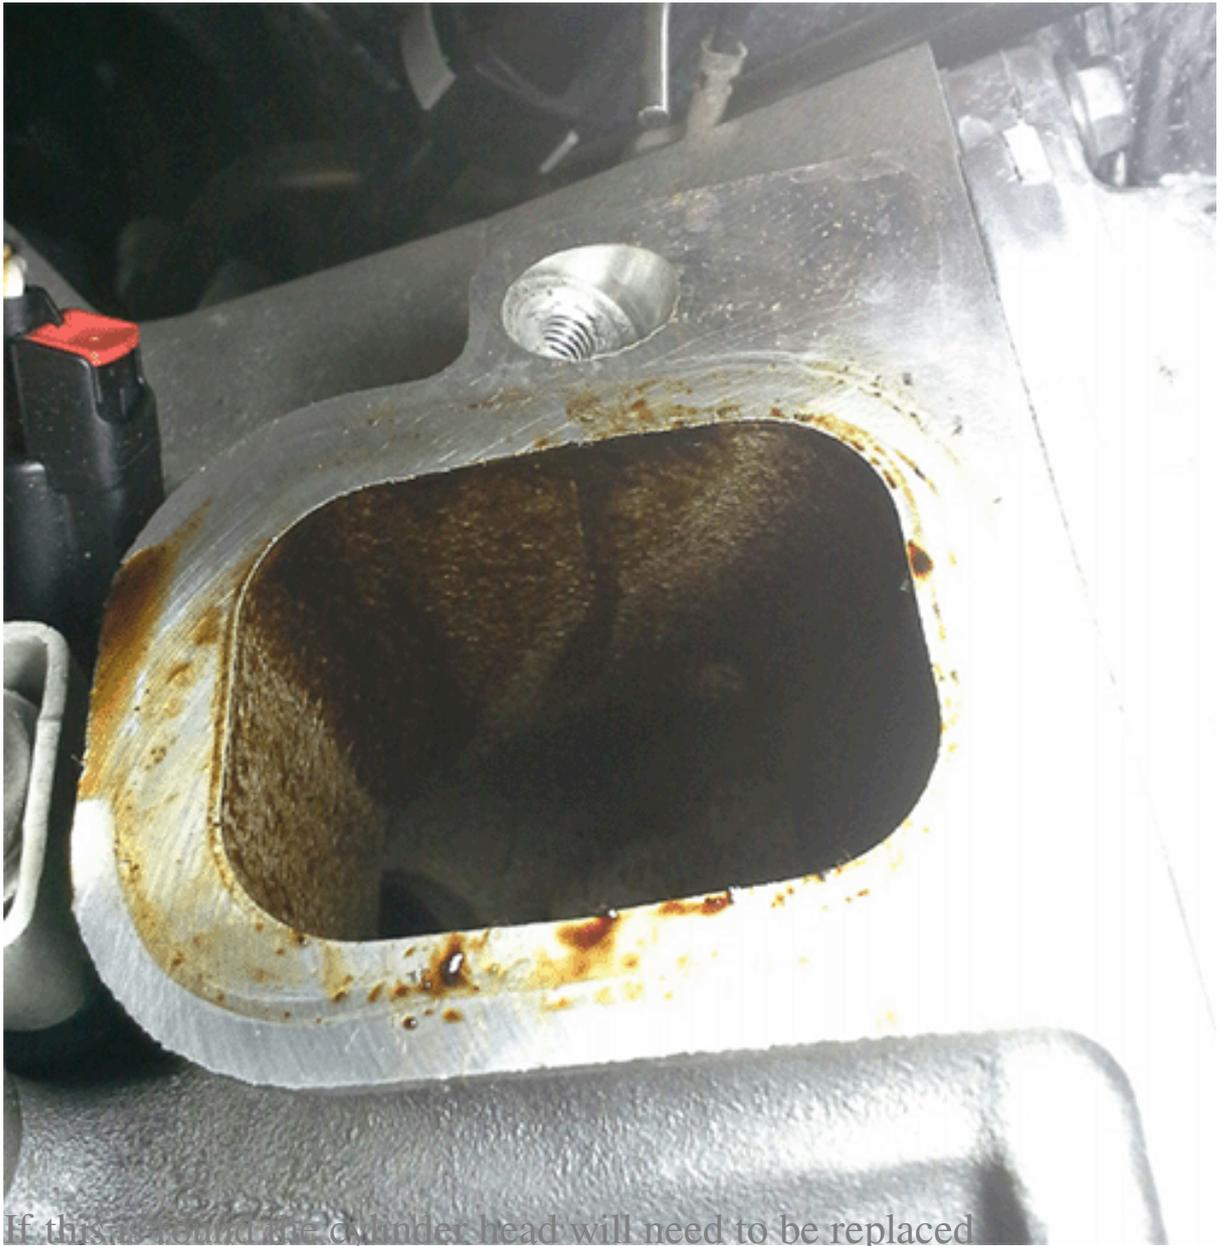
If the head casting line is the concern the intake port will be wet with a coolant oil mix.

If this is found the cylinder head will need to be replaced
