2016 - 2017 Corvette: Service Bulletin: #PIP5498: SES Lamp P050D P0300 Setting On A Cold Start

#PIP5498: SES Lamp P050D P0300 Setting On A Cold Start - (May 18, 2017)

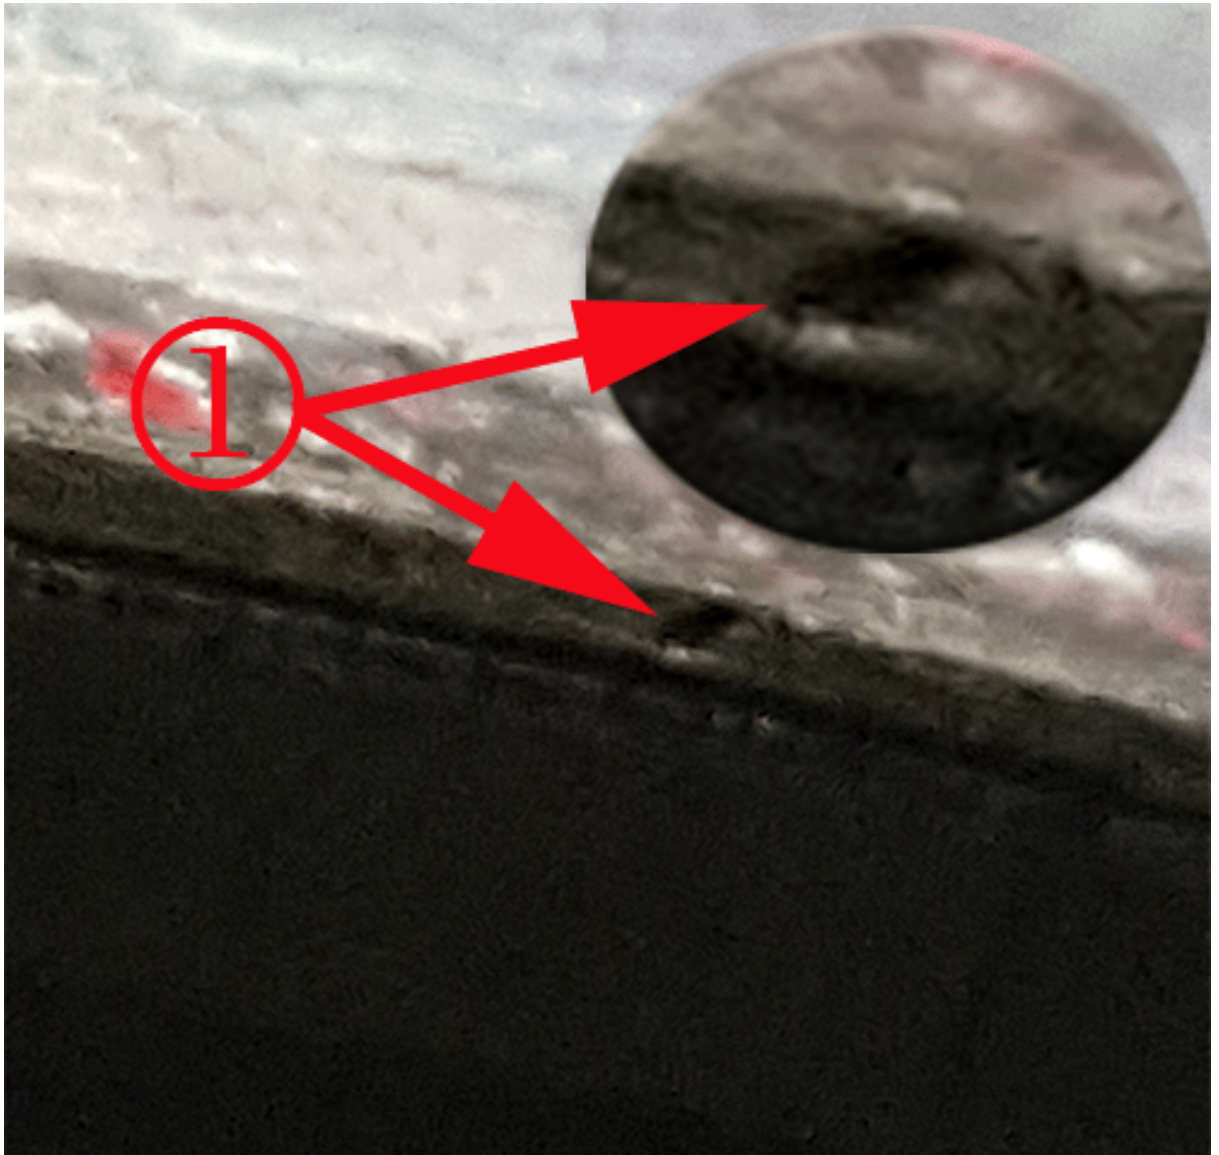
For coolant entry at the liner to deck face casting of the cylinder bore.

It is hard to see the actual source (pin hole) but it usually streams down the liner so that you can see it with a borescope. (Sometimes) The top of the piston will be steam cleaned.

Do not confuse residual fuel on the piston crown / surface as coolant. Some fuel residue may be present and can be mistaken as coolant (reason for the cooling system Dye to be added). Use black light to confirm the liquid is coolant. If this concern is present, do not replace the cylinder head because that will not repair this concern. Call PQC per the latest version of 02-07-30-029, if required, reference this PI and replace the engine.
